**The author(s) shown below used Federal funds provided by the U.S. Department of Justice and prepared the following final report:**

**Document Title: Forensic Analysis of Ignitable Liquid Fuel Fires in Buildings**

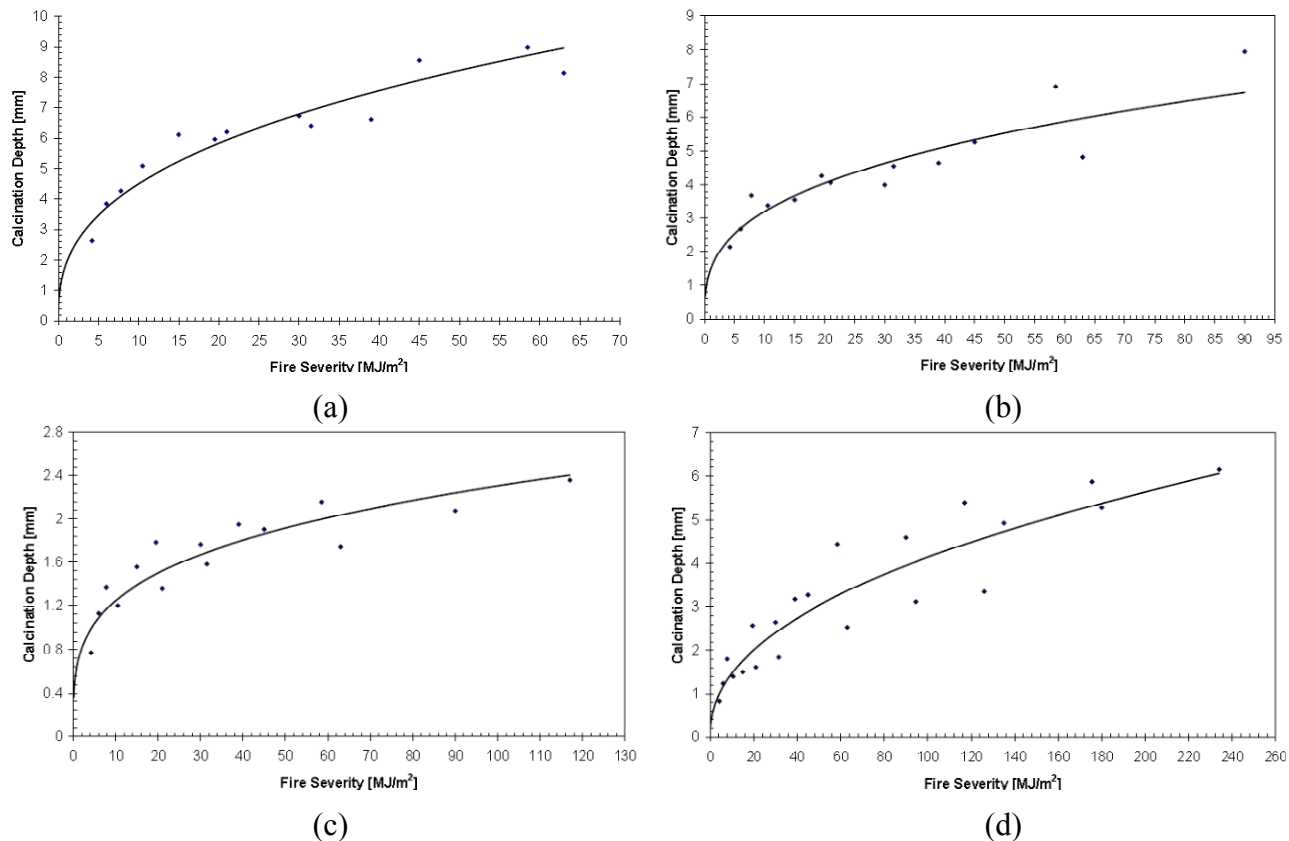
Figure 1. Summary of calcination depth versus fire severity correlations for (a) 10 mm standard board, (b) 10 mm Fireline board, (c) 10 mm Noiseline board, and (d) 19 mm Fireline board developed by Chu [2004].

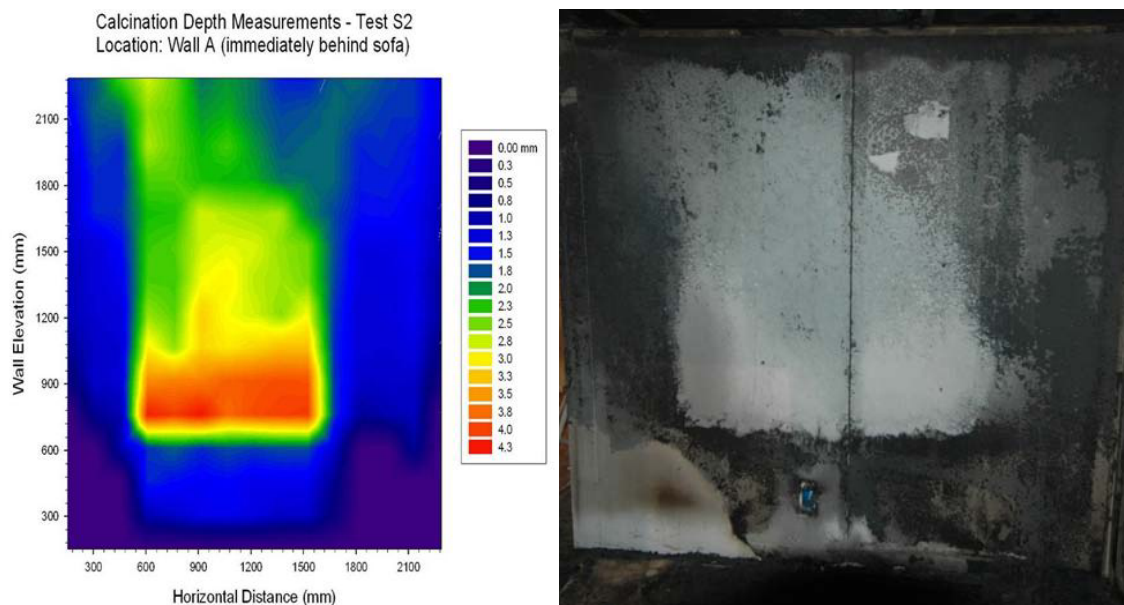
Figure 2. Comparison between calcination probe survey illustration (left) and photograph of fire pattern (right) from Test S2 [Mealy et al. 2006].

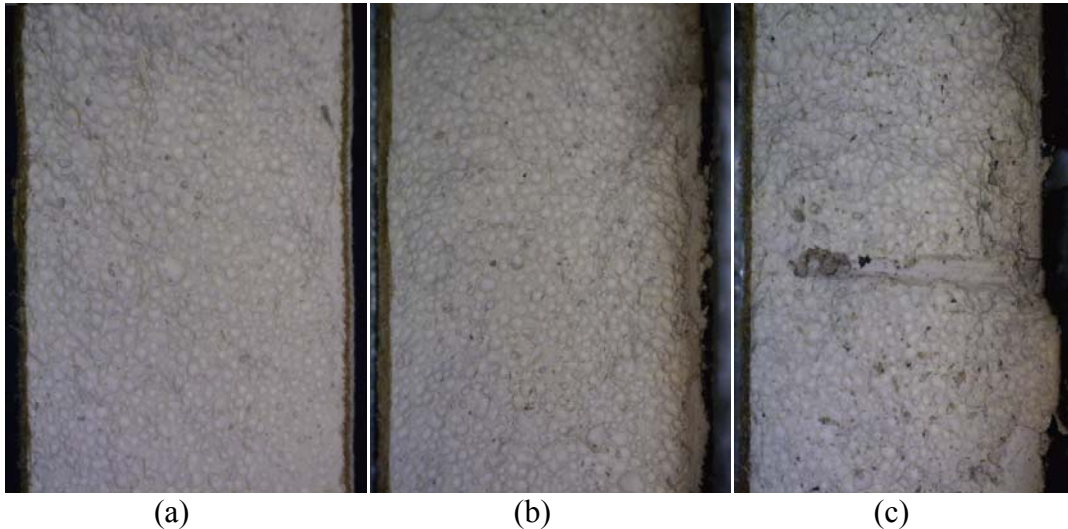
Figure 6. Cross-sections of 12.7 mm (0.5 in.) USG Sheetrock GWB:  
(a) unexposed, (b) 6 MJ/m<sup>2</sup>, and (c) 12 MJ/m<sup>2</sup>.

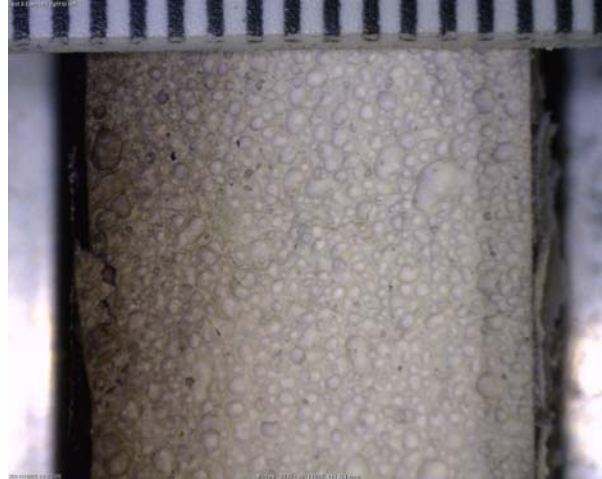
Figure 7. Multiple areas of discoloration within the cross-section of 12.7 mm (0.5 in.) USG Sheetrock GWB exposed on right side to  $65 \text{ kW/m}^2$  for 10 minutes ( $39 \text{ MJ/m}^2$ ).

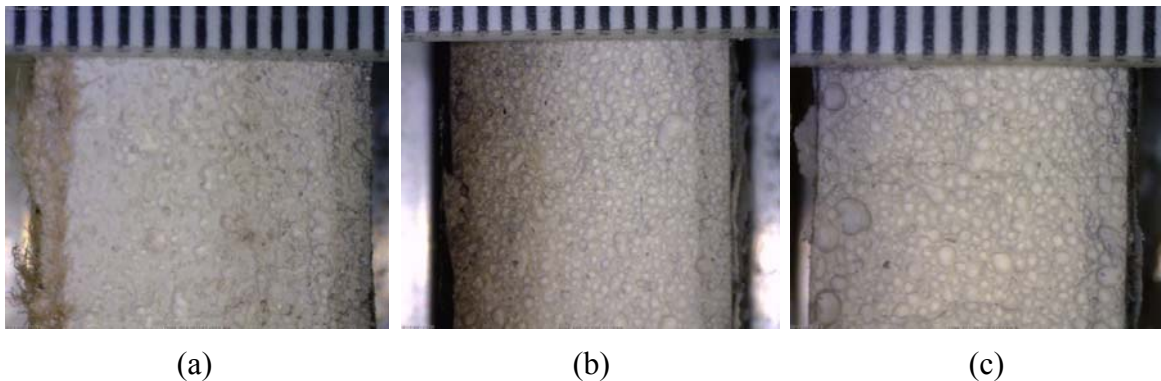
Figure 8. Cross-sections of 12.7 mm (0.5 in.) USG Sheetrock GWB exposed, from the right, to  $65 \text{ kW/m}^2$  for (a) 5 min. ( $20 \text{ MJ/m}^2$ ), (b) 10 min. ( $39 \text{ MJ/m}^2$ ), and (c) 30 min. ( $117 \text{ MJ/m}^2$ ).

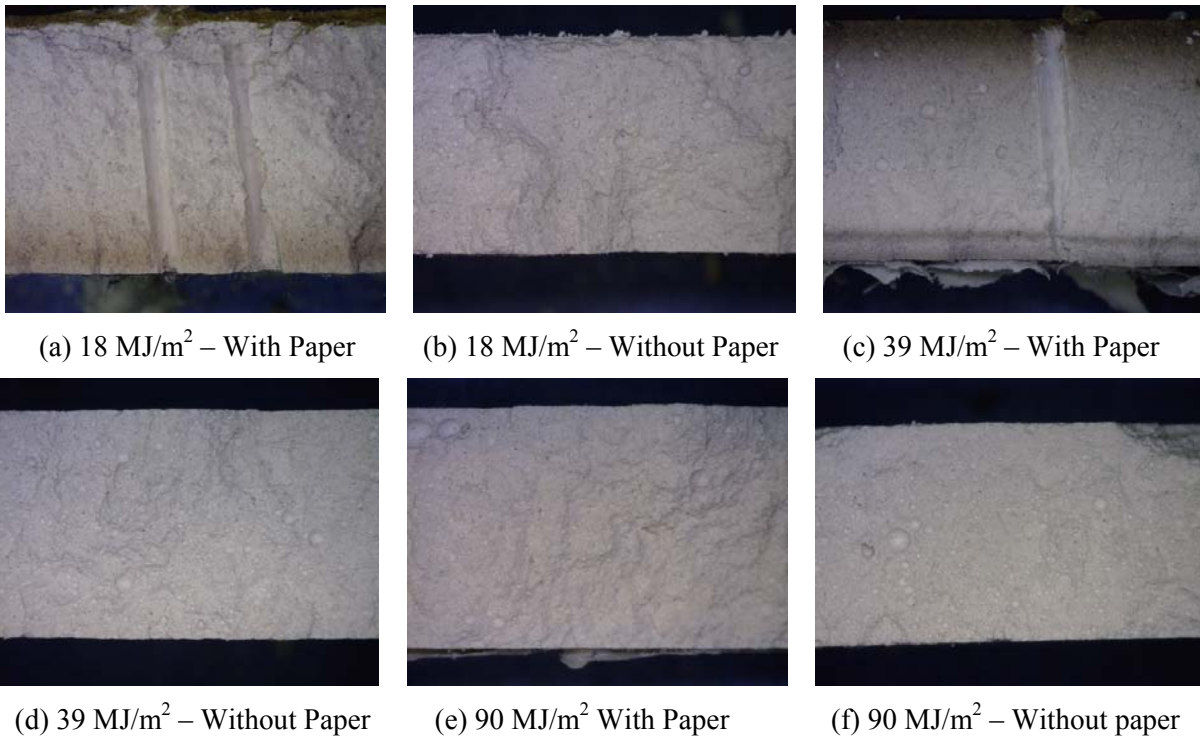
Figure 9. Side by side comparison of CertainTeed GWB exposed to 18, 39, and 90 MJ/m<sup>2</sup> with and without paper facing.

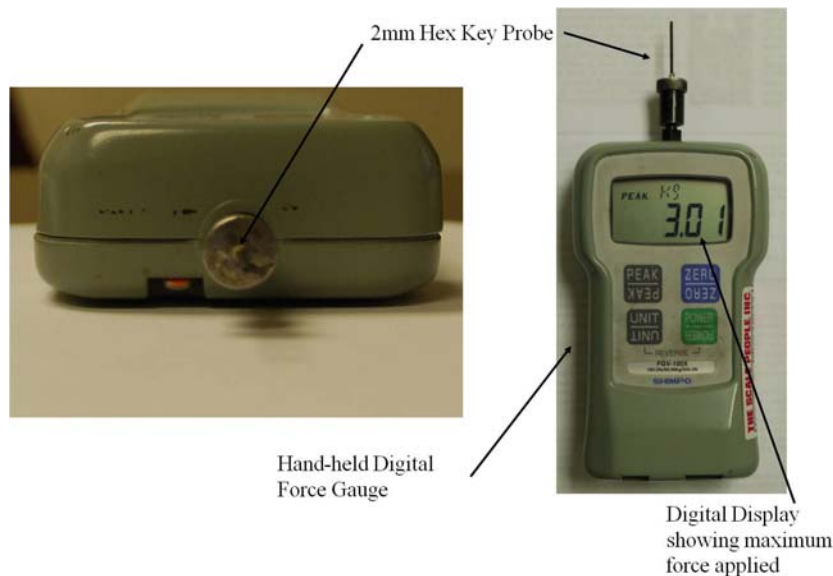
Figure 10. Hand-held calcination depth probe.

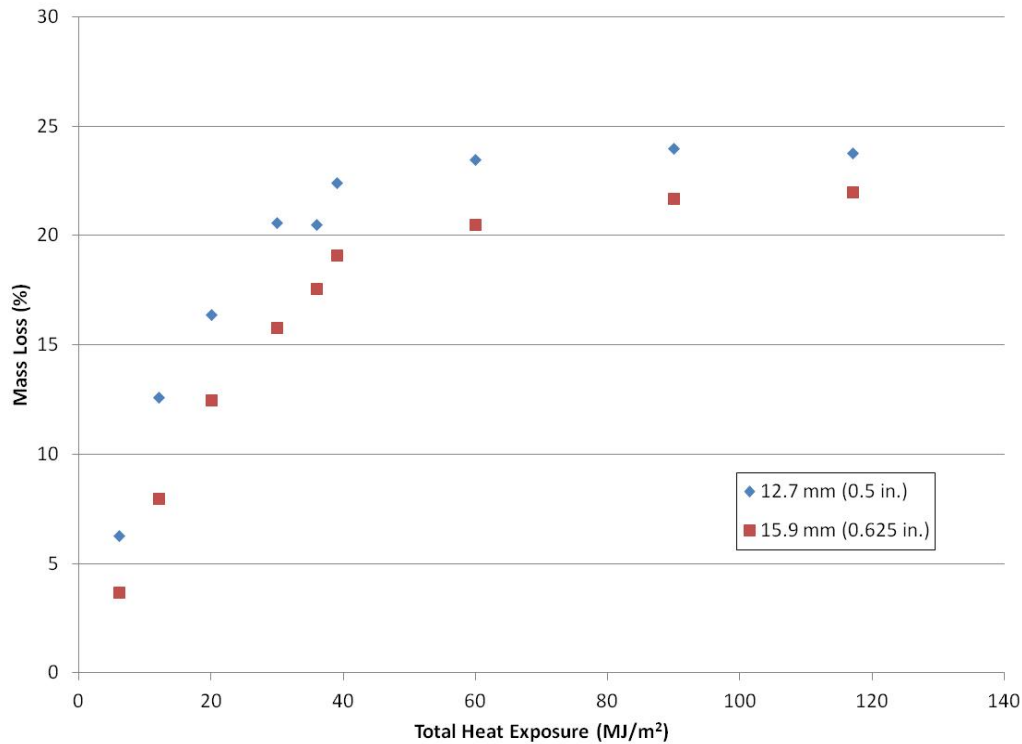
Figure 12. Mass loss as a function of heat exposure for small-scale GWB samples.

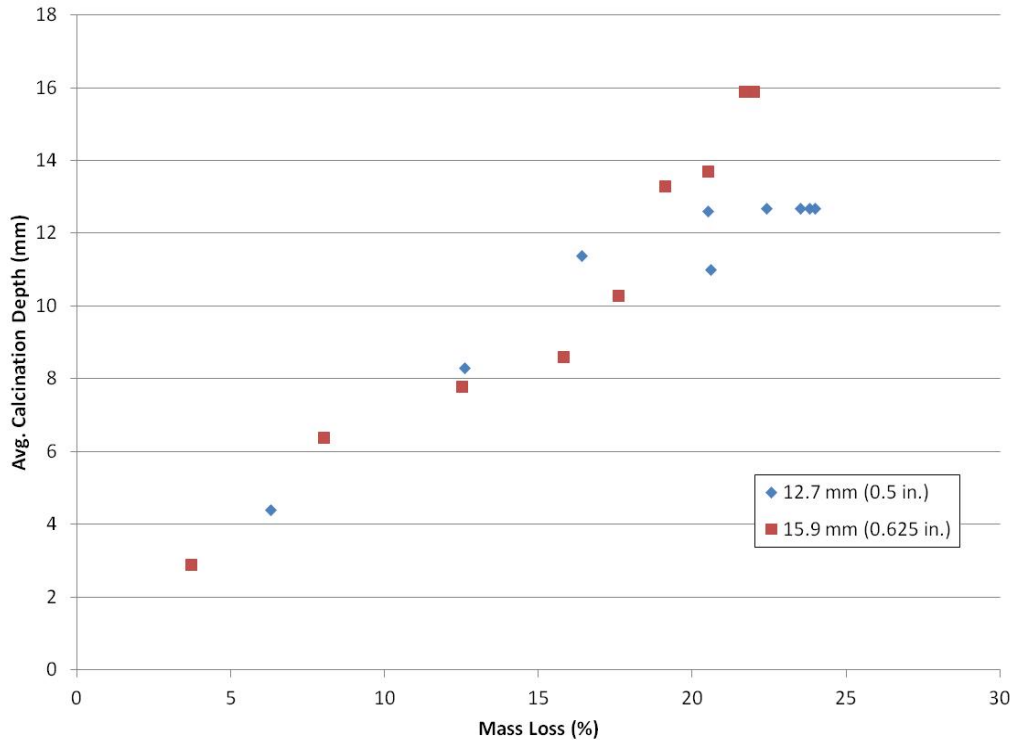
Figure 14. Calcination depths in relation to mass loss percentages.

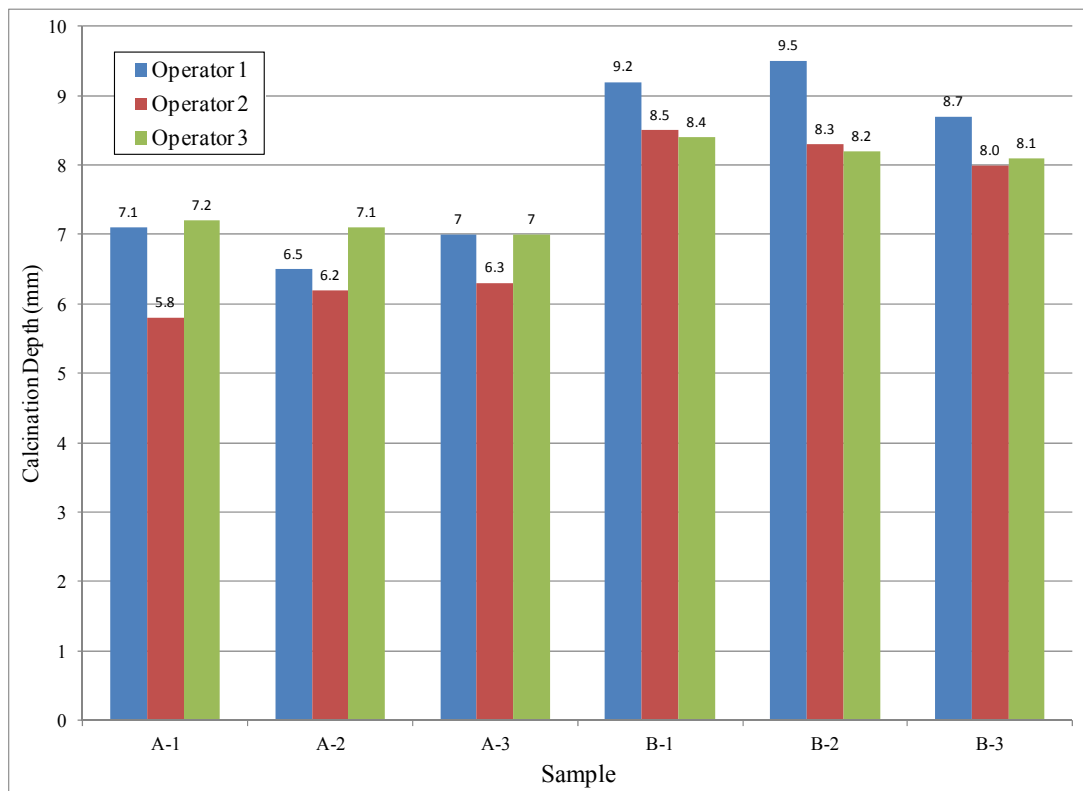
Figure 15. Comparison of calcination depth measurements collected by three different operators.

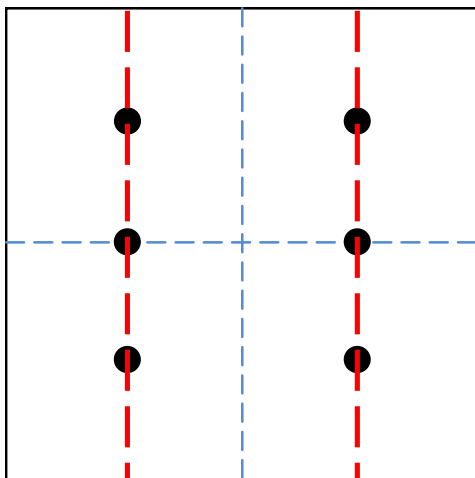
Figure 16. Probe (black circles) and break (red dashed line) locations. Centerlines (blue dashed line) shown for reference.

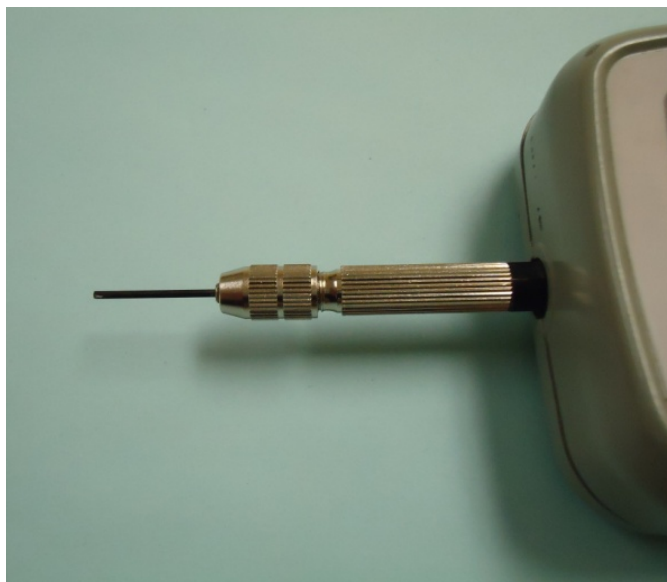
Figure 17. Chuck Attachment with Hex Key

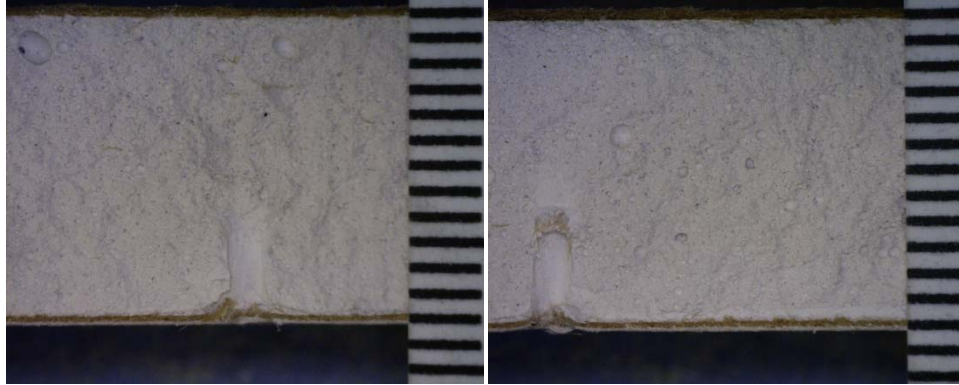
(a) CertainTeed – 3 MJ/m<sup>2</sup>

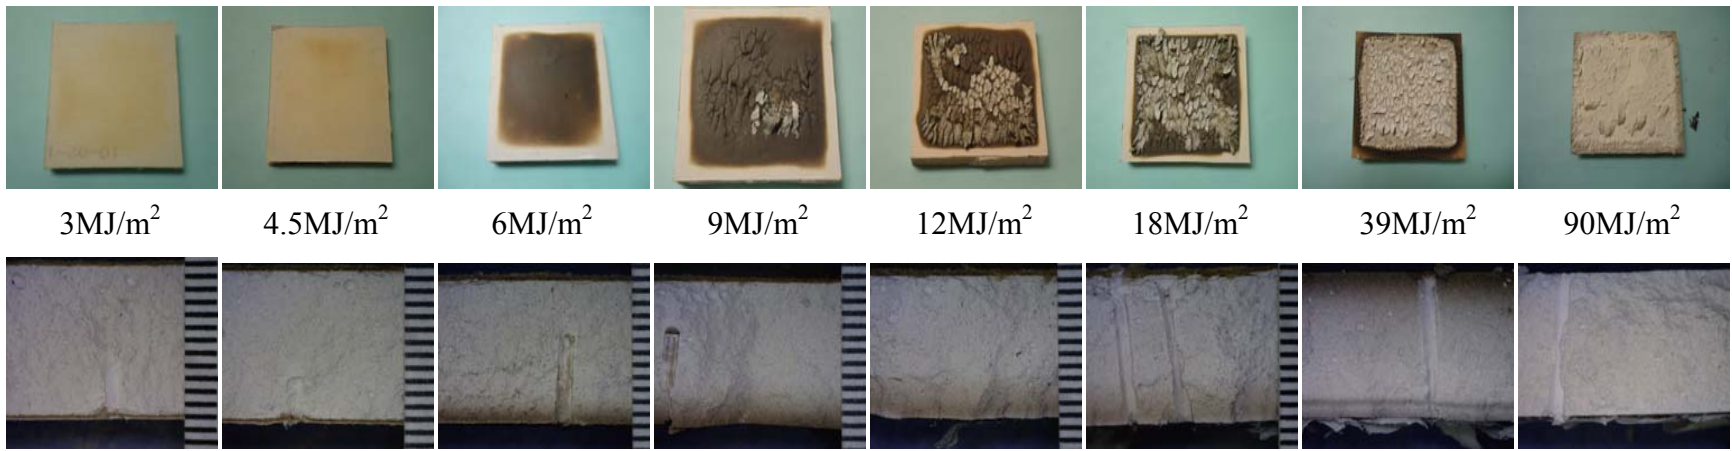
Figure 21. Visual progression of CertainTeed GWB face and cross section.

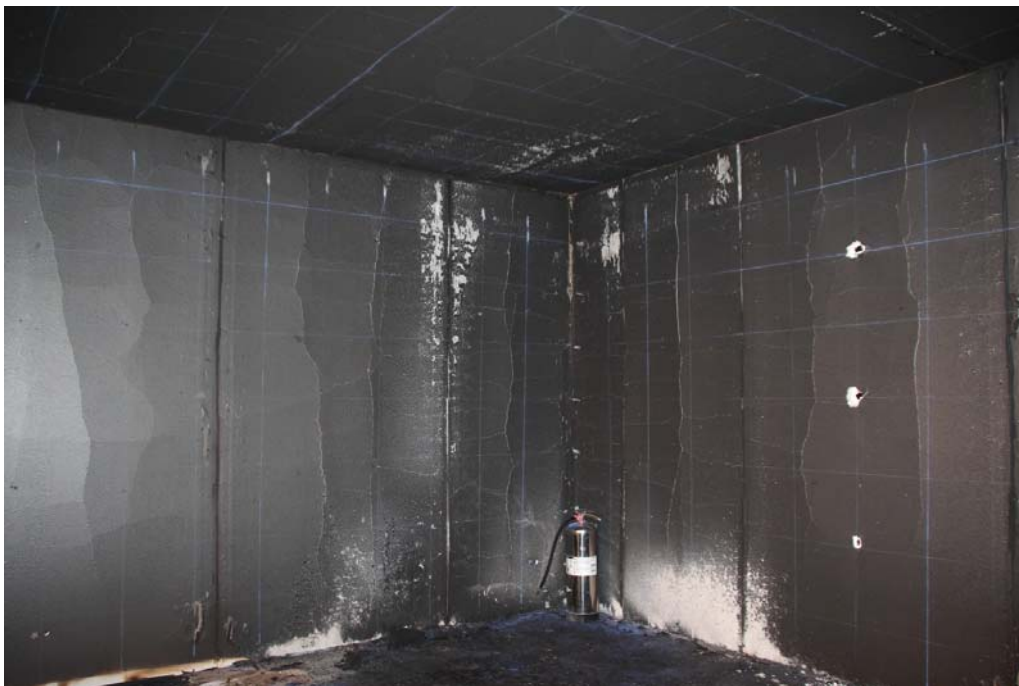
Figure 22. Chalk line grid (blue) installed over top of thermally damaged GWB for calcination depth survey.

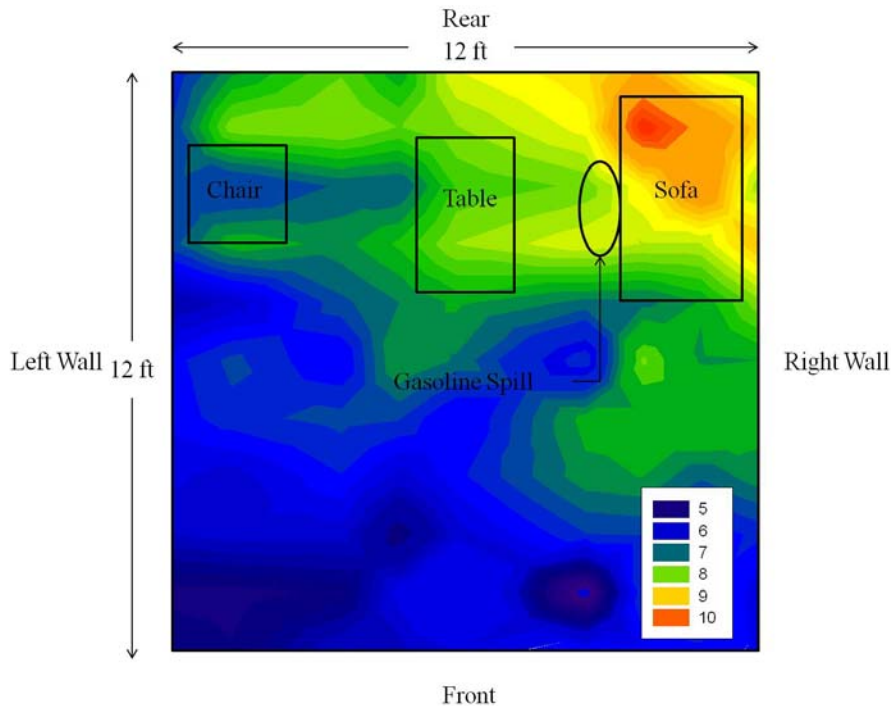
Figure 23. Calcination depth contour plot of ceiling in Test 6-2 (color-coded depths in mm).

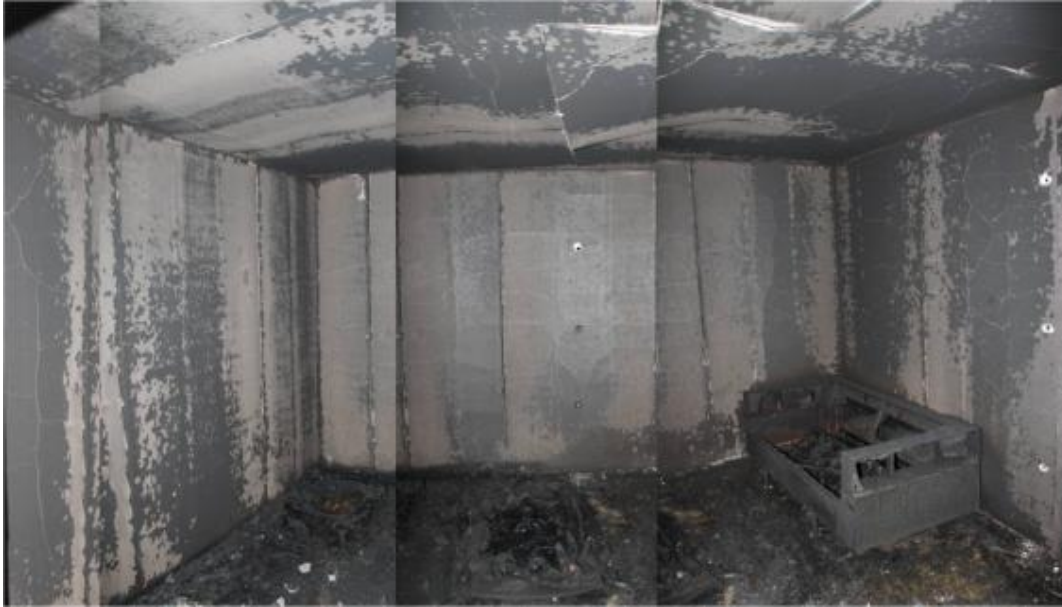
Figure 24. Composite photograph of fire patterns on walls and ceiling of enclosure after Test 6-4.

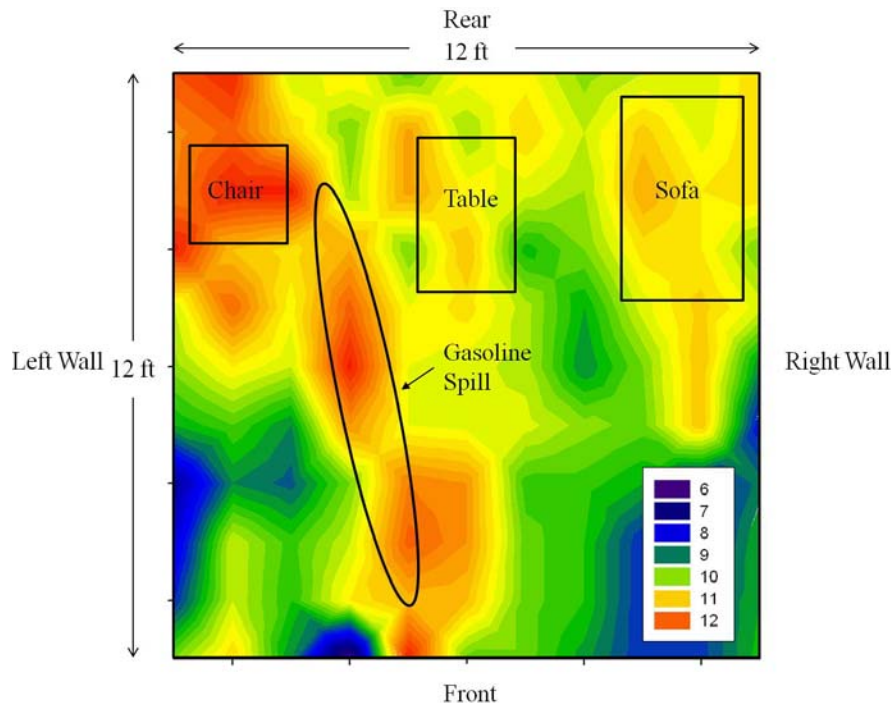
Figure 25. Calcination depth contour plot of ceiling in Test 6-4 (color-coded depths in mm).

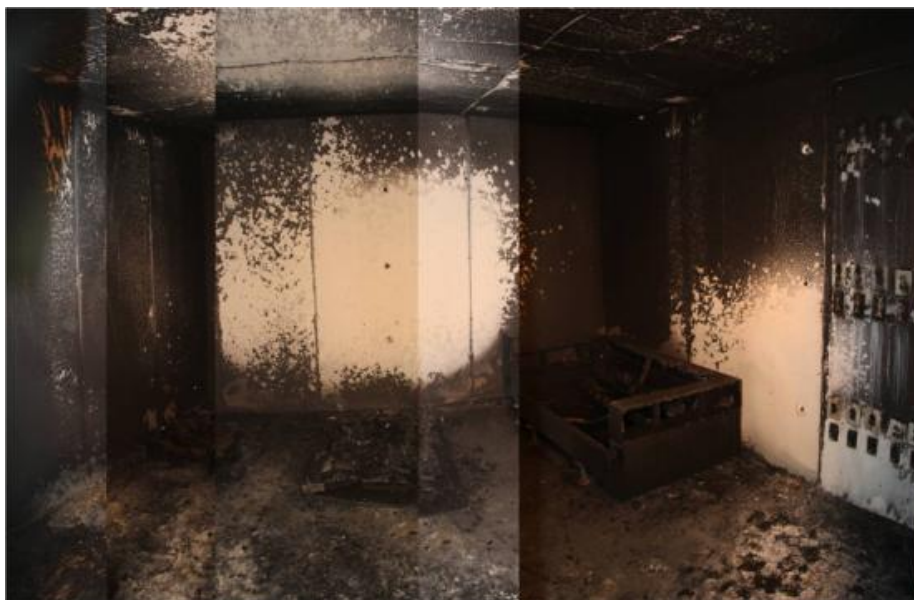
Figure 26. Fire patterns on walls and ceiling of enclosure after Test 6-5.

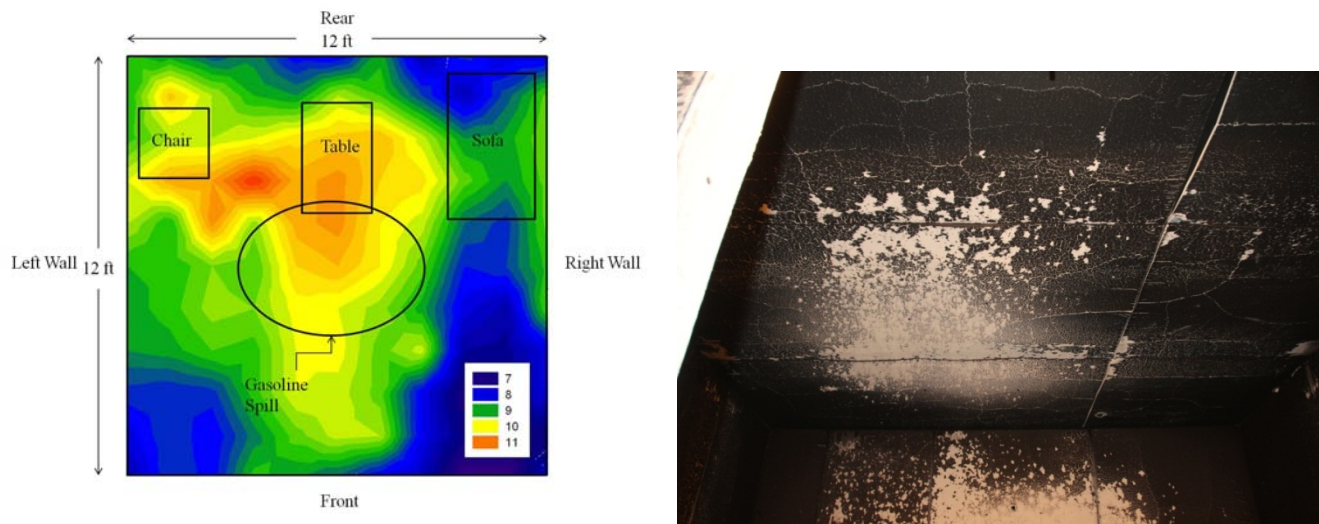
Figure 27. Calcination depth contour plot of ceiling in Test 6-5 [left] (color-coded depths in mm) and photograph of condition of ceiling [right].

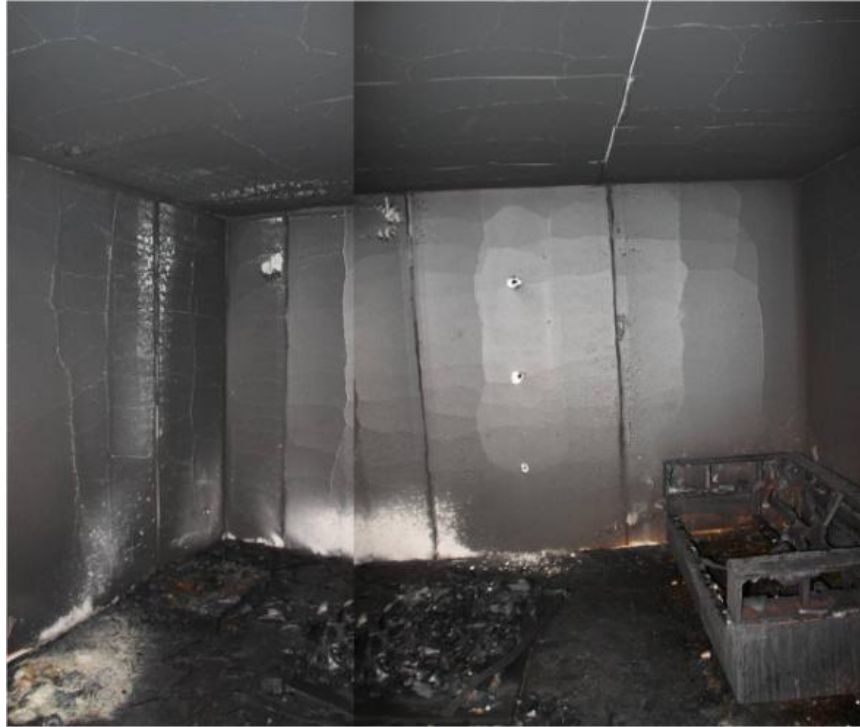
Figure 28. Condition of the walls and ceiling of enclosure after Test 6-6.

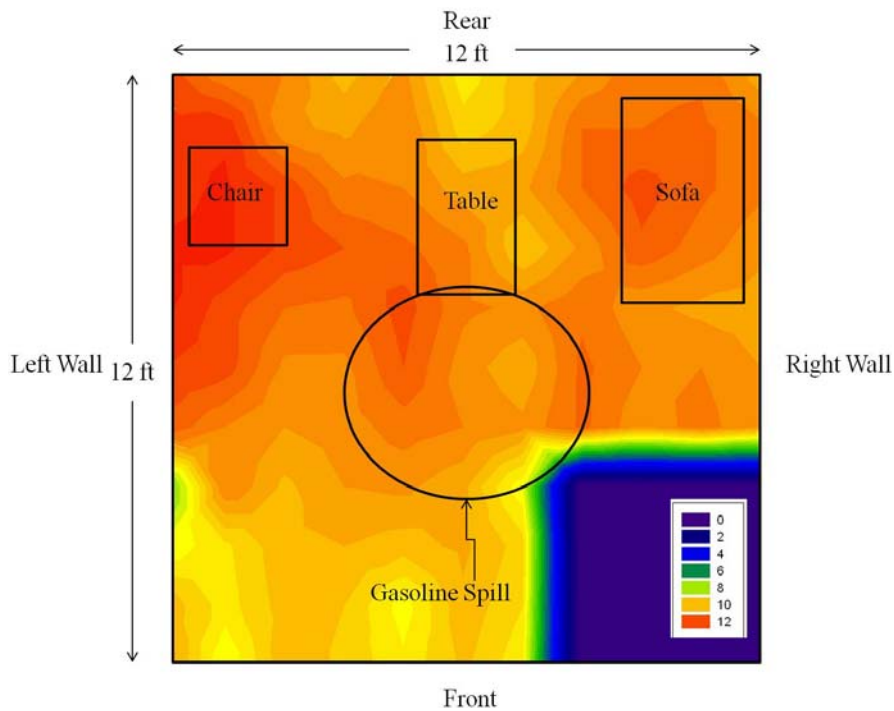
Figure 29. Calcination depth contour plot of ceiling in Test 6-6 (color-coded depths in mm).

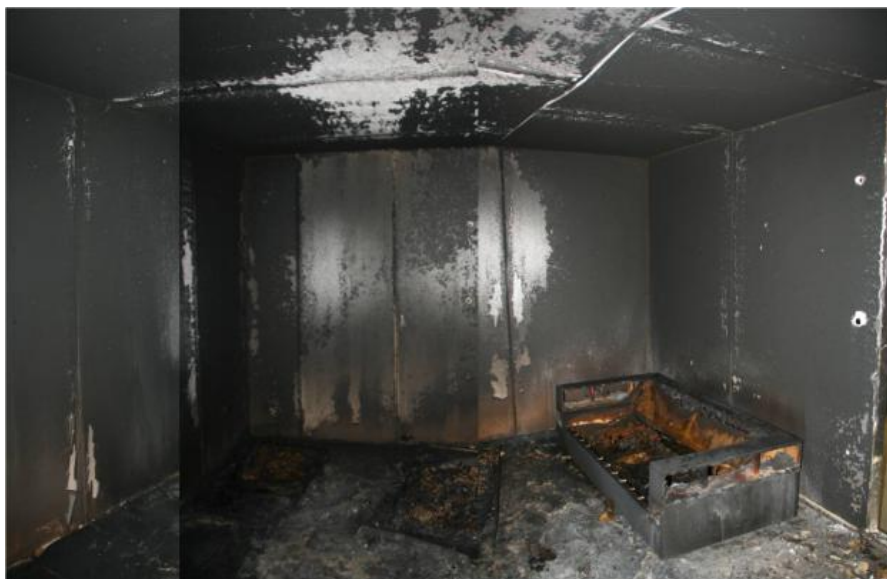
Figure 31. Condition of enclosure ceiling after Test 6-7.

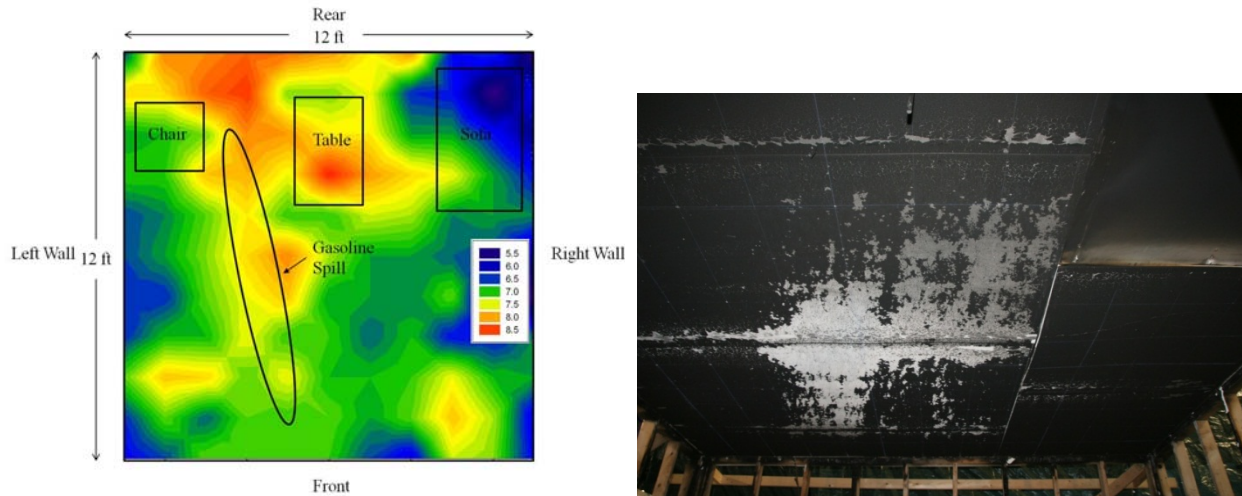
Figure 32. Calcination depth contour plot of ceiling in Test 6-7 [left] (color-coded depths in mm) and photograph of ceiling condition [right].

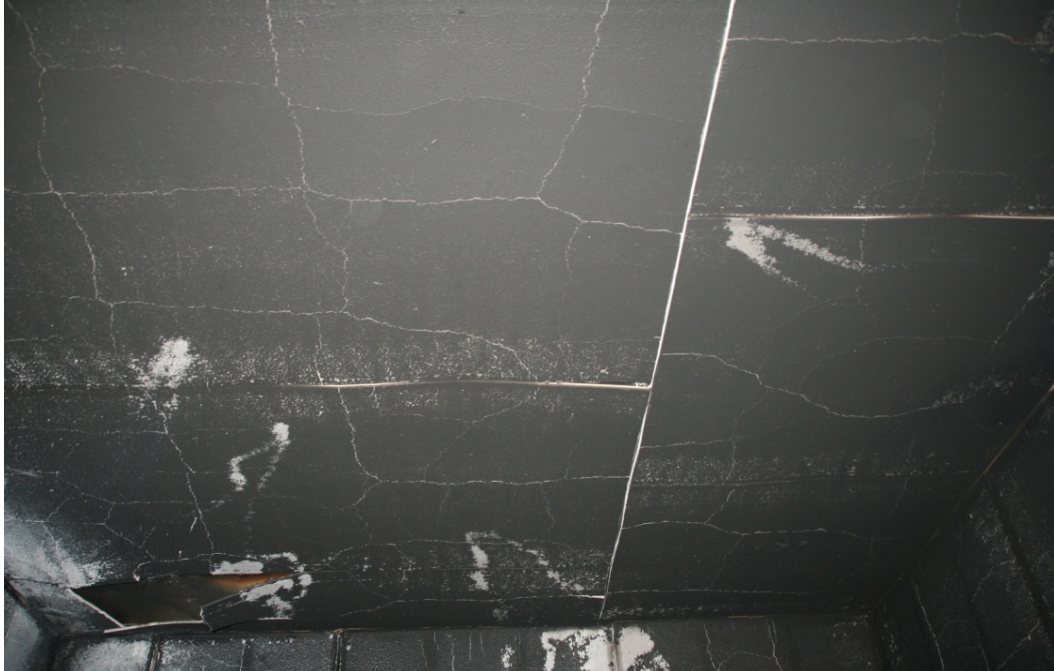
Figure 33. Condition of enclosure ceiling after Test 6-8.

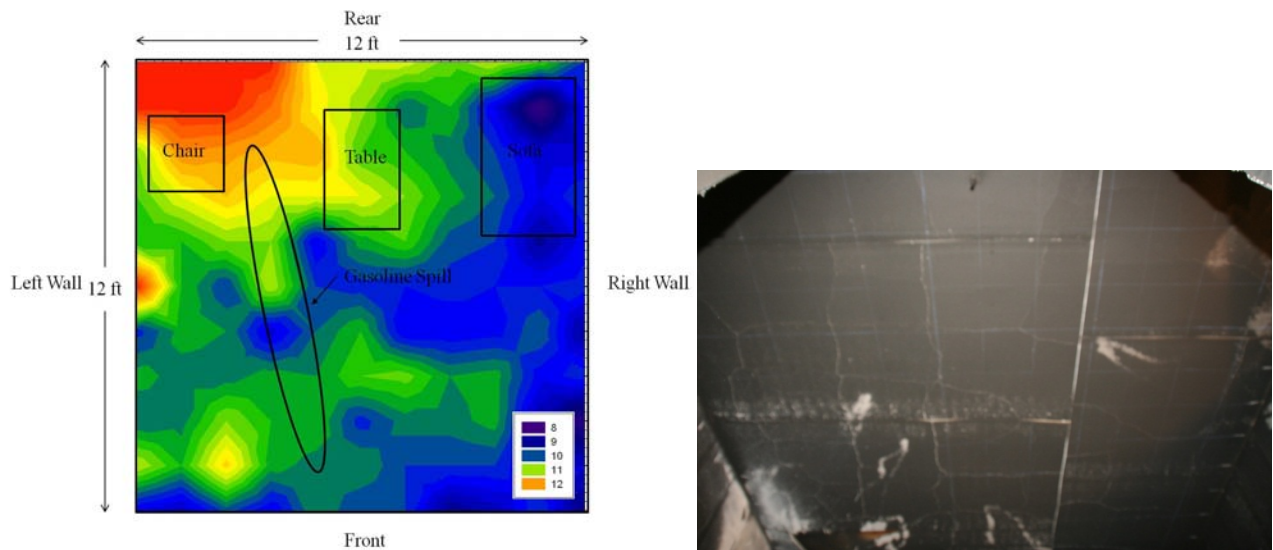
Figure 34. Calcination depth contour plot of ceiling in Test 6-8 [left] (color-coded depths in mm) and photograph of the ceiling condition [right].

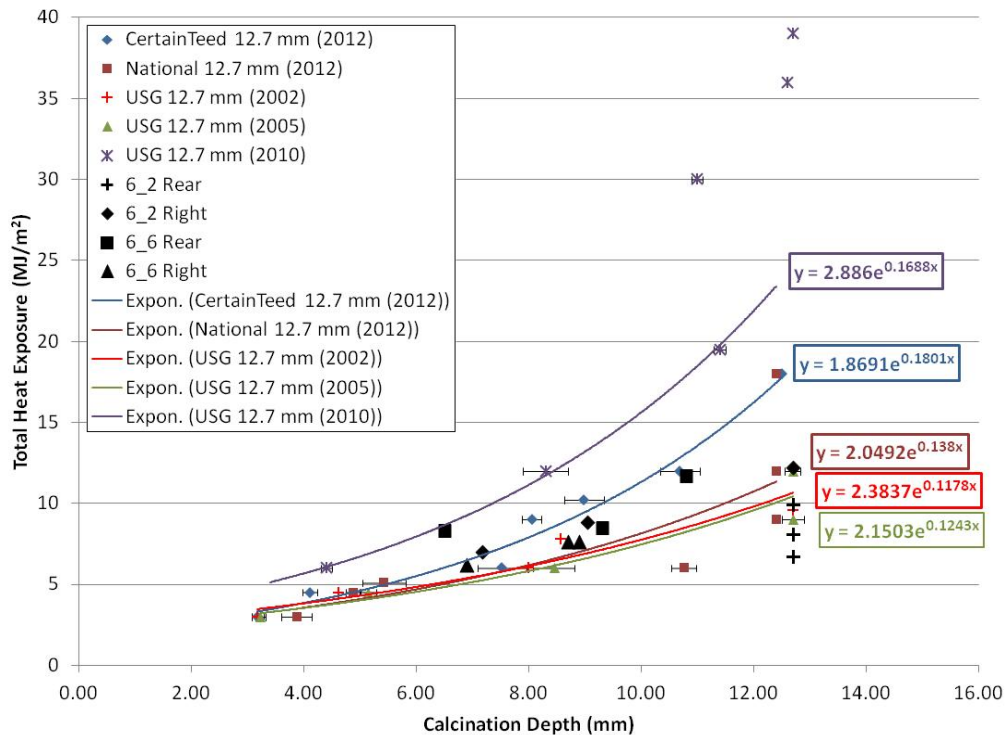
Figure 35. Full-scale calcination measurements compared to 12.7 mm (0.5 in.) GWB correlations.

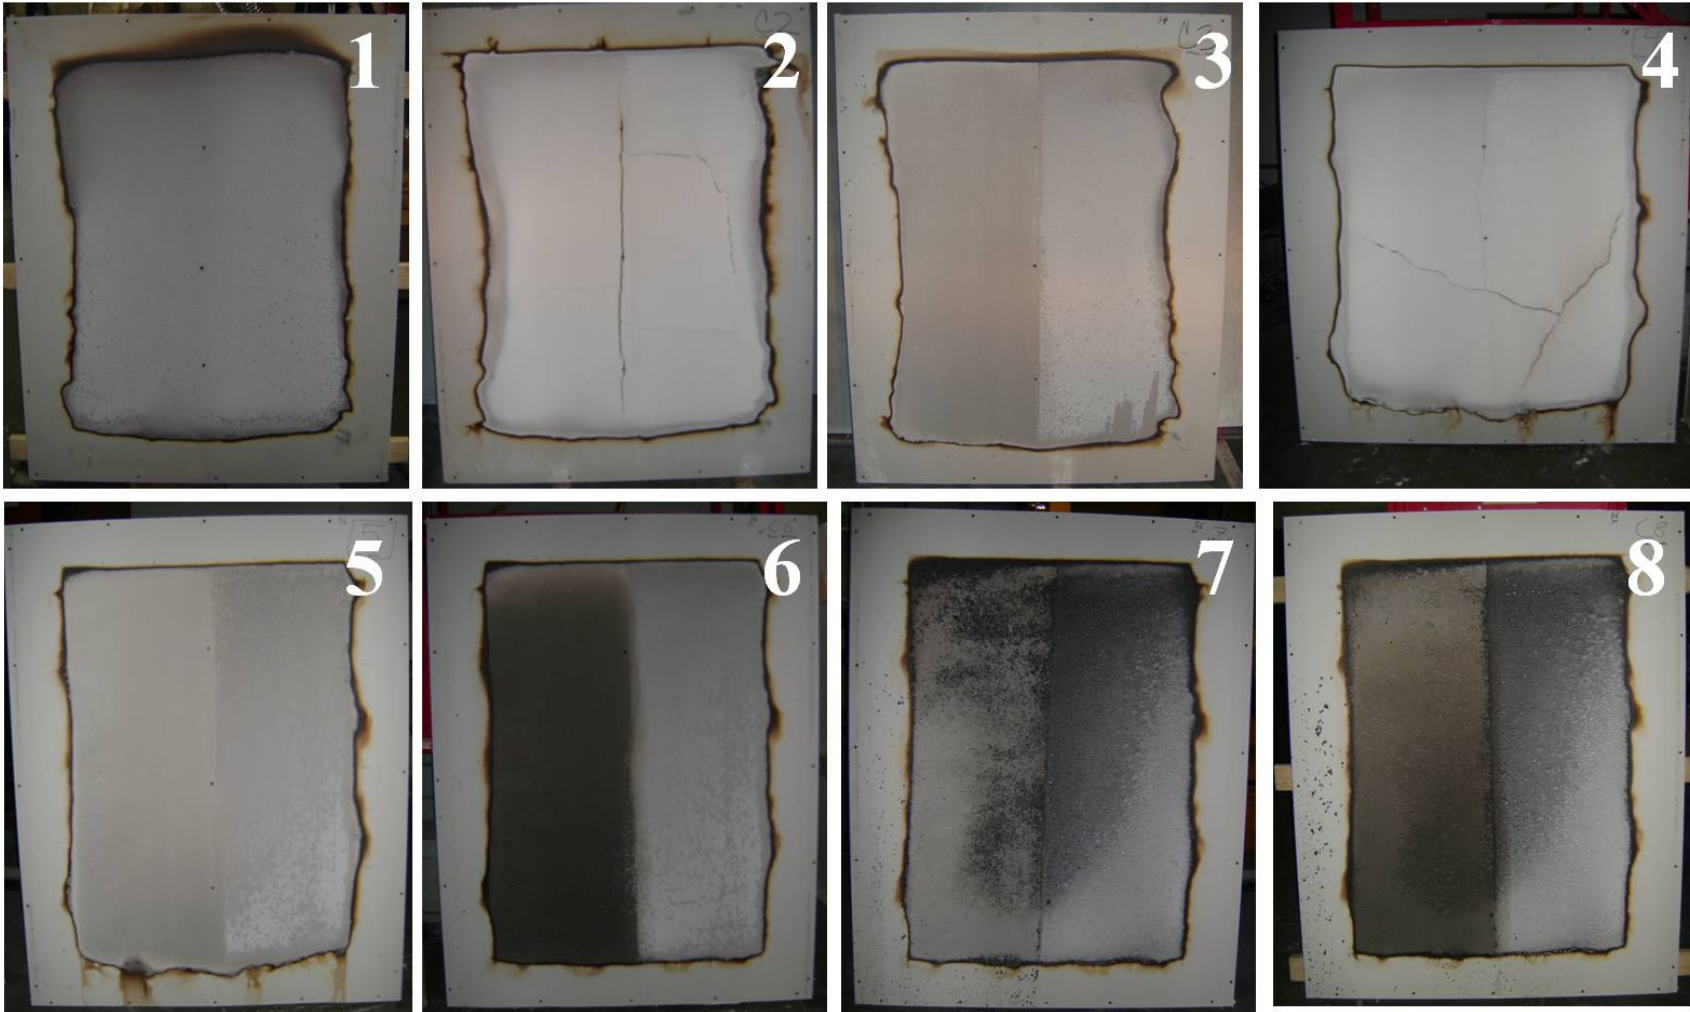
Figure 39. Condition of intermediate-scale test walls after thermal and water spray exposures (left side of each image).

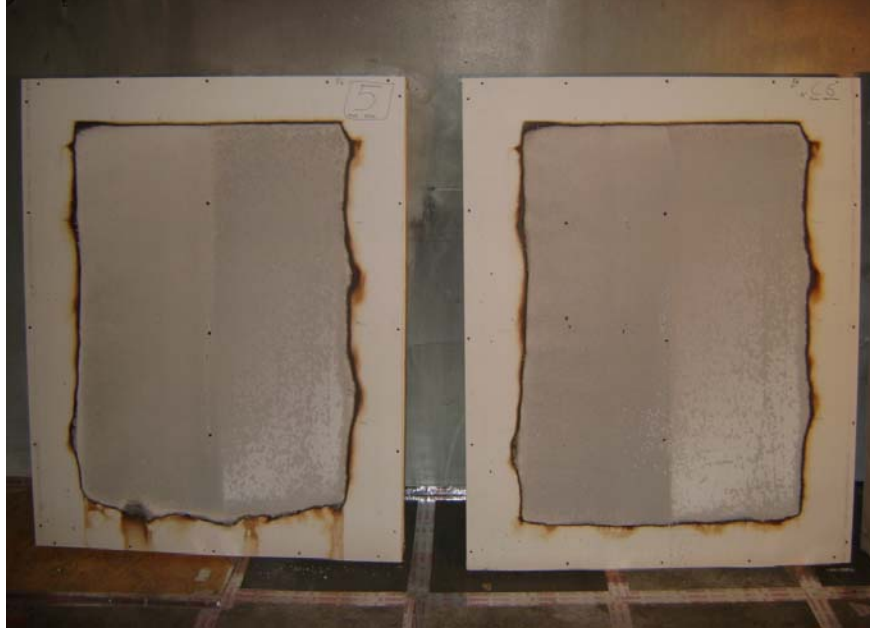
Figure 40. Comparison of test wall color (Test 5 [left] and Test 6 [right]) after 30 day drying period.

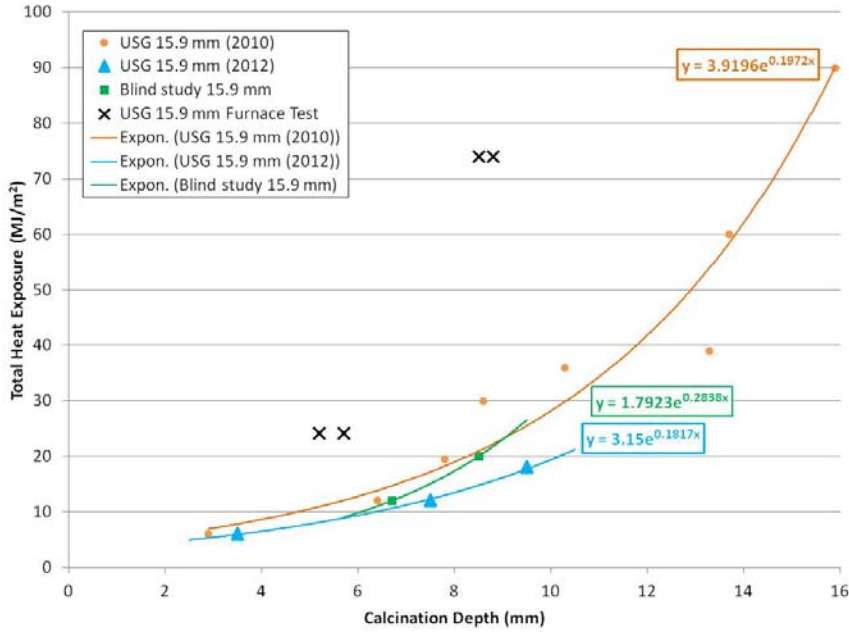
Figure 42. Furnace test comparison to calcination correlations (15.9 mm USG).

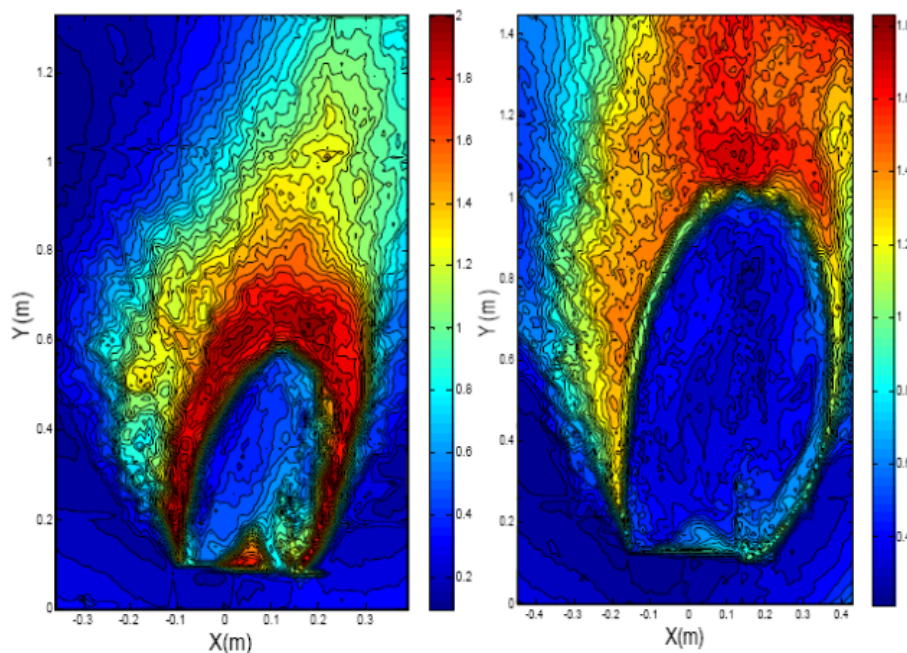
Figure 43. Optical density contour plots of soot deposition on gypsum wallboard from adjacent gasoline pool fires as presented by Riahi [2011]. Image on left represents the 440 s exposure while image on right represents 700 s exposure.

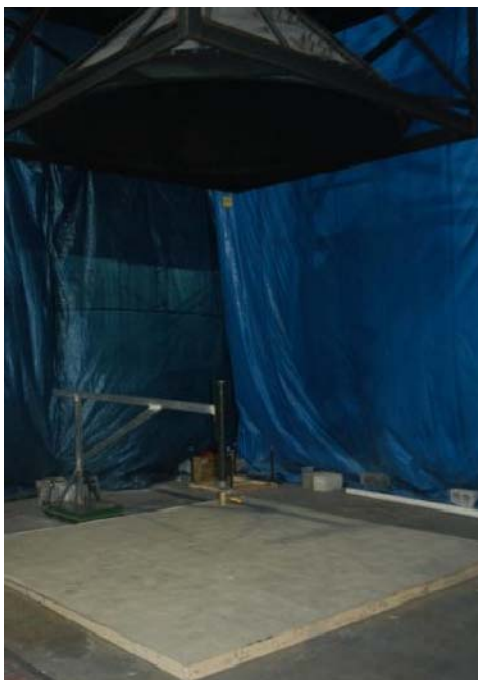
Figure 44. Vinyl floor constructed for open burn testing.

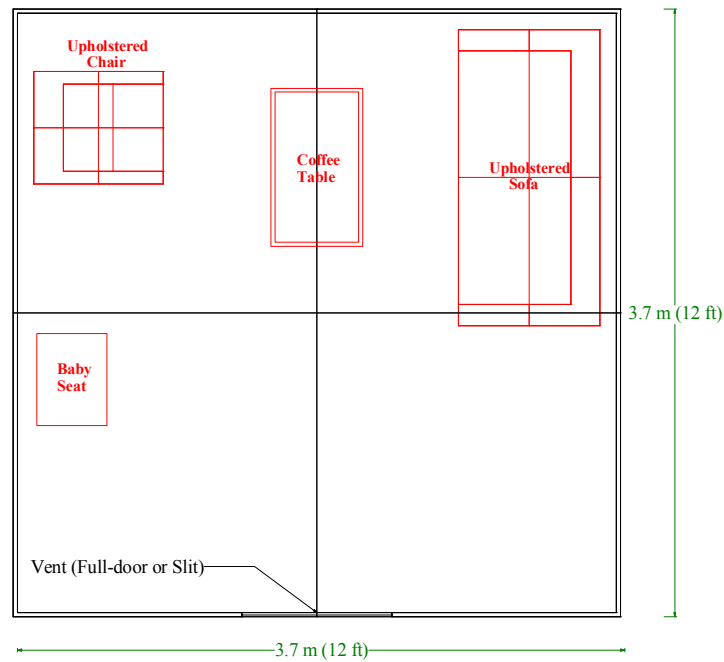
Figure 45. Plan view of test enclosure with Class A furnishings present.

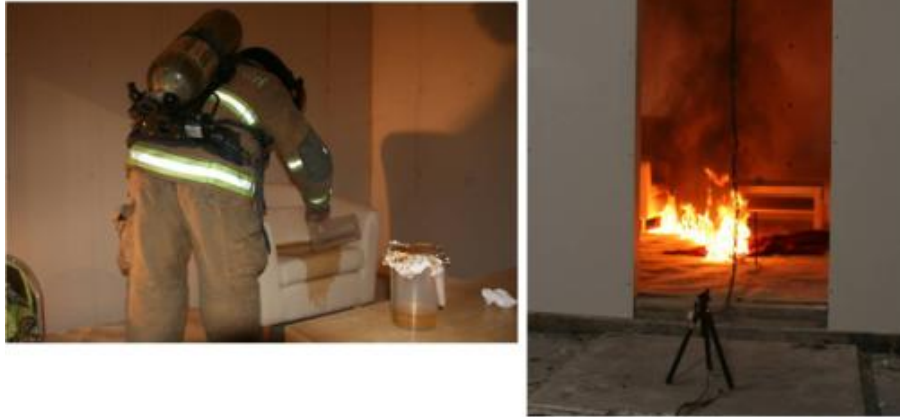
Figure 48. Gasoline spill on seat of upholstered chair (left) and trailer leading from front of chair to doorway (right).

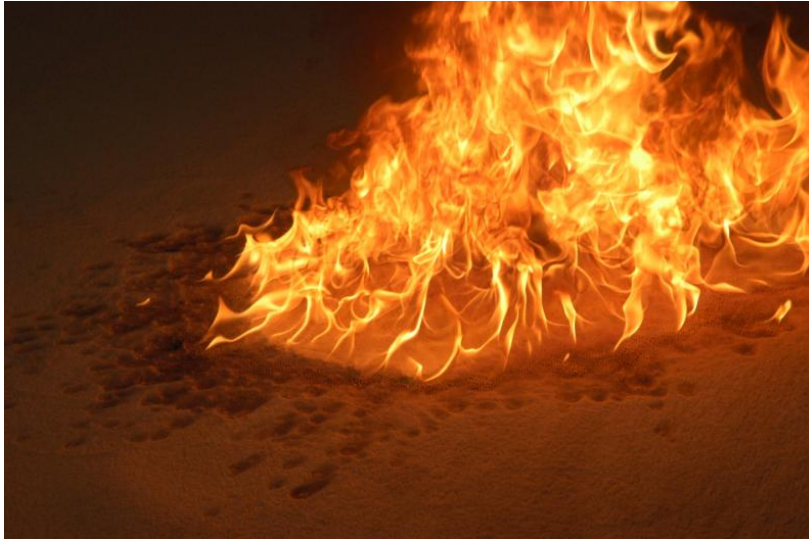
Figure 49. Early stage of gasoline spill fire on carpet.
