**The author(s) shown below used Federal funds provided by the U.S. Department of Justice and prepared the following final report:**

**Document Title: Forensic Analysis of Ignitable Liquid Fuel Fires in Buildings**

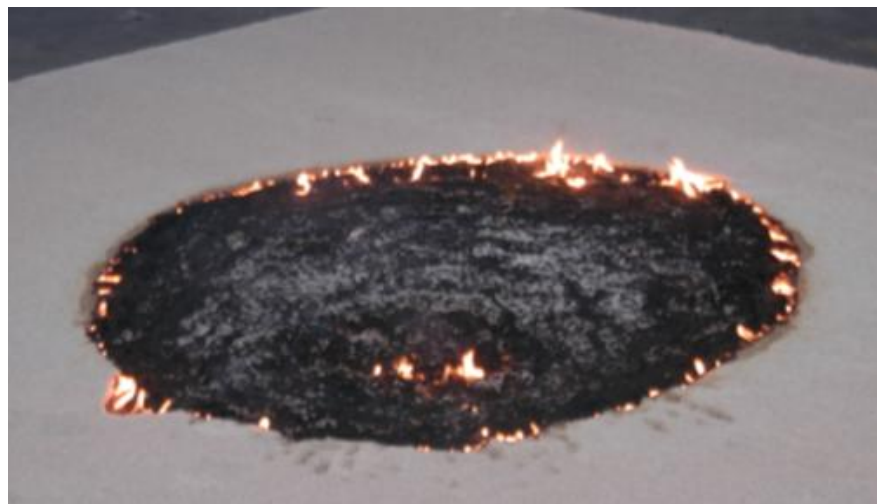
Figure 50. Residual flaming along perimeter of carpet flooring after self-extinguishment of gasoline spill fire.

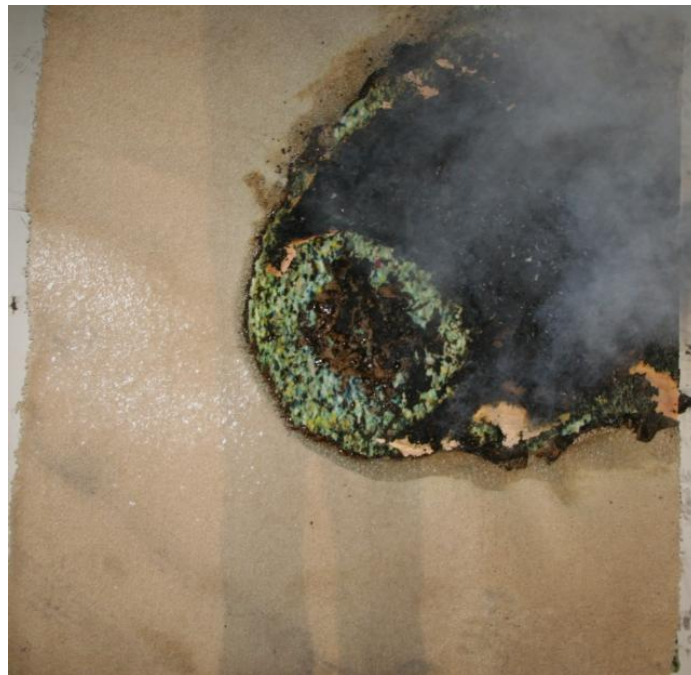
Figure 51. Photograph illustrating the lack of thermal degradation in the initial spill area (center of sample) despite severe damage to adjacent carpet and padding material (upper right corner).

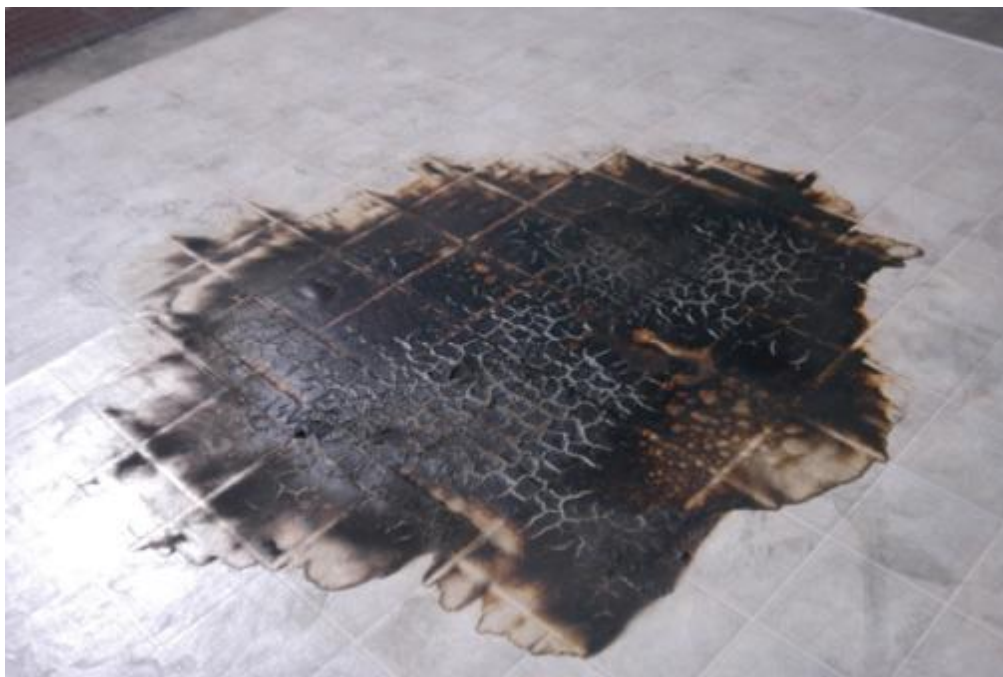
Figure 52. 2.0 L Gasoline spill fire pattern on vinyl flooring in the open.

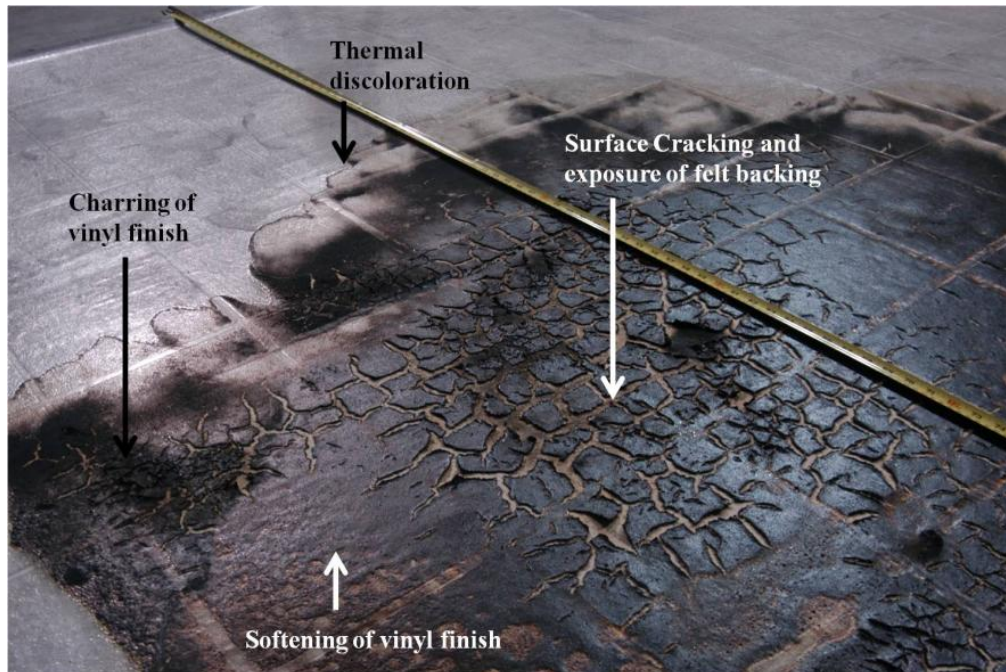
Figure 53. Illustration showing various degrees of thermal degradation of vinyl flooring due to gasoline spill fire in the open.

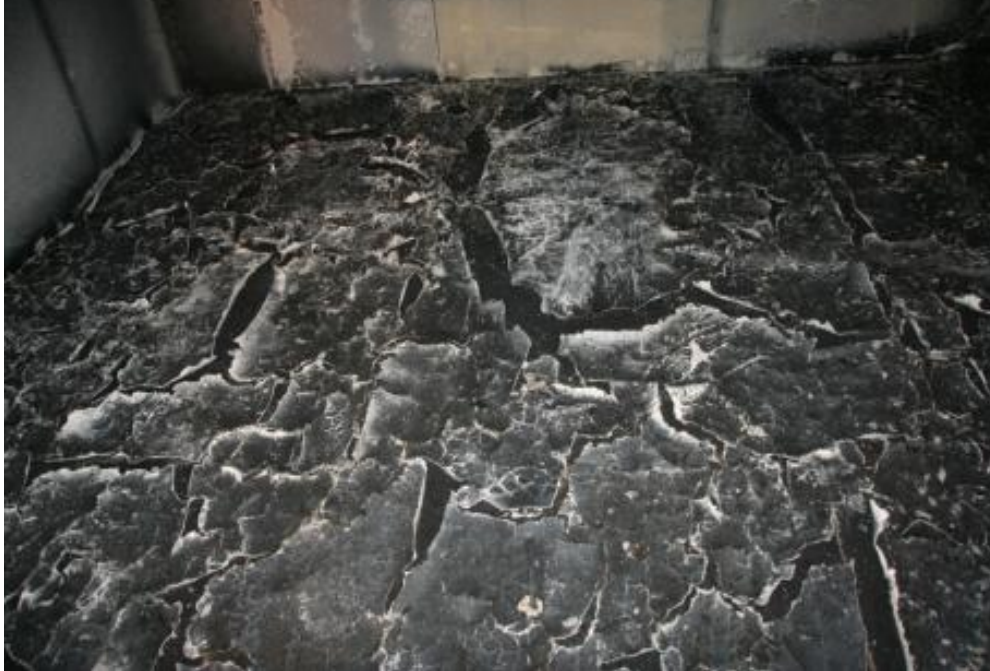
Figure 54. Condition of vinyl flooring after 2.0 L (0.52 gal) gasoline spill fire in enclosure.

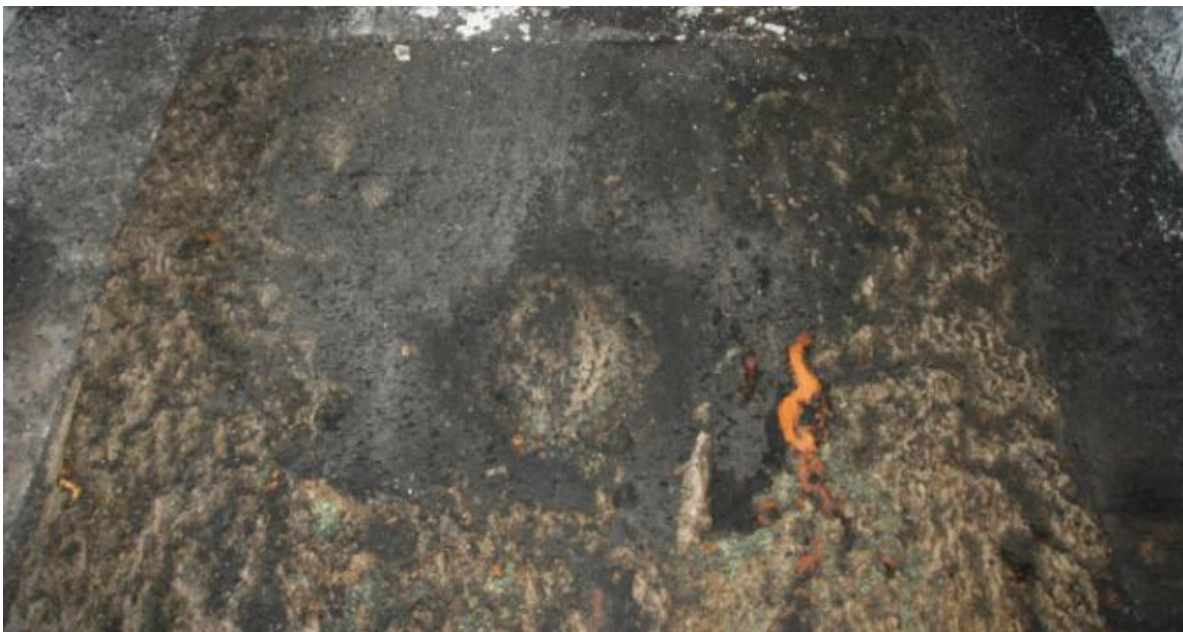
Figure 55. Condition of carpet flooring after 2.0 L (0.52 gal) gasoline spill fire in enclosure.

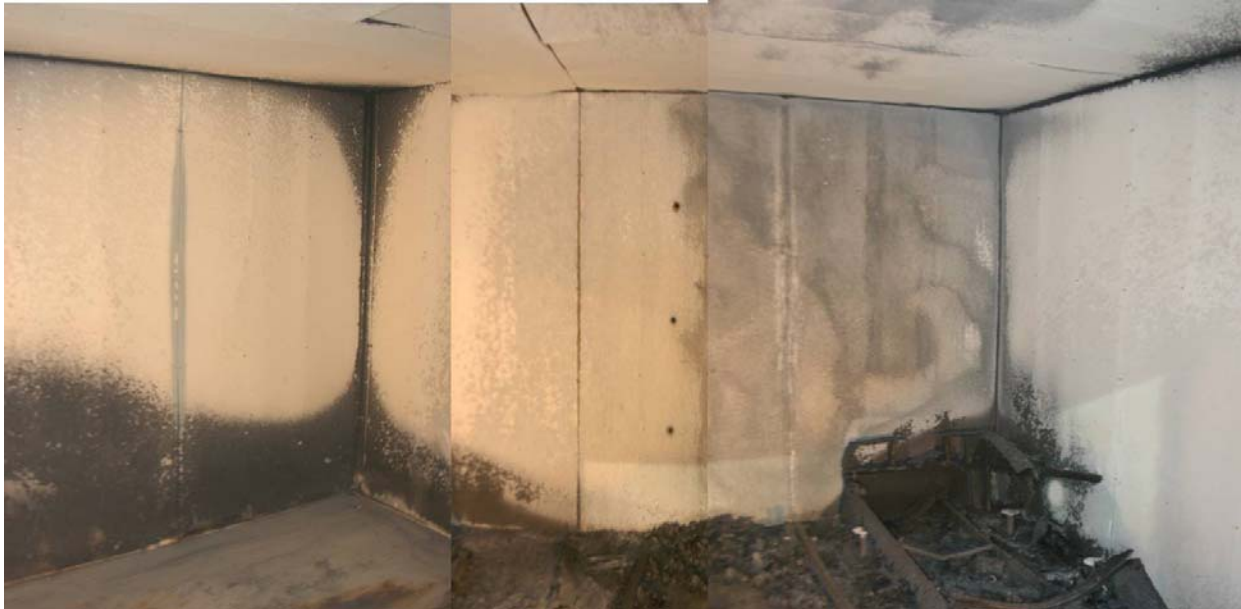
Figure 56. Composite post-test enclosure condition for Test 6-0.

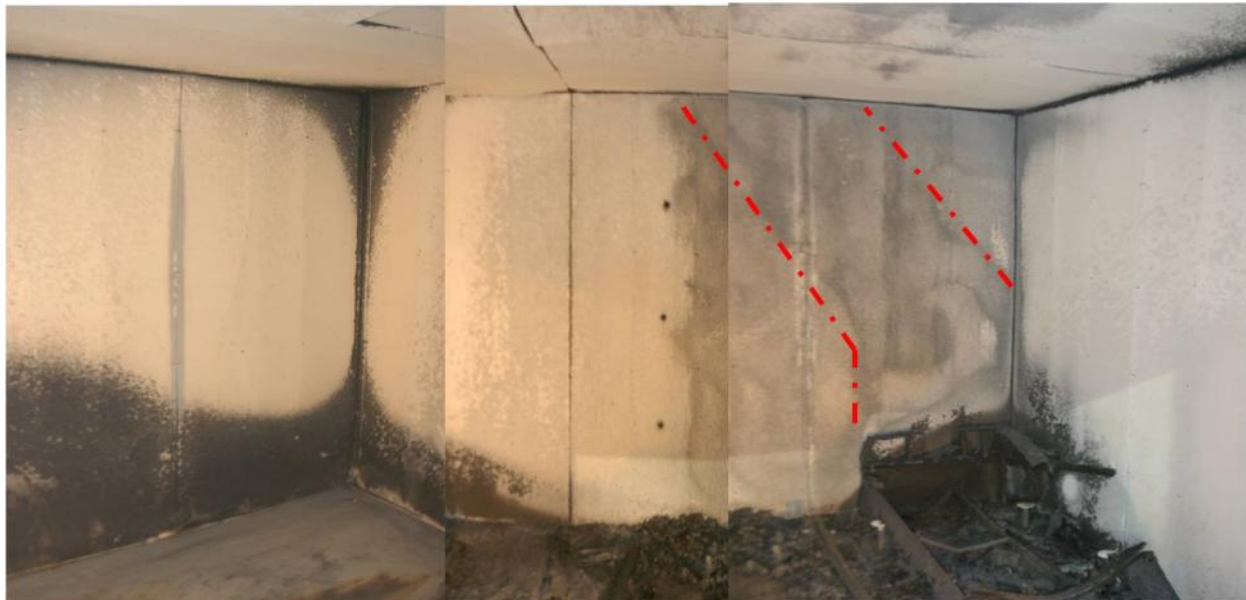
Figure 57. Annotated composite photograph of post-test fire condition (Test 6-0) showing location of plume pattern.

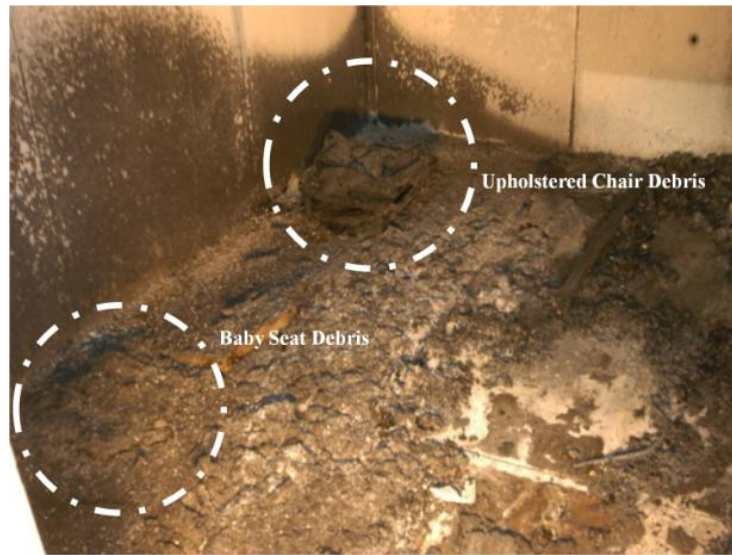
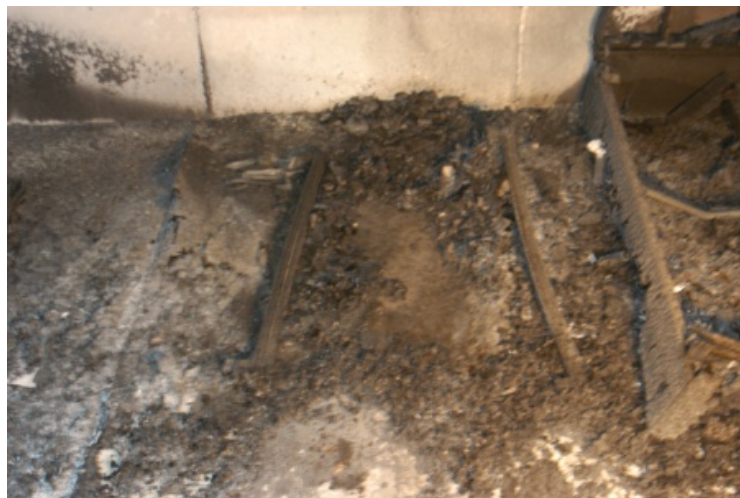
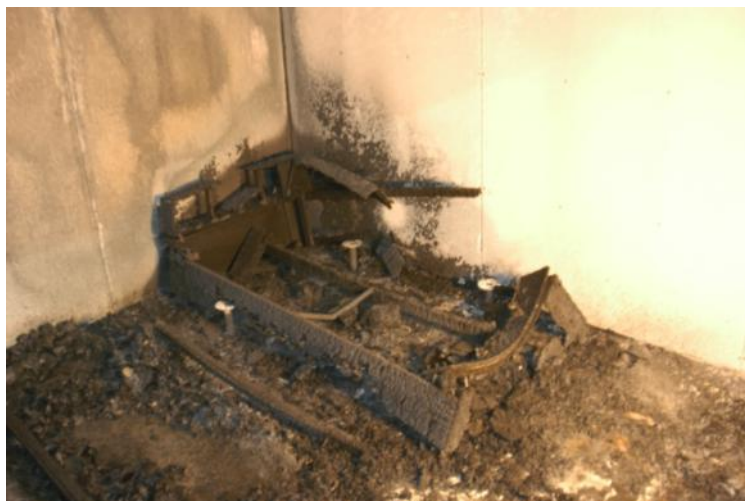
Figure 58. Remnants of upholstered chair (left), coffee table (middle) and upholstered sofa (right) after Test 6-0.

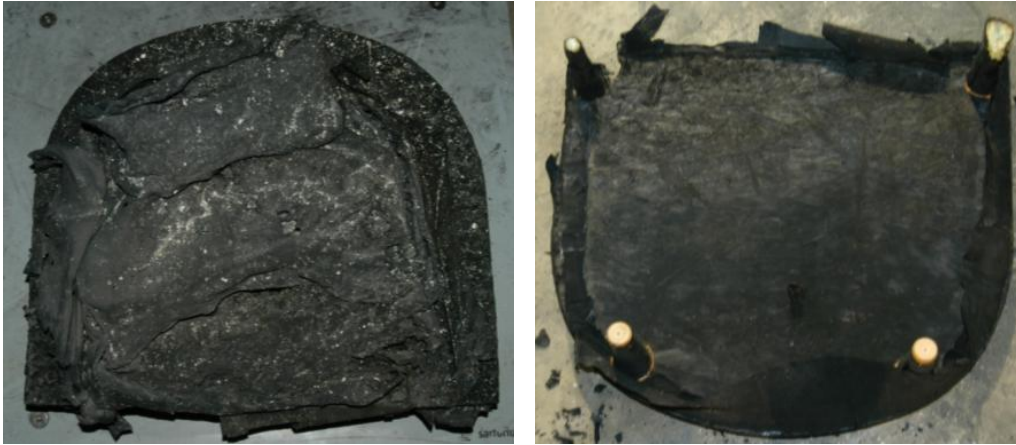
Figure 59. Close up photographs of the topside (left) and underside (right) of the upholstered chair after Test 6-0.

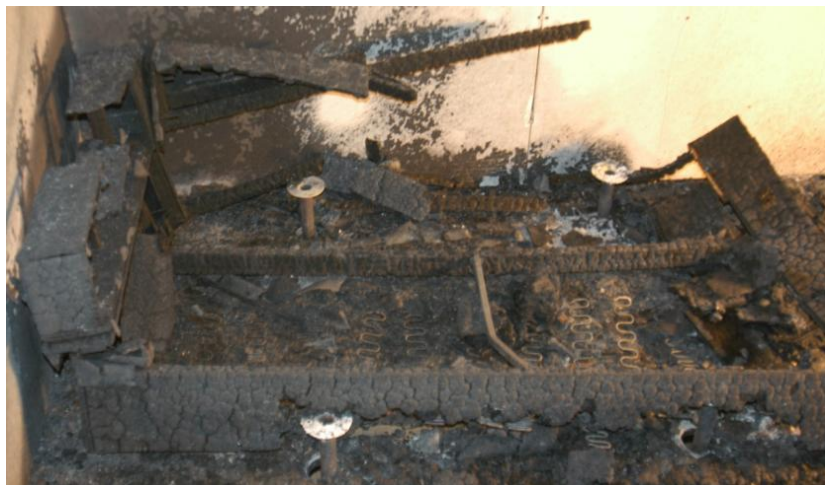
Figure 60. Close up photograph of upholstered sofa debris after Test 6-0.

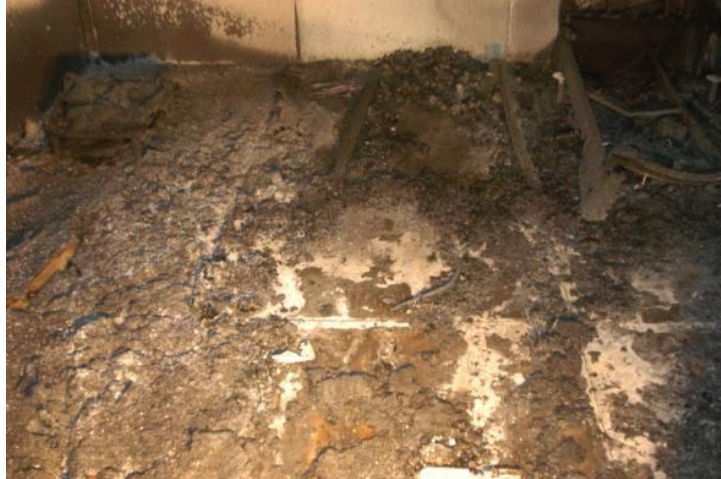
Test 6-1 consisted of an initiating 2.0 L (0.52 gal) gasoline spill fire on carpet that was centered in front of the upholstered sofa. This test reached flashover conditions in approximately two minutes and sustained fully developed burning for a period of approximately two minutes. During fully developed burning, average upper layer temperatures within the enclosure were approximately 655°C (1211°F) over the duration of the post-flashover conditions. Over the course of this test, approximately 27 percent of the fuel load within the enclosure (i.e., furnishings and flooring) was consumed. Representative photographs of the condition of the enclosure after the fire was manually extinguished are shown in Figure 62.

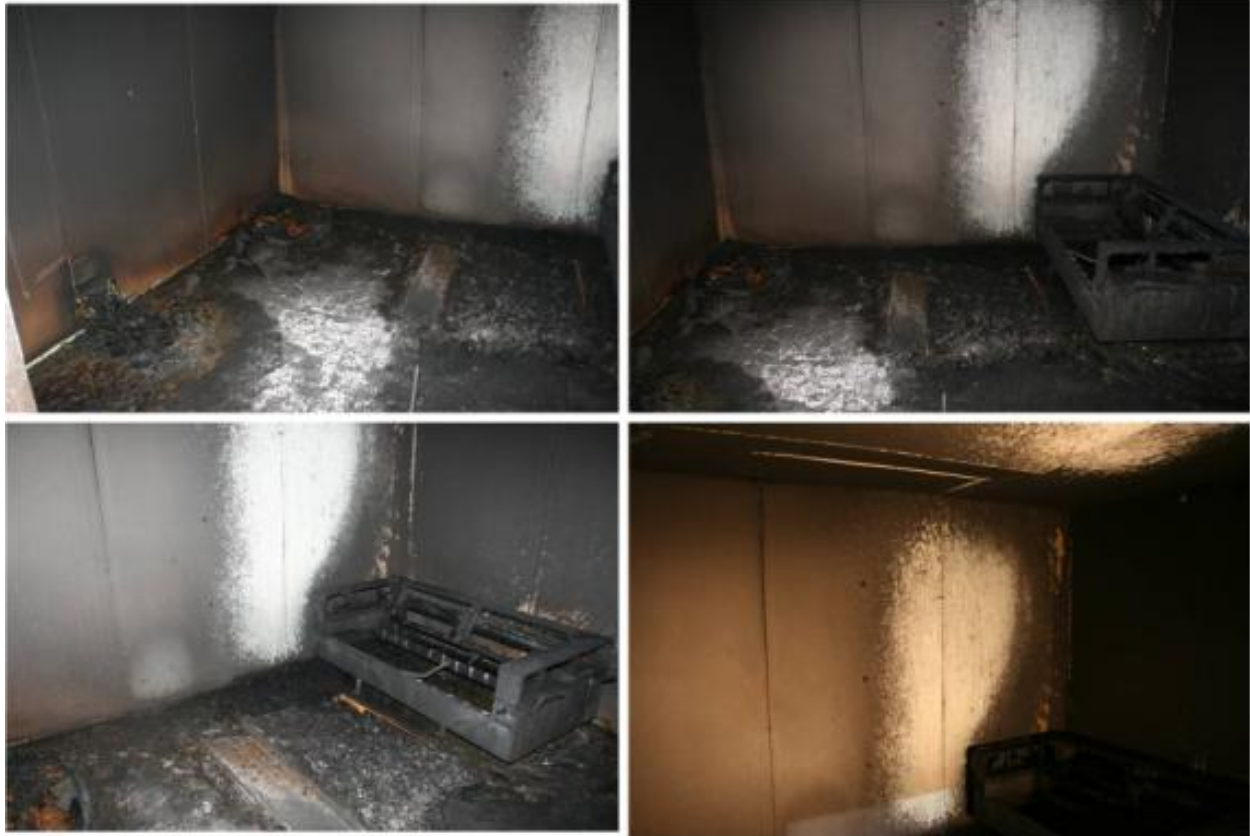
Figure 62. Enclosure conditions after Test 6-1.

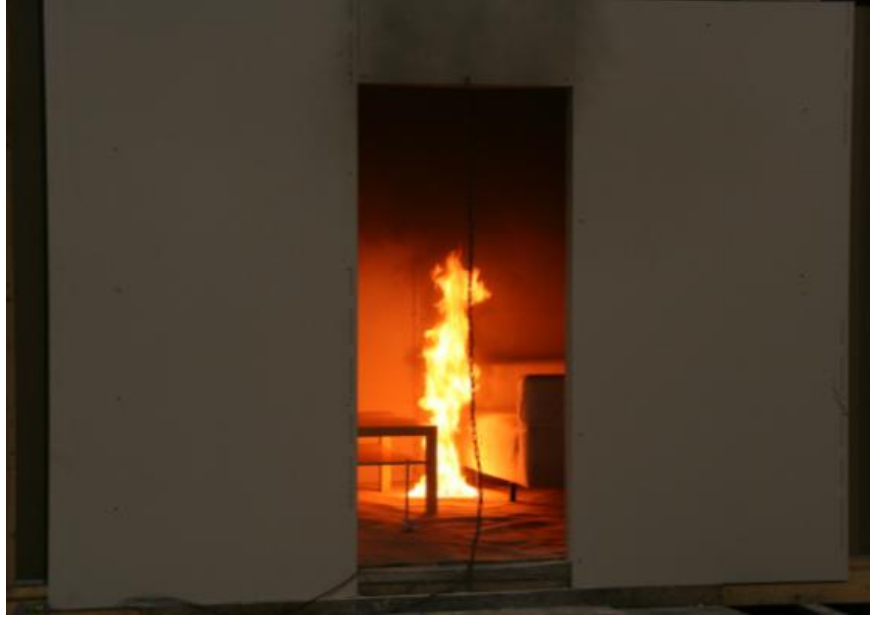
Figure 63. Initiating fire used in Test 6-1.

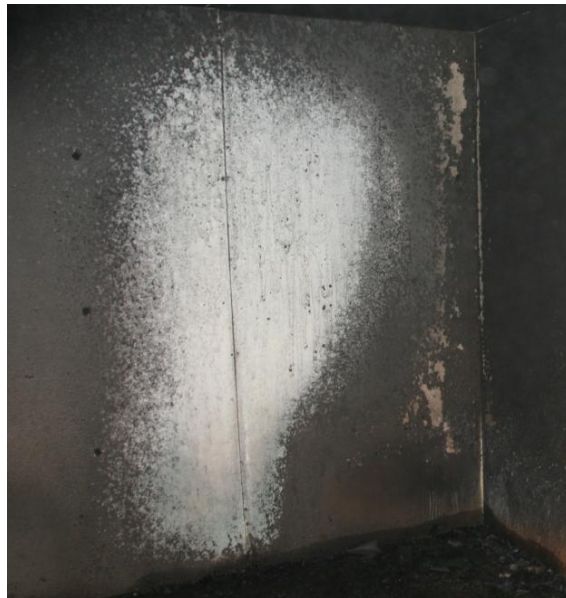
Figure 64. Close up photograph of wall pattern identified in Test 6-1.

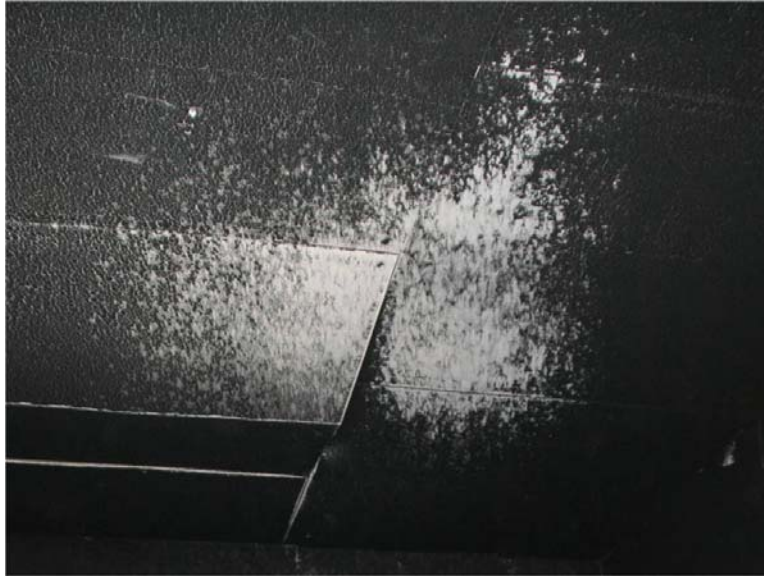
Figure 66. Close-up of ceiling pattern observed after Test 6-1.

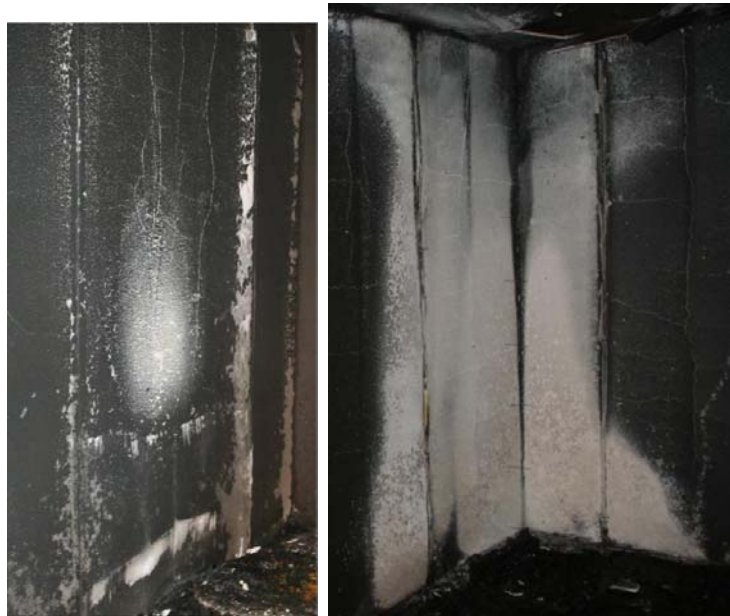
Figure 67. Examples of clean burn patterns during early stages of formation (left – Test 6-3) and after significant heating (right – Test 6-8).

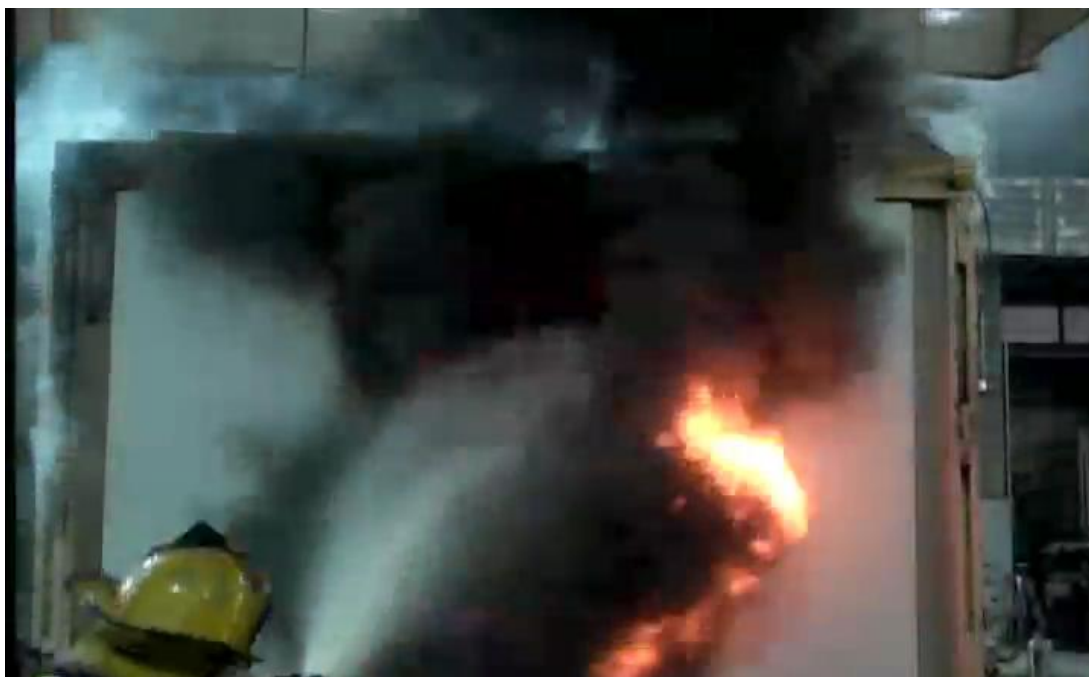
Figure 68. Initial hose stream angle used to suppress the fire in Test 6-1.

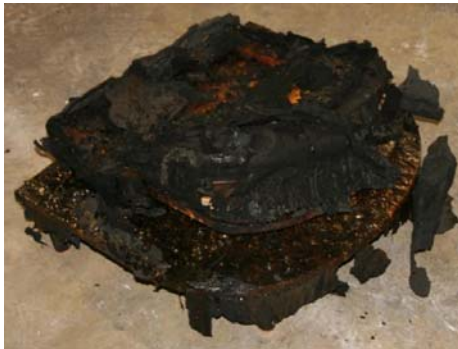
(a) Mass Loss Fraction = 0.27

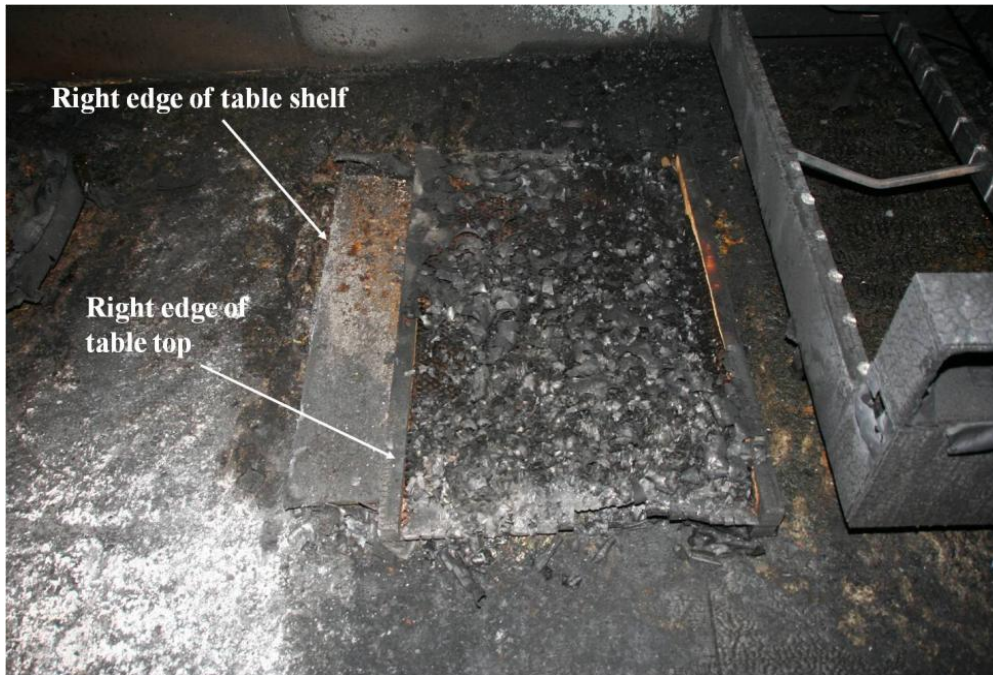
Figure 70. Location of tabletop relative to table shelf after Test 6-1.

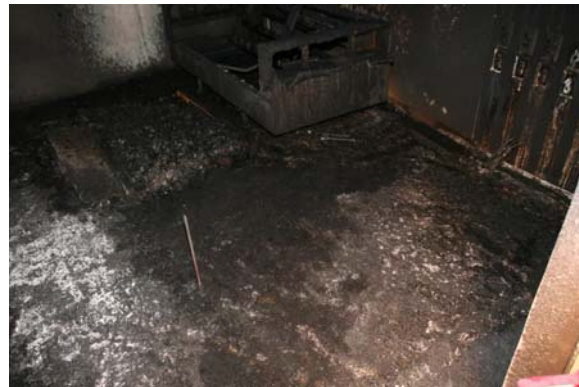
(b) Right half of flooring

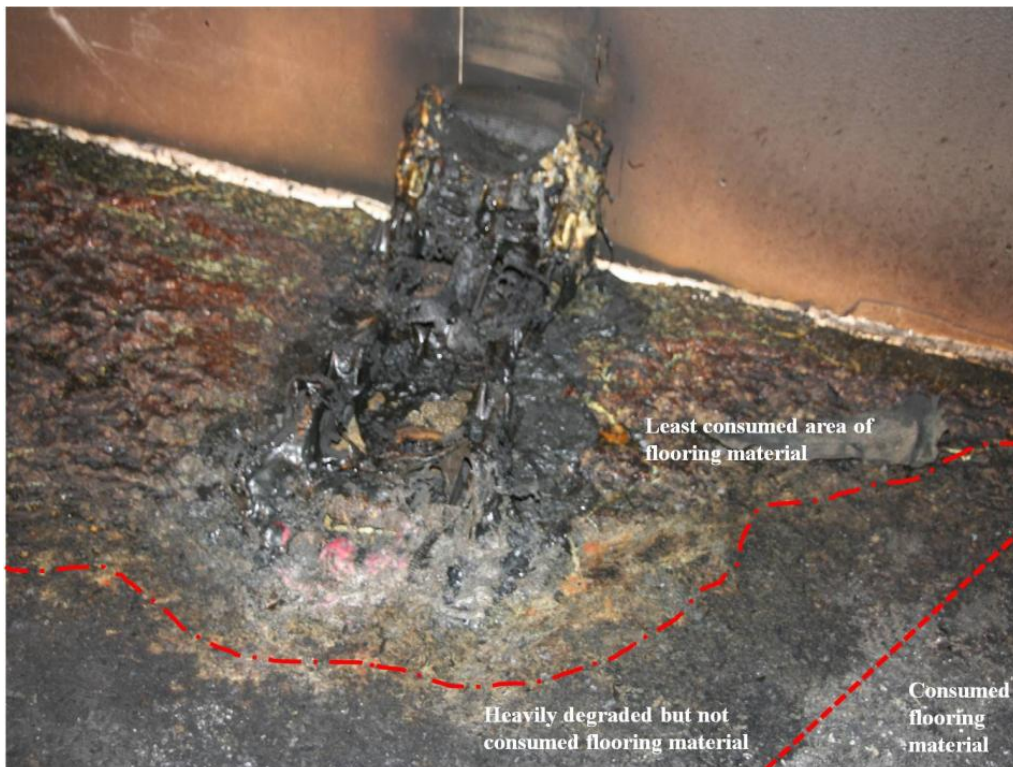
Figure 72. Annotated photograph showing various degrees of thermal degradation noted on flooring material after Test 6-1.

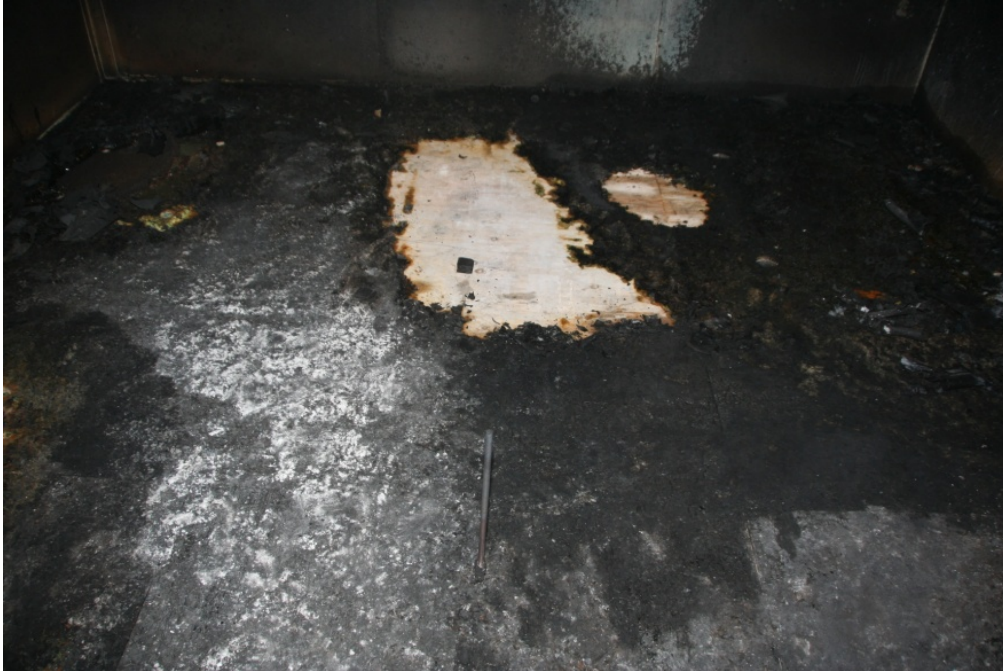
Figure 73. Condition of flooring material after furniture debris cleared from the room in Test 6-1.

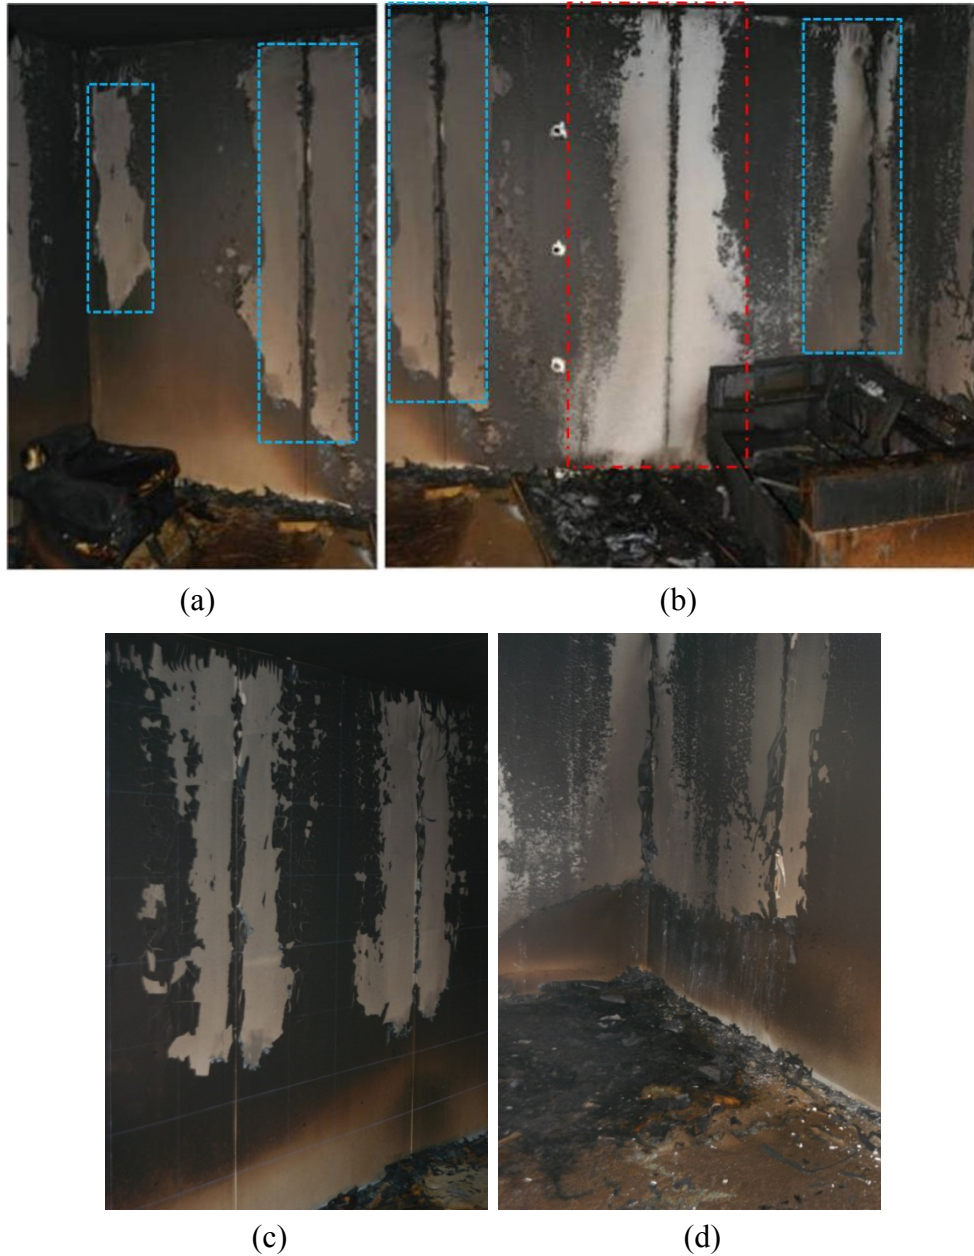
Figure 74. Photographs of (a) left side of rear wall, (b) right side of rear wall, (c) left wall, and (d) right wall of the enclosure after Test 6-2.

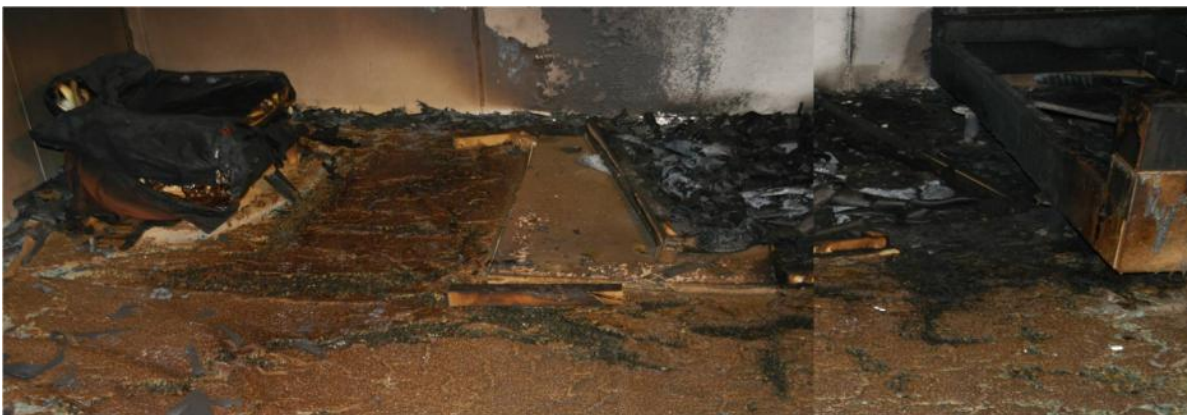
Figure 76. Composite photo illustrating condition of Class A furnishings after Test 6-2.

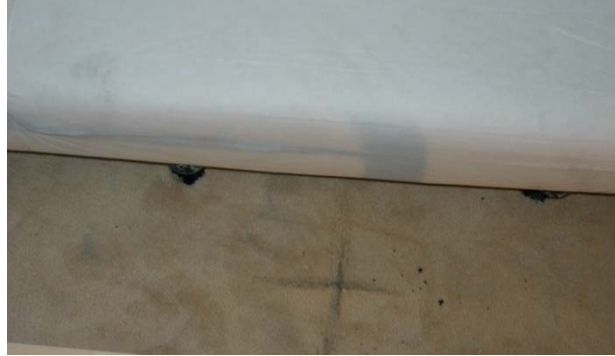
(a) Spill location on carpet centered between load cell supports below sofa

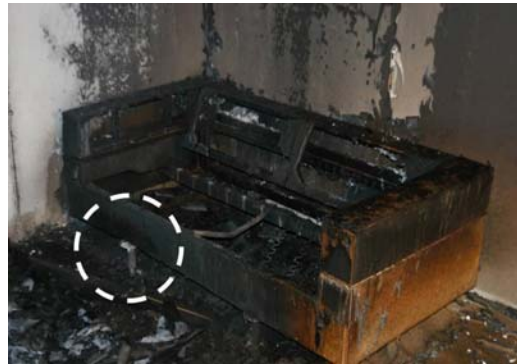
(c) Area of load cell support highlighted with sofa in enclosure

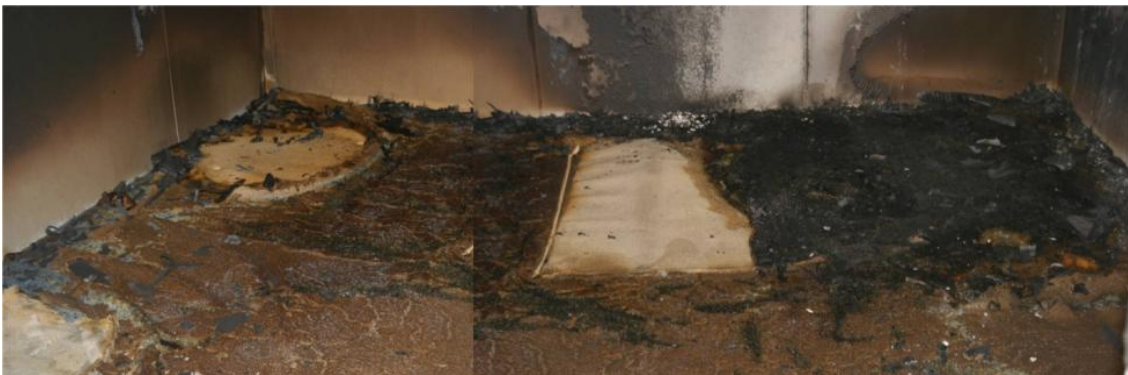
(a) View from door with protected carpet areas under chair (back left), table (center) and baby seat (bottom left corner)

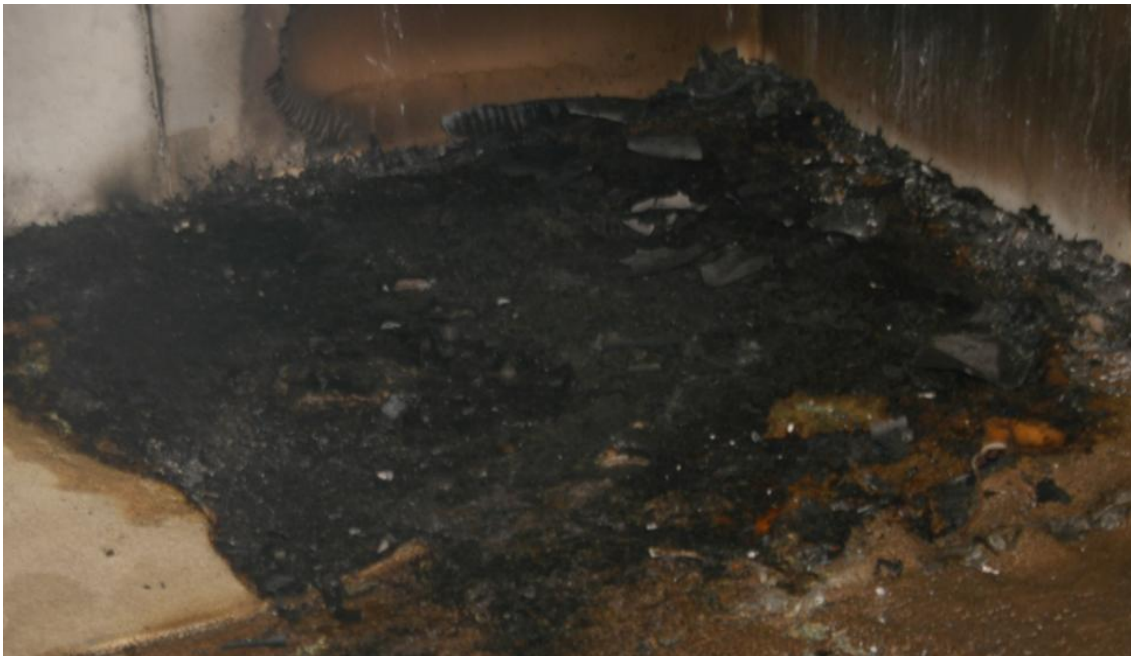
(b) Floor area of initiating spill fire between table and sofa

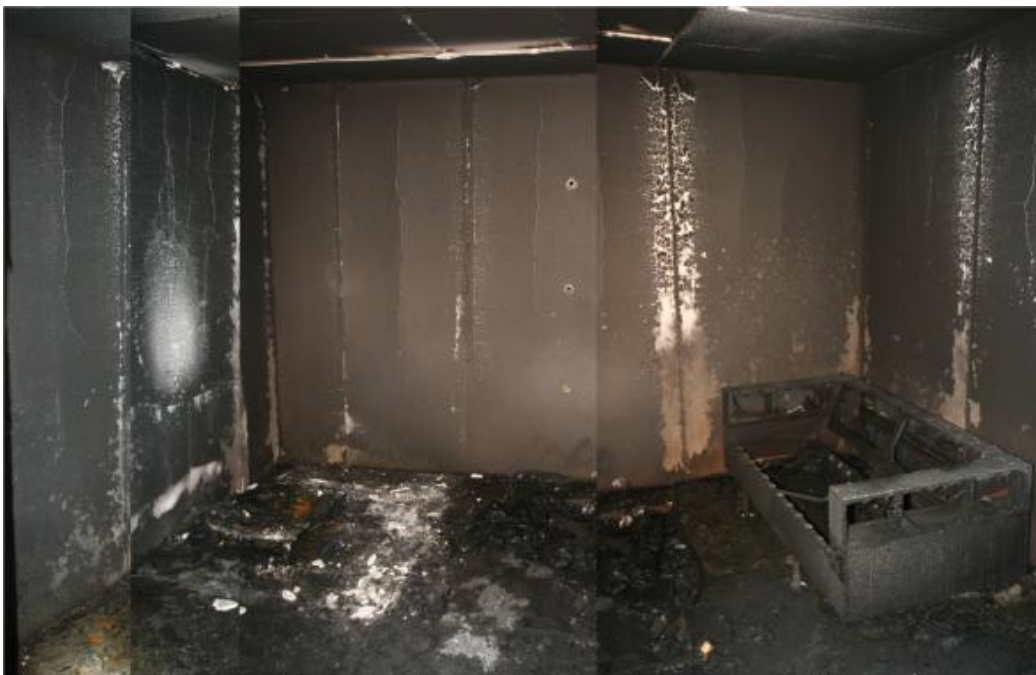
Figure 79. Composite photograph of enclosure conditions after Test 6-3.

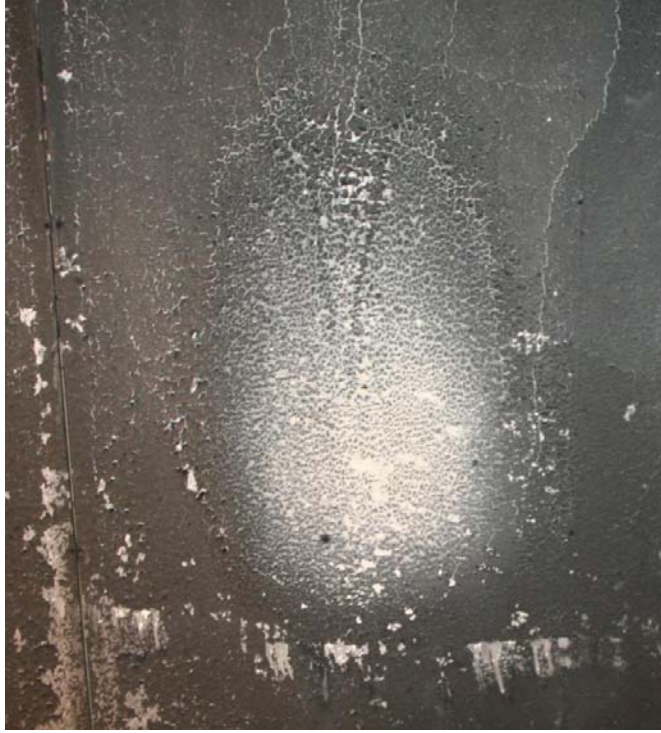
Figure 80. Close up photograph of wall pattern identified behind the upholstered chair in Test 6-3.

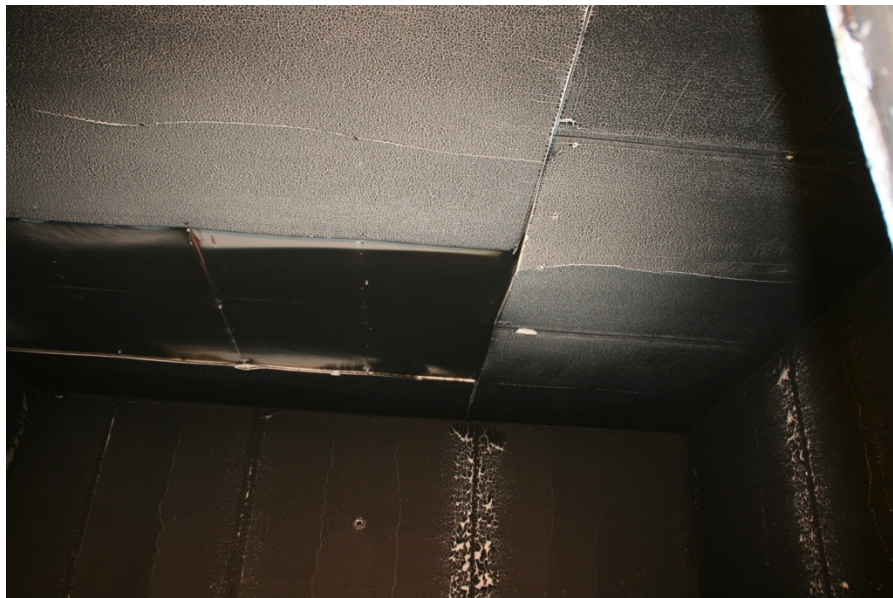
Figure 81. Condition of ceiling after Test 6-3.

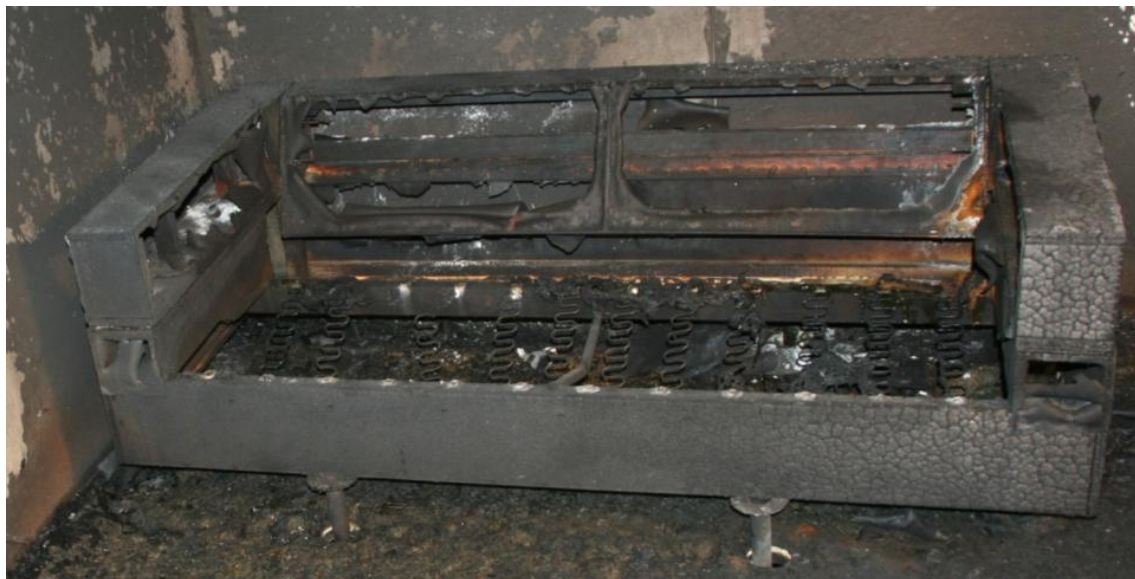
Figure 82. Damage to front right corner of upholstered sofa after Test 6-3.

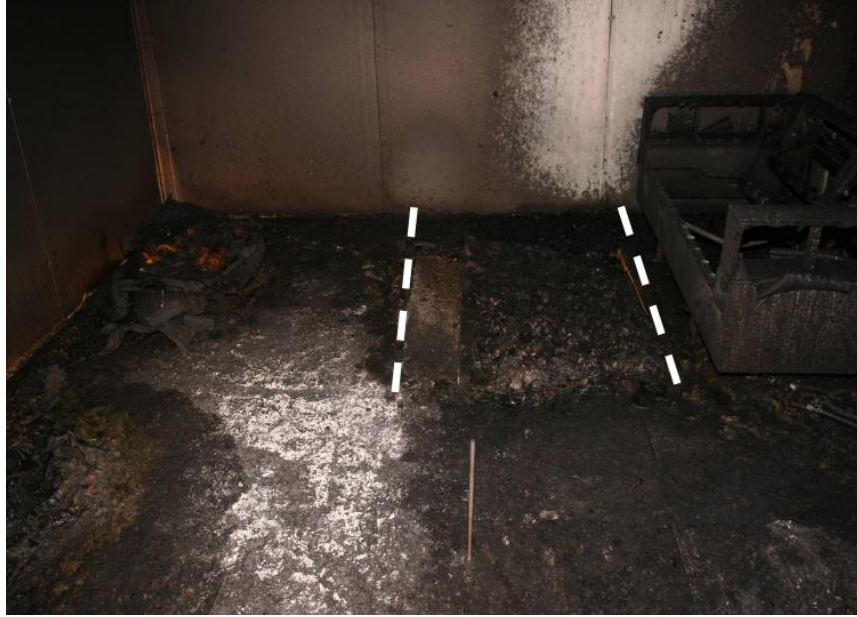
(a) Coffee table location relative to sofa after Test 6-1.

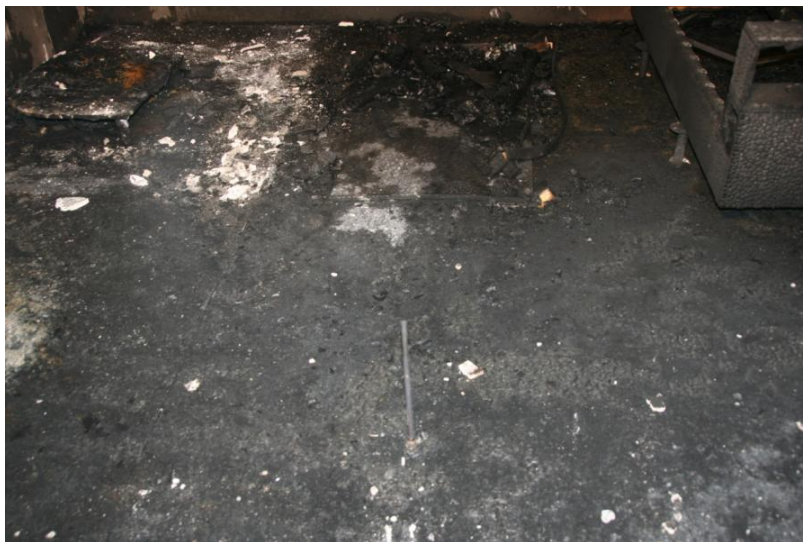
Figure 84. Condition of carpet flooring after Test 6-3.

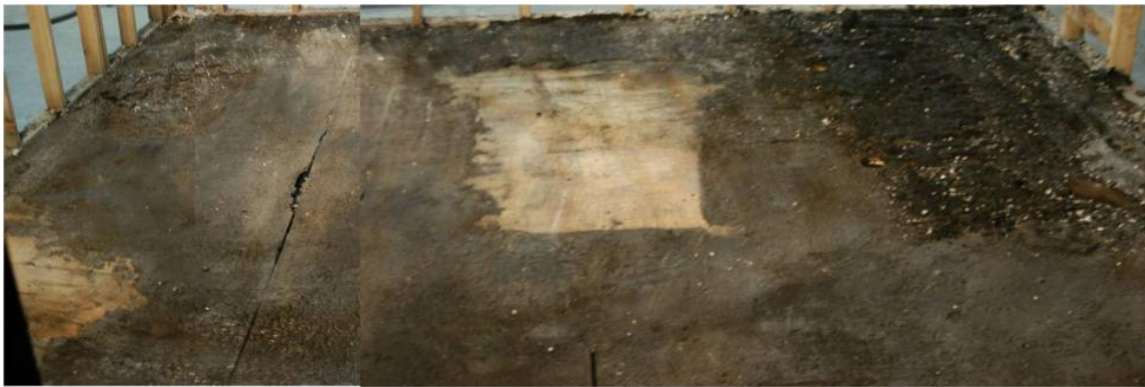
Figure 86. Composite photo of flooring after removal of fire debris from Test 6-3.

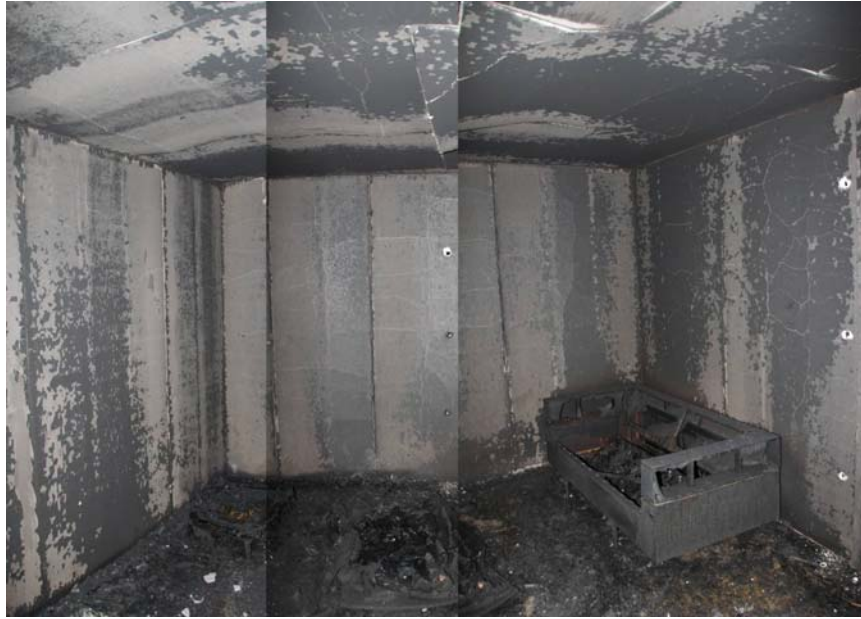
Figure 87. Composite photo of the enclosure after Test 6-4.

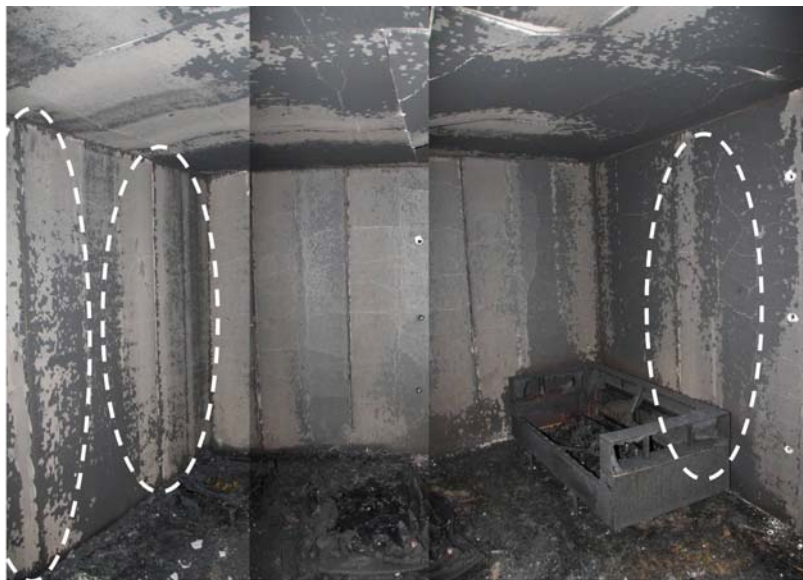
Figure 88. Annotated composite photo from Test 6-4 showing location of patterns identified in sidewalls of the enclosure.
