**The author(s) shown below used Federal funds provided by the U.S. Department of Justice and prepared the following final report:**

**Document Title: Forensic Analysis of Ignitable Liquid Fuel Fires in Buildings**

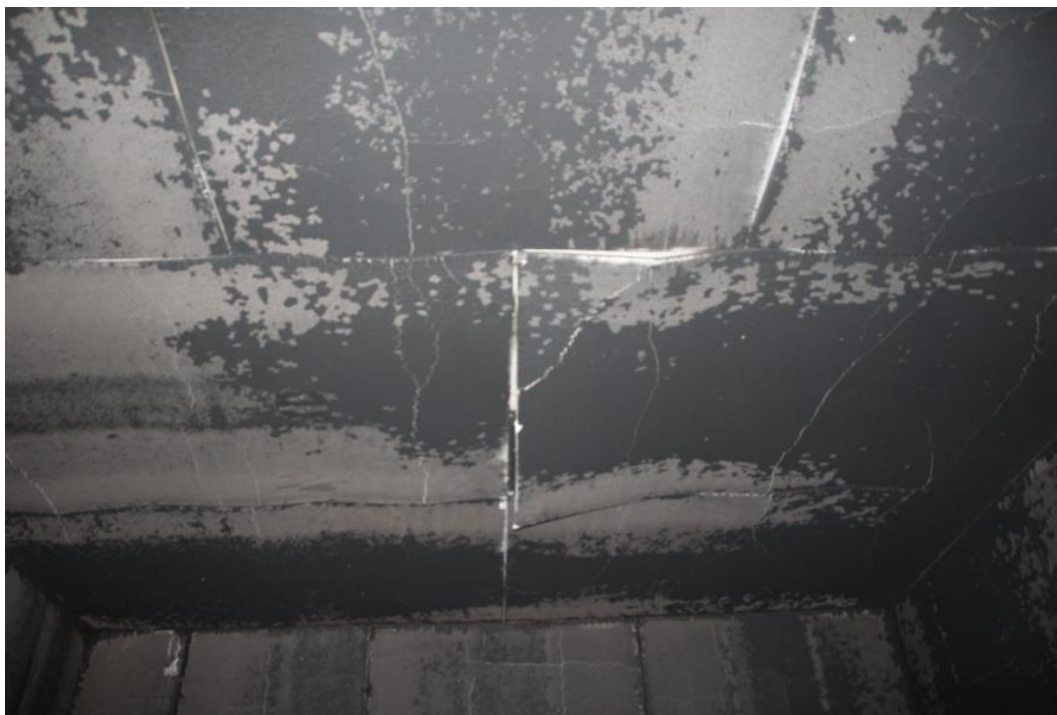
Figure 89. Ceiling of enclosure after Test 6-4.

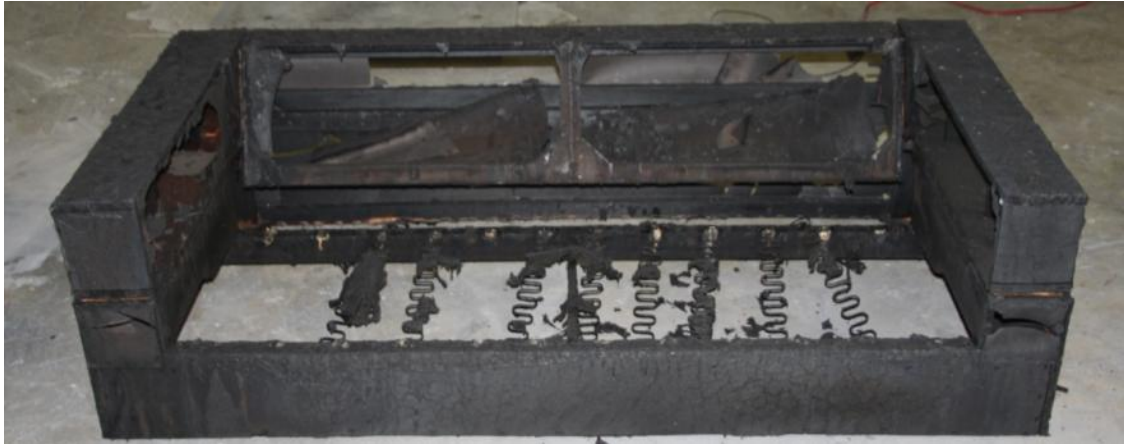
Figure 90. Condition of upholstered sofa after Test 6-4.

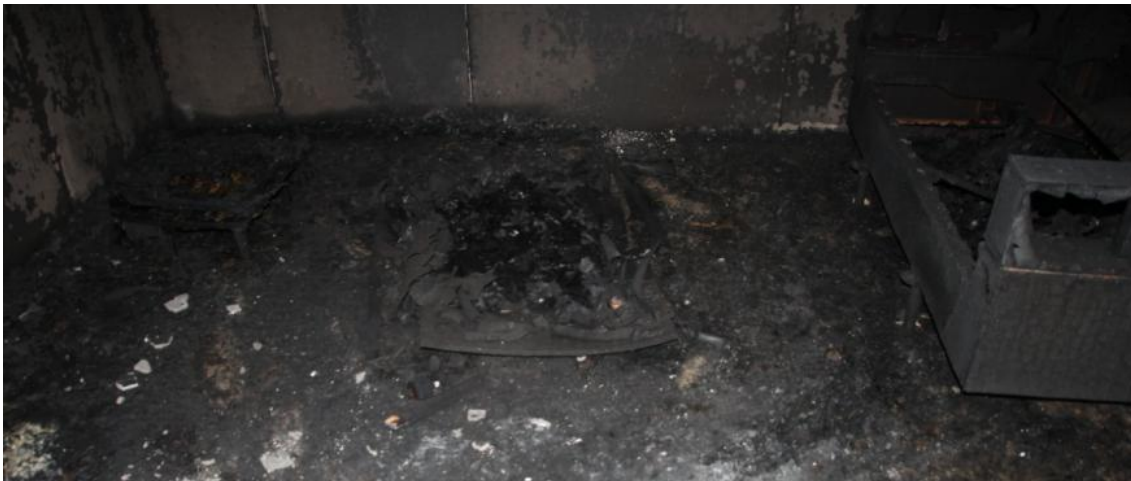
Figure 91. Location of coffee table after Test 6-4 showing downward collapse, not preferential collapse towards sofa as seen in Tests 6-1 and 6-2.

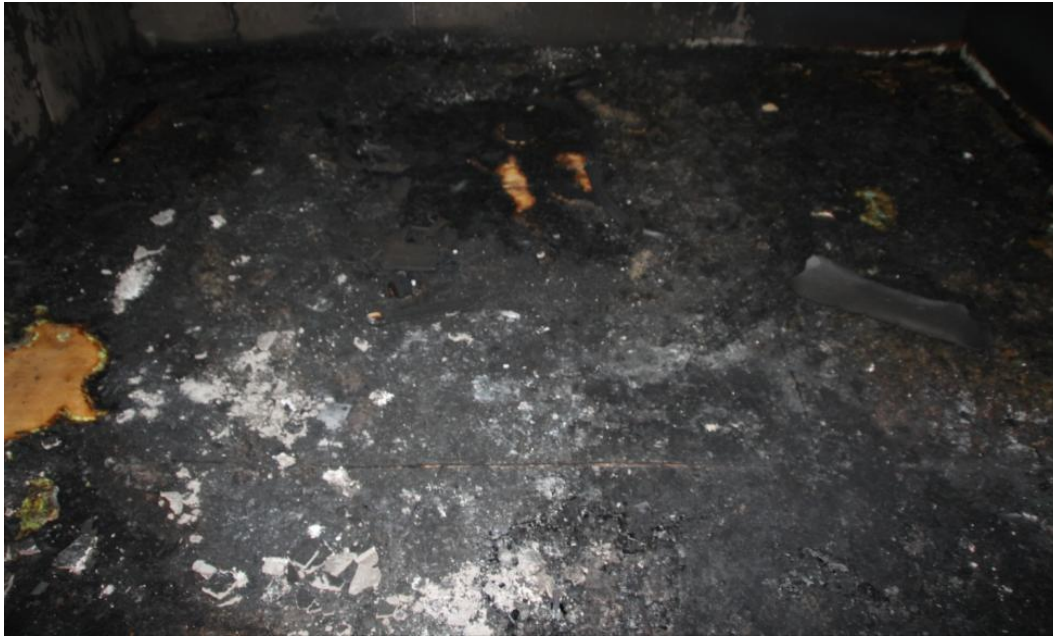
Just as in Test 6-3, the carpet flooring in this test was completely involved and primarily consumed during the fire. Photographs of the condition of the floor immediately after Test 6-4 and after the enclosure was overhauled are provided in Figure 92. Compared to Test 6-3, the flooring after this test was more consumed. This was attributed to the prolonged burning duration, which permitted flooring material, even in protected areas, to become involved. As shown in Figure 92, even the area beneath the coffee table in this test was mostly consumed, whereas in previous tests, this area was relatively unburned.

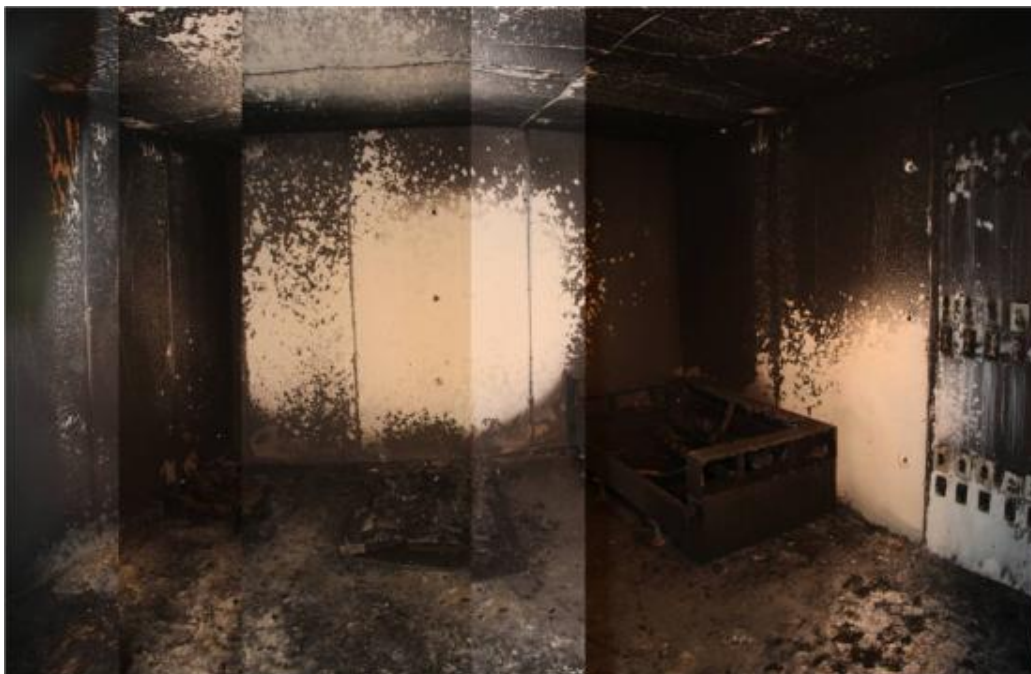
Figure 93. Composite photograph of enclosure conditions after Test 6-5.

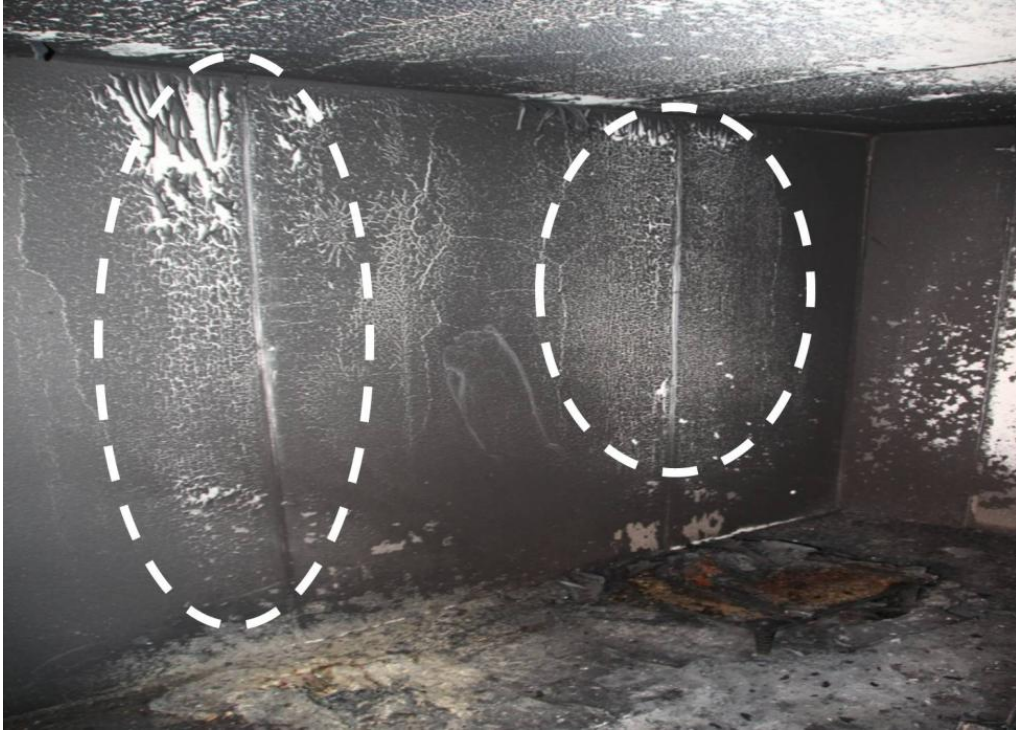
Figure 95. Whitish patterns of relatively reduced soot that were located on the walls above the upholstered chair and baby seat after Test 6-5.

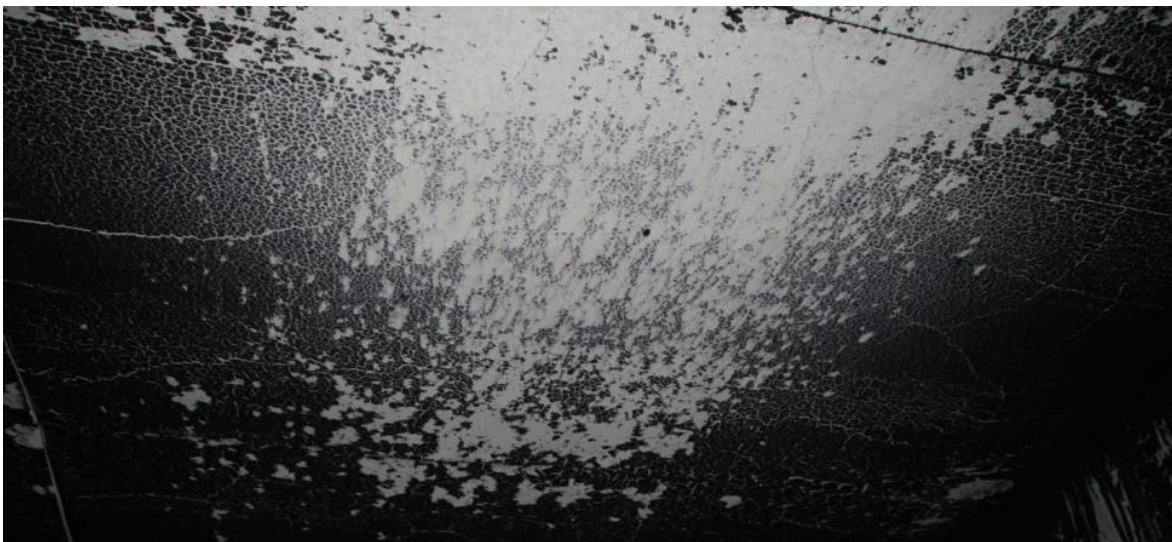
Figure 96. Pattern identified on the ceiling of the enclosure after Test 6-5.

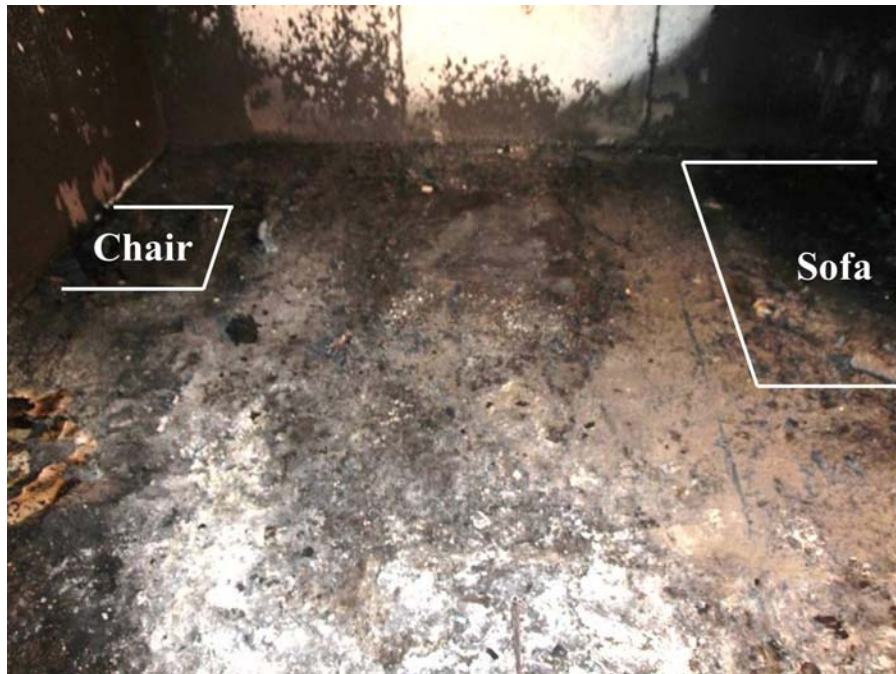
Figure 98. Condition of vinyl flooring after Test 6-5.

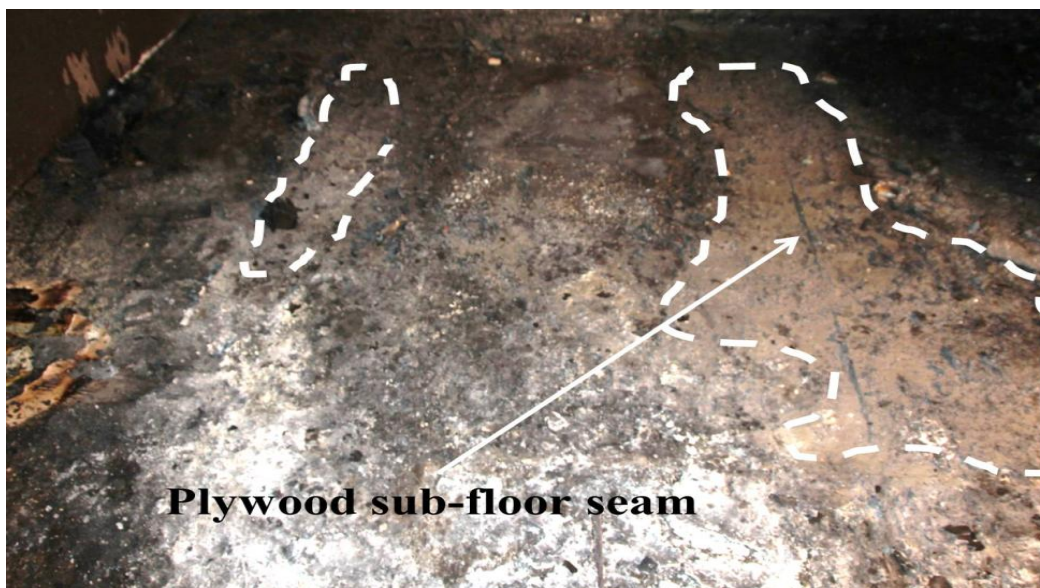
Figure 99. Annotated photograph describing condition of vinyl flooring after Class A materials were removed from Test 6-5.

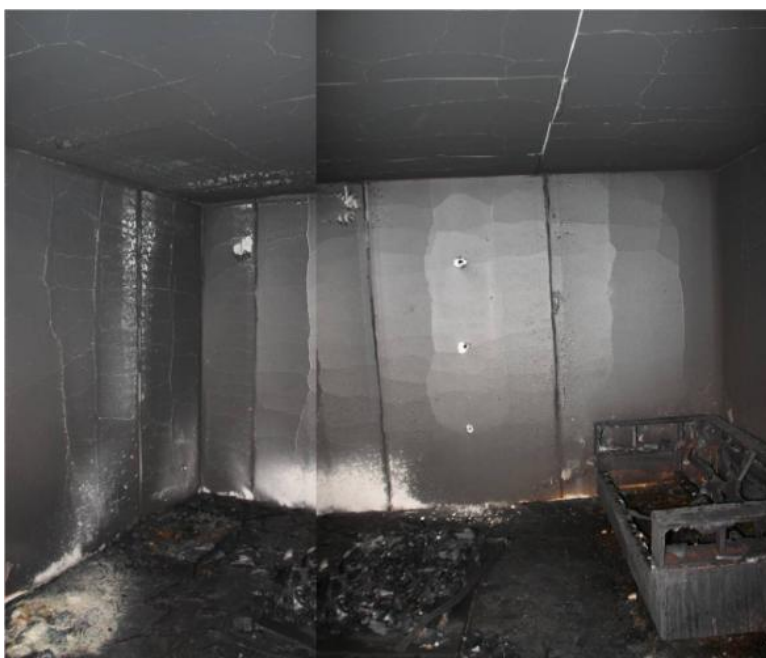
Figure 100. Composite photograph of enclosure conditions after Test 6-6.

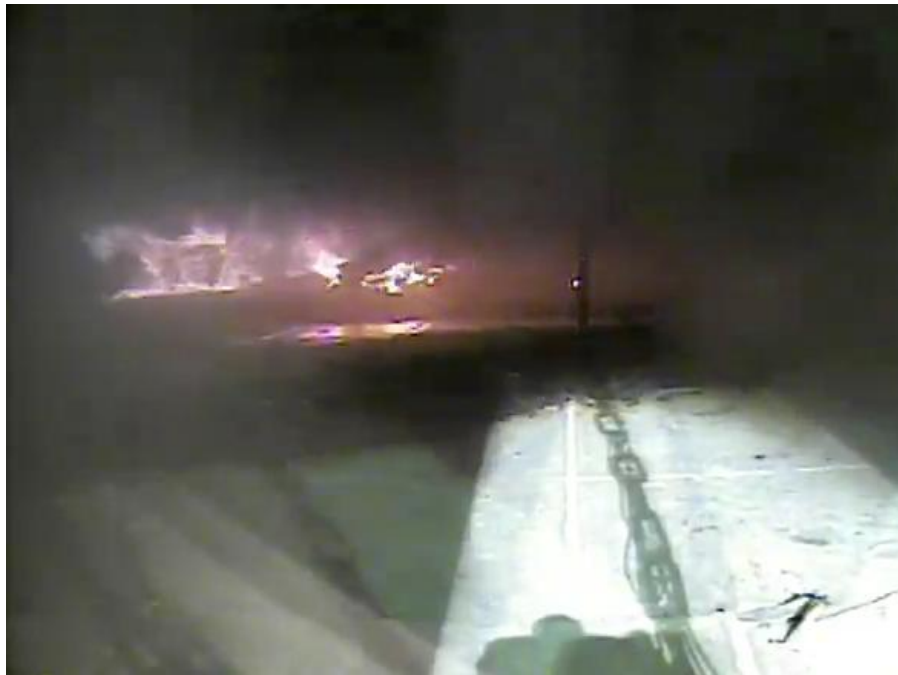
Figure 101. Low level burning in left, rear corner of the enclosure during Test 6-6 (view from vent at 215 s after ignition).

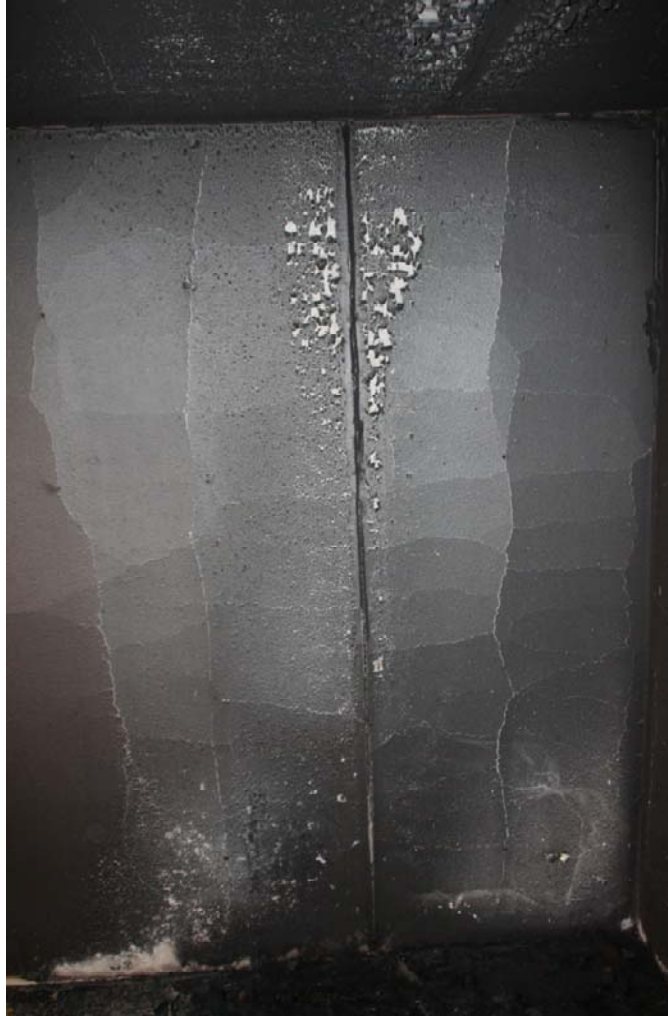
Figure 102. Photograph of absence of soot noted on left wall of the enclosure behind the upholstered chair.

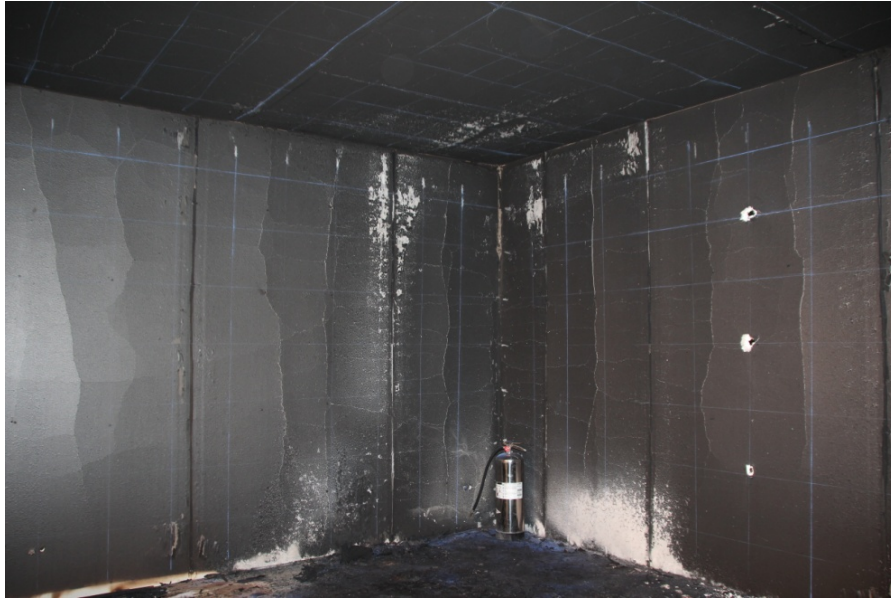
There was also a clean burn pattern at the base of the left wall associated with the melted plastic remains of the baby seat (see Figure 103). As shown in Figure 103, the area located behind the baby seat suggests that the fire plume from the burning baby seat was potentially bending towards the rear corner of the enclosure. This migration of the fire towards the rear of the enclosure has been noted in previous testing.

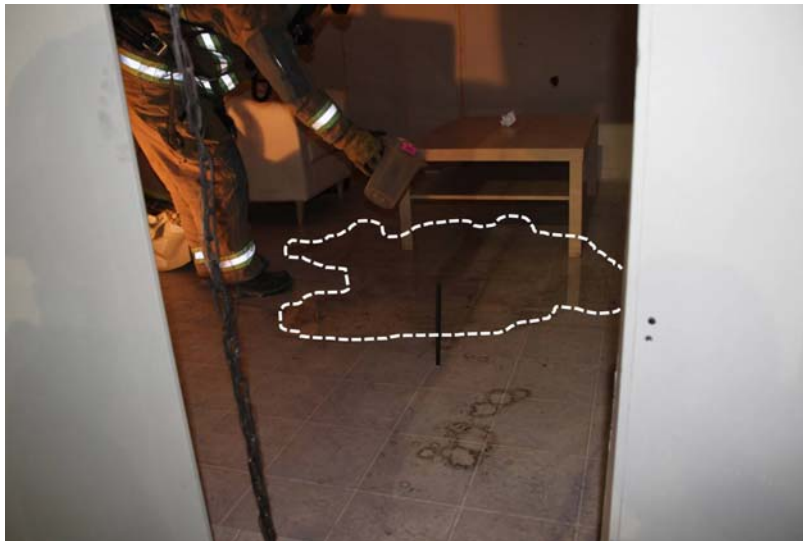
The vinyl flooring in this test was thermally degraded but less so than was noted in Test 6-5. The majority of the material was still present and generally only blackened with limited charring/cracking of the material to expose the plywood subfloor. A photograph of the condition of the vinyl flooring after Test 6-6 is provided in Figure 104.

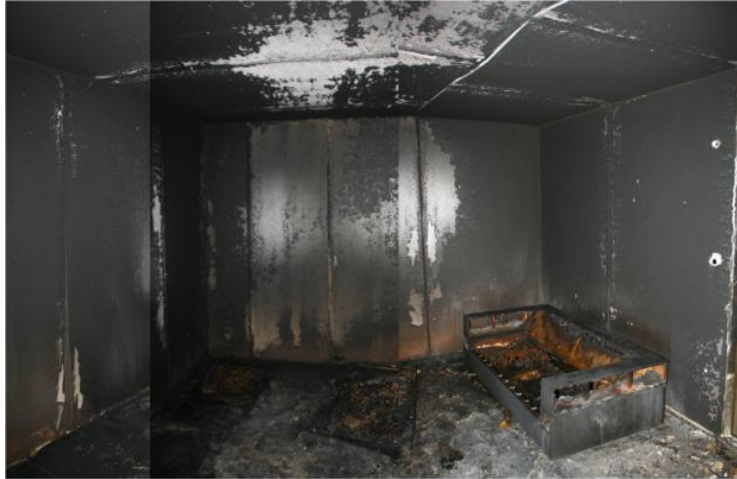
Multiple different patterns were identified on the enclosure walls and ceiling after Test 6-7. The largest pattern was on the rear wall of the enclosure. The pattern originated approximately 0.6 m (2 ft) from the rear, left corner at floor level and extended to the ceiling. The top edge of the pattern was consistently at this elevation over the entire width (i.e., 2.4 m (8 ft)), while the bottom edge of the pattern increased in elevation above the floor from left to right. The pattern was identified because of the glossy nature of this section of wall relative to the matted black color of the neighboring GWB. The GWB paper in this location was consumed. The soot staining and glossy appearance was on the gypsum material.

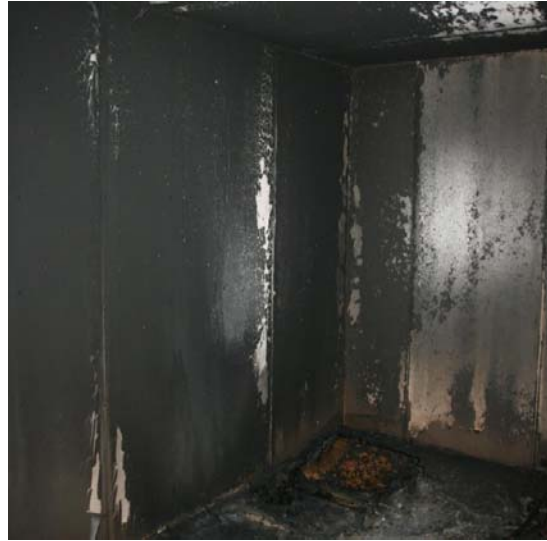
Figure 106. Condition of wall behind upholstered chair after Test 6-7.

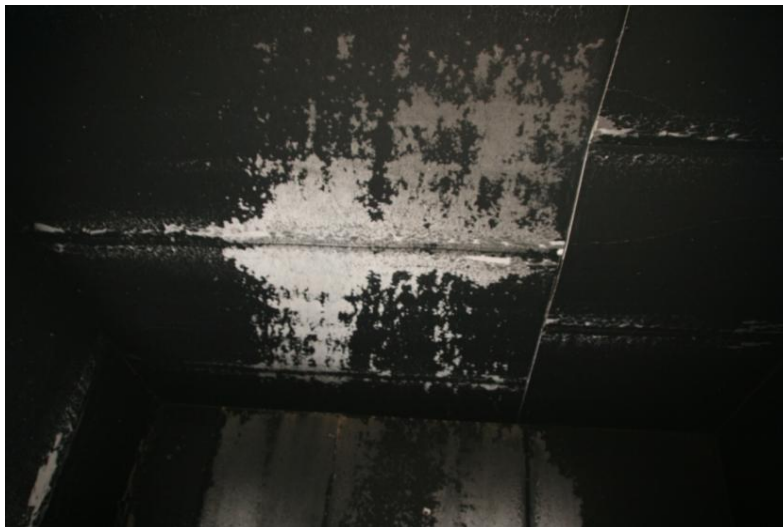
Figure 107. White area identified on ceiling of enclosure after Test 6-7.

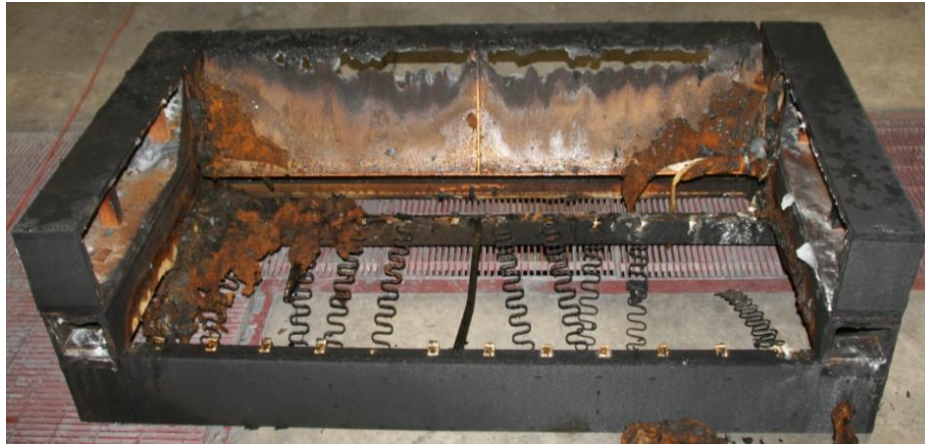
After this test, sections of foam were still present on both the upholstered sofa and upholstered chair. Photographs of these two pieces of furniture are provided in Figure 108. One main difference between the furnishings was the extent of thermal degradation on the legs of the upholstered chair compared to the lower sections of the upholstered sofa. The chair legs were heavily charred (see charring on front leg of upholstered chair in Figure 108(b)) despite the fact that there was polyurethane foam still attached to the topside of the chair. This is consistent with the initiating spill fire in front of the chair. The upholstered sofa frame was only thermally discolored (i.e., blackened) with no evidence of charring. Only the top surface of the wooden table was consumed with sections of the honeycomb core material still present.

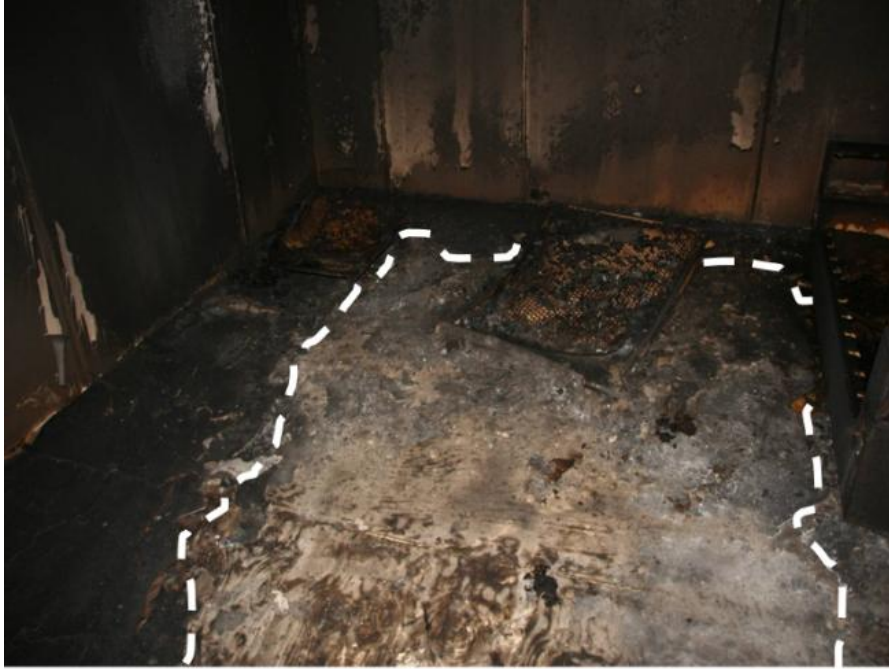
Figure 109. Condition of vinyl flooring after Test 6-7.

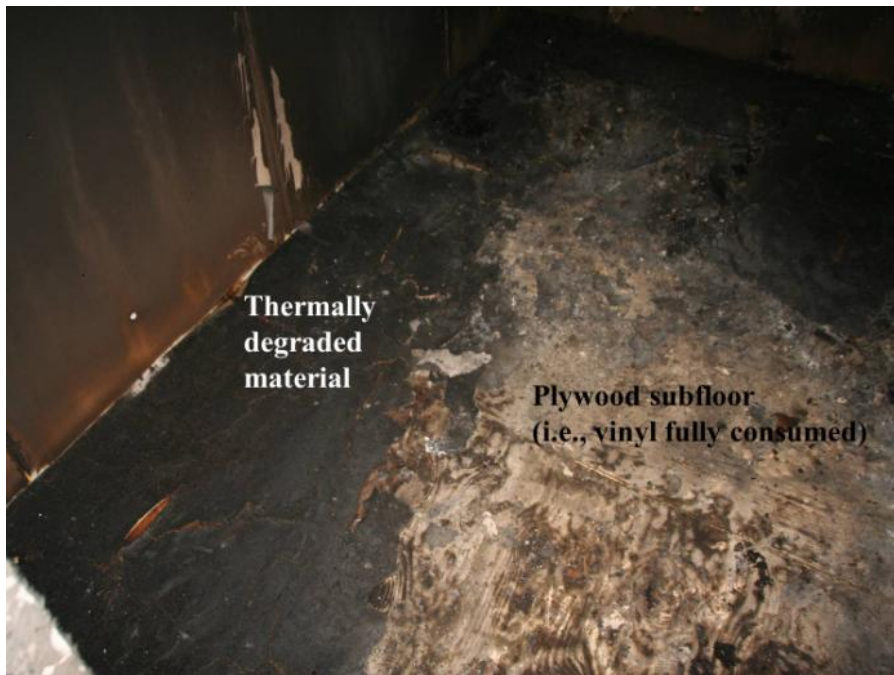
Figure 110. Close up of difference in damage to flooring after Test 6-7.

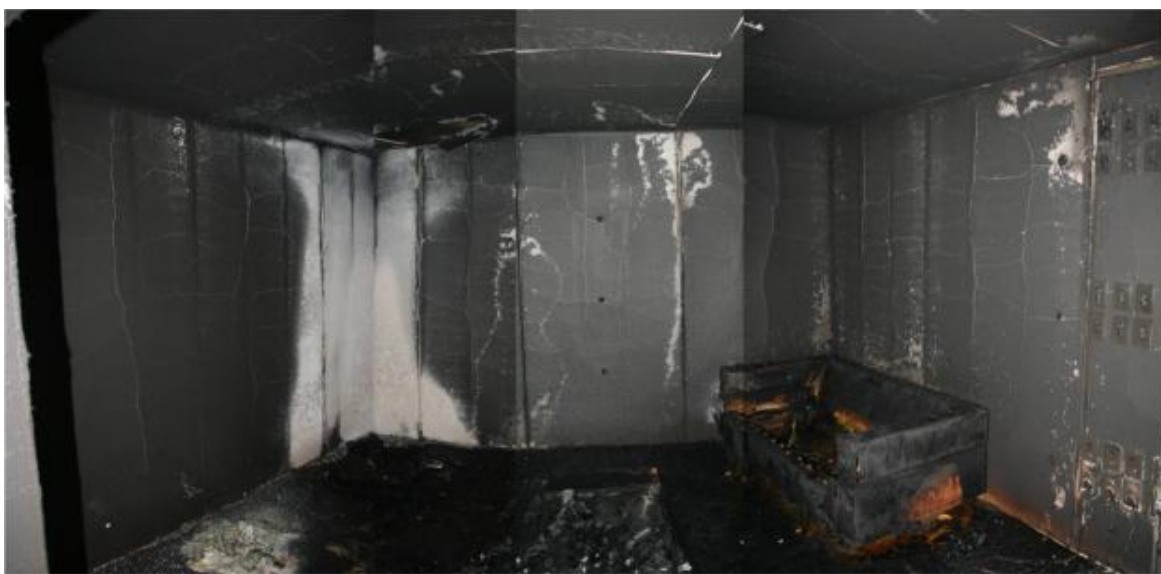
Figure 111. Composite photograph of enclosure conditions after Test 6-8.

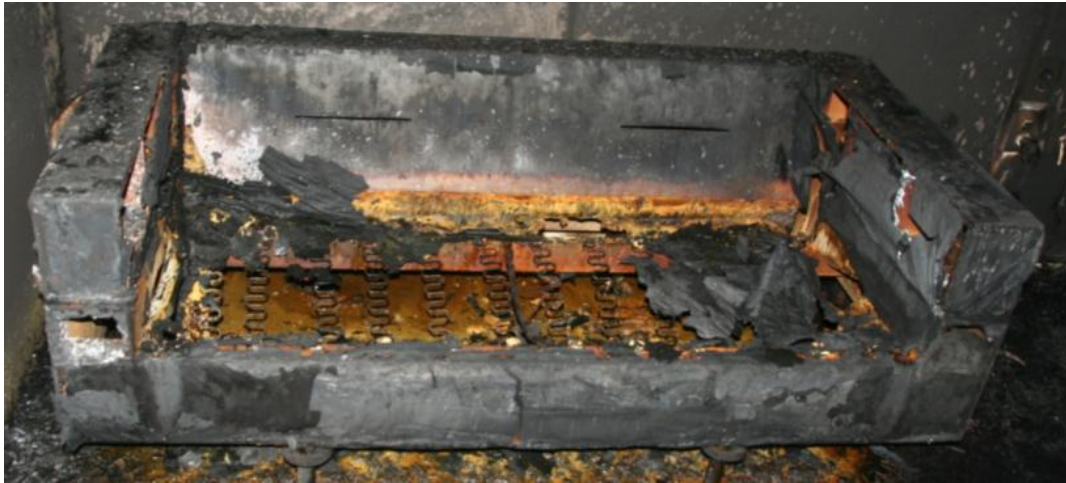
The mass loss fraction of the upholstered chair in this test was far more severe (0.56) than any of the other Class A furnishings. The upholstered sofa and table each loss less than ten percent of their original mass. Photographs of these pieces of furniture are provided in Figure 112.

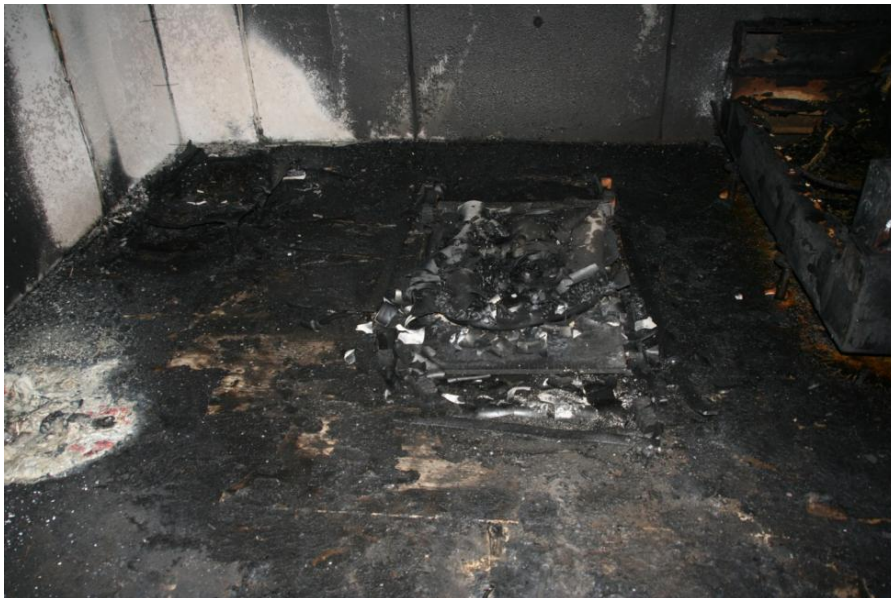
Figure 113. Condition of vinyl flooring after Test 6-8.

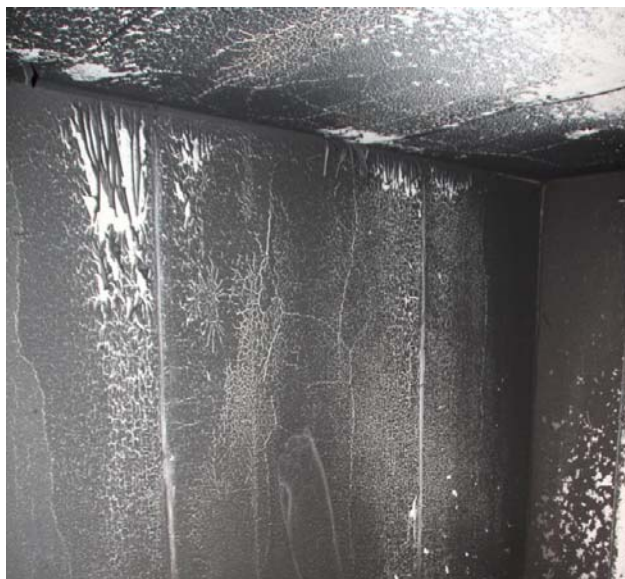
Figure 114. Example of sooted GWB paper that was partially consumed during Test 6-5.

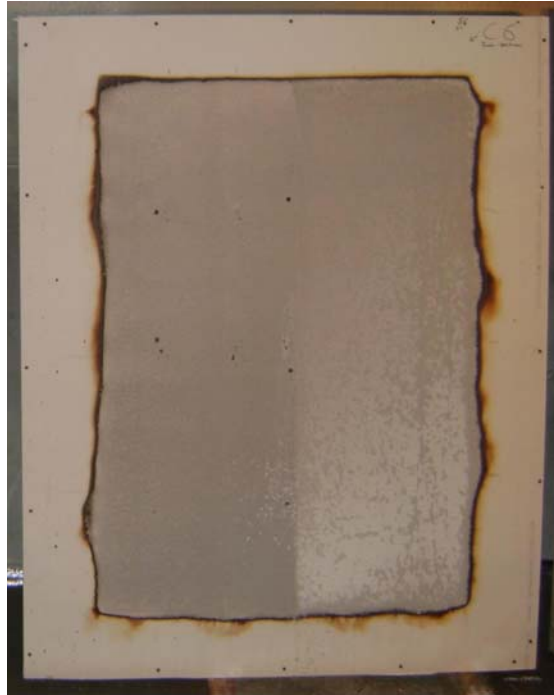
(a) Clean burn pattern on lower right hand corner of GWB with paper ash still present.

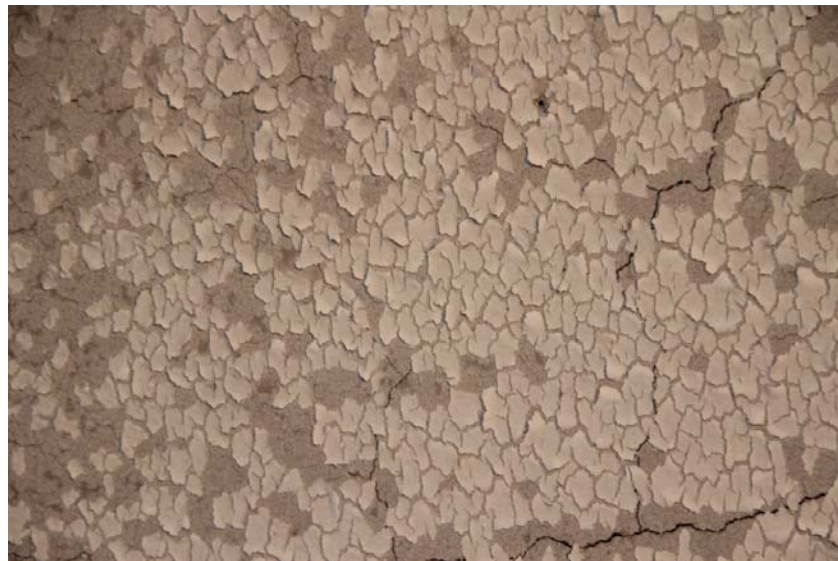
(b). Close up photograph of paper ash on gypsum wallboard.

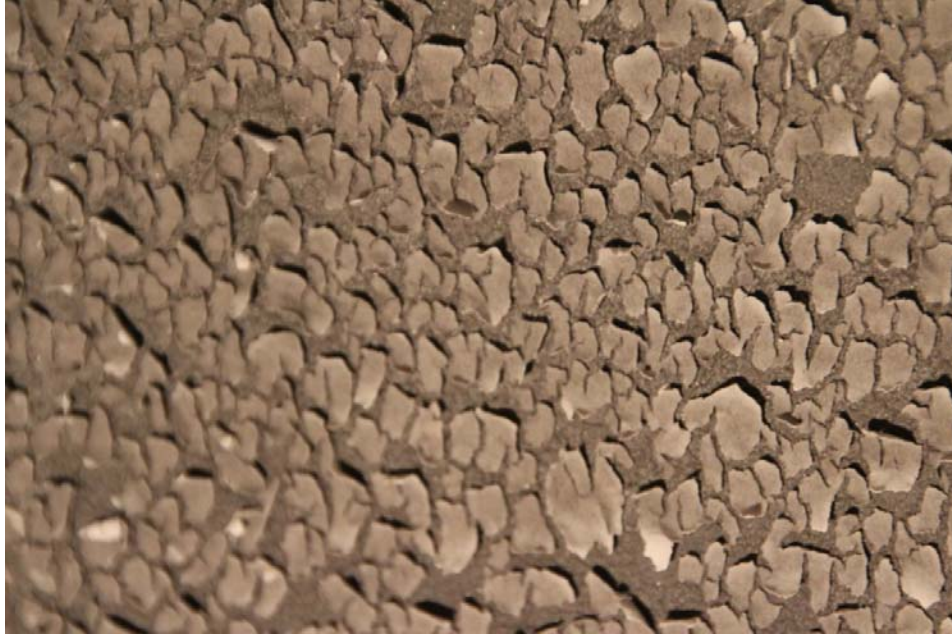
Figure 116. Close up photograph of paper ash on gypsum wallboard still covered with soot (Test 7).

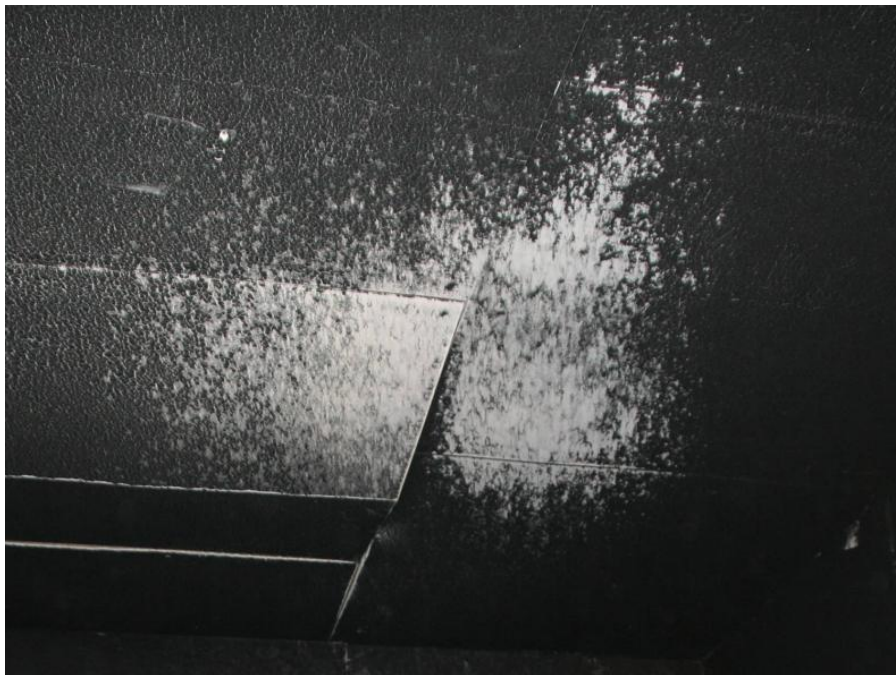
Figure 117. Suppression pattern from Test 6-1.

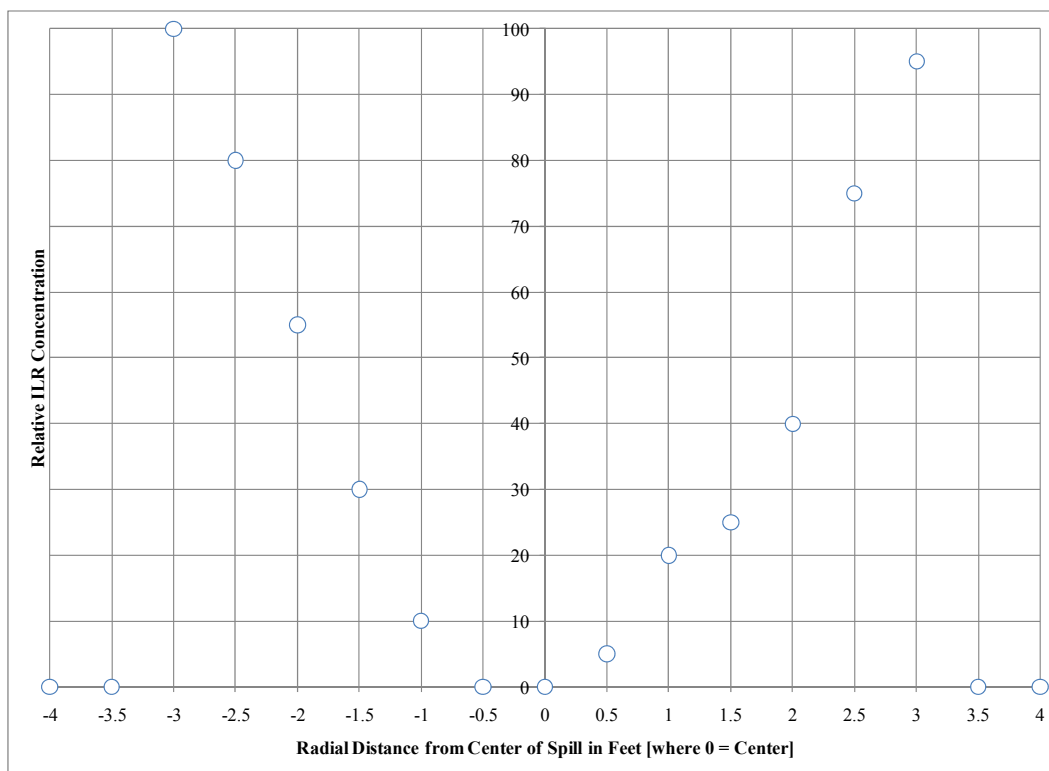
Figure 119. Graphical representation of O'Donnell [1985] ILR sampling findings.

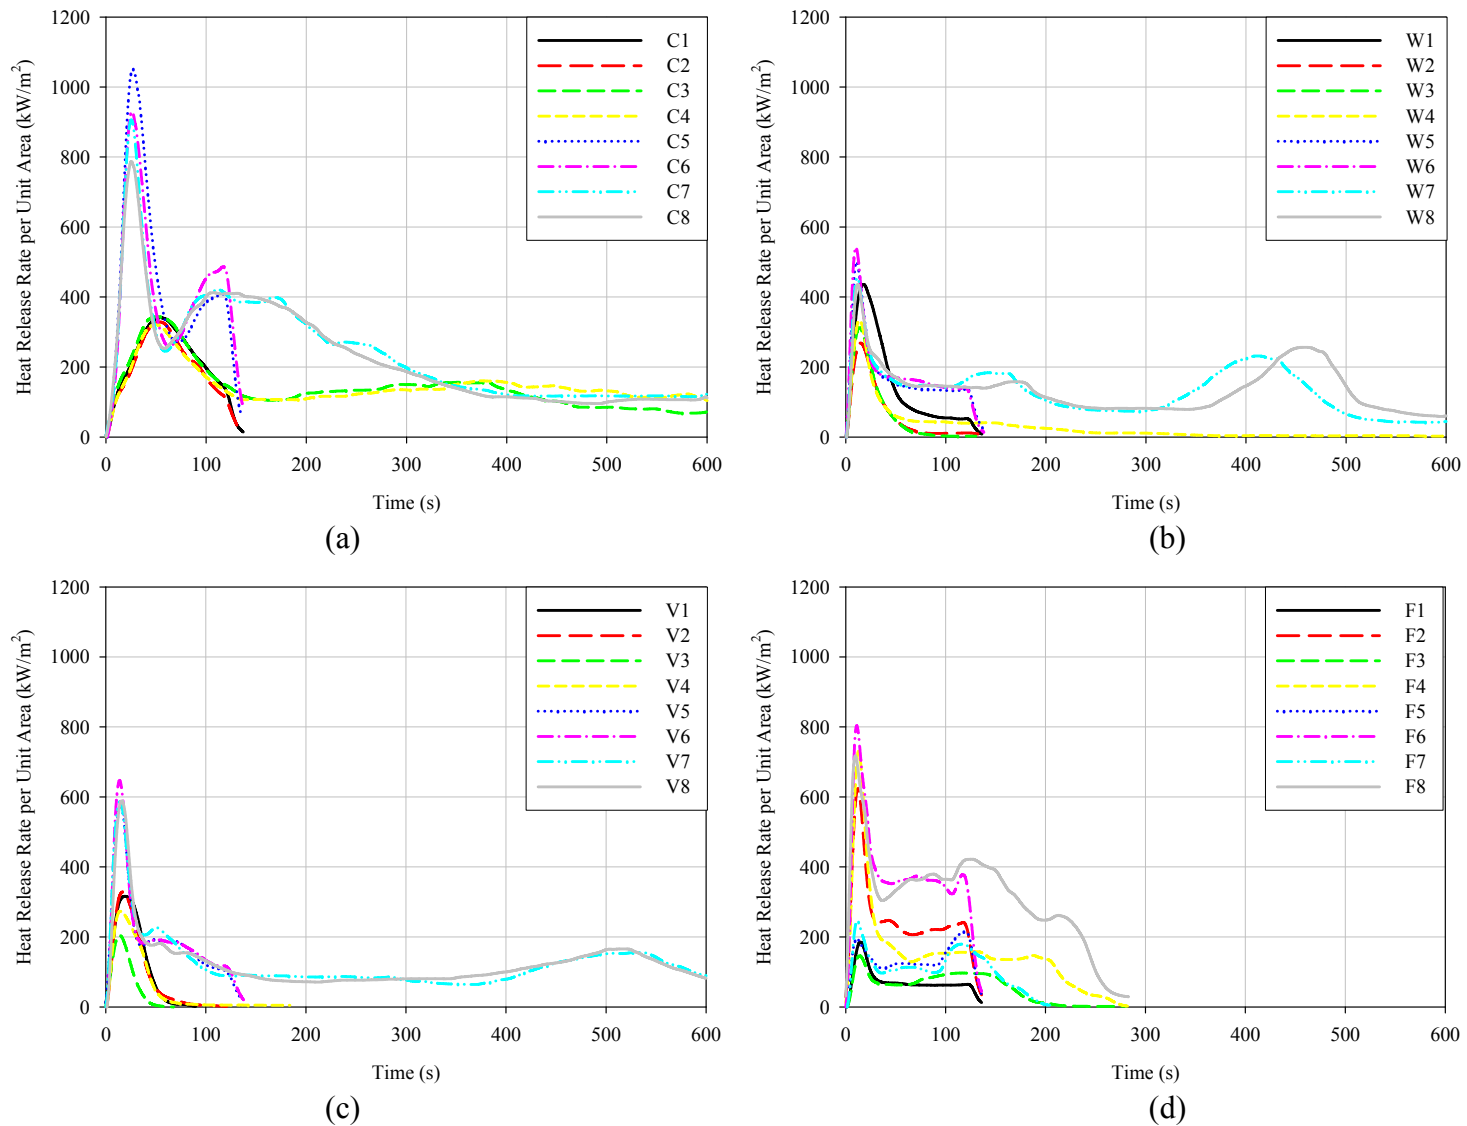
Figure 120. Heat release rate profiles from small-scale gasoline spill fire testing in a cone calorimeter on (a) carpet, (b) plywood, (c) vinyl, and (d) furniture material.

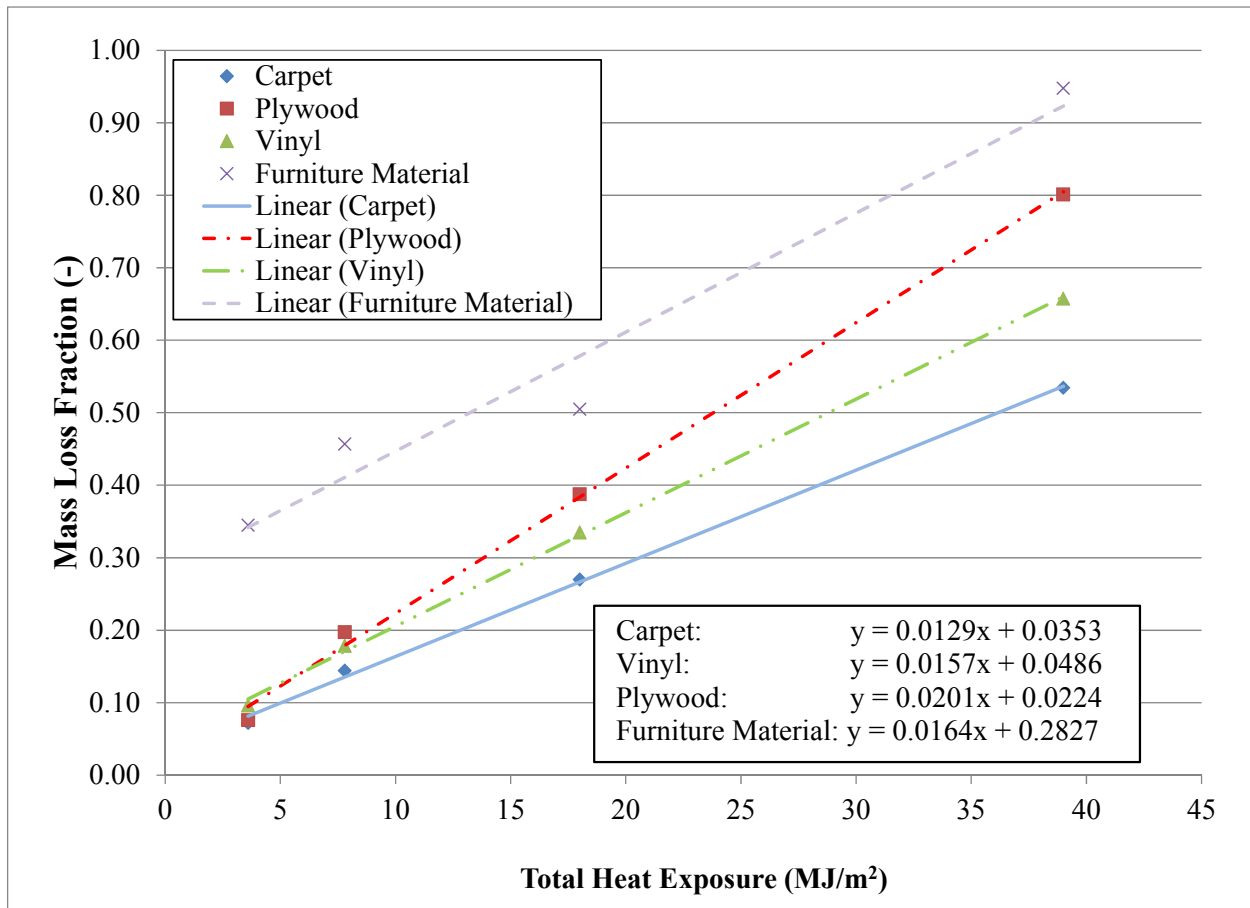
Figure 121. Extent of damage to substrate material as a function of estimated total heat exposure to substrate from combustion of gasoline spill and substrate material burning.

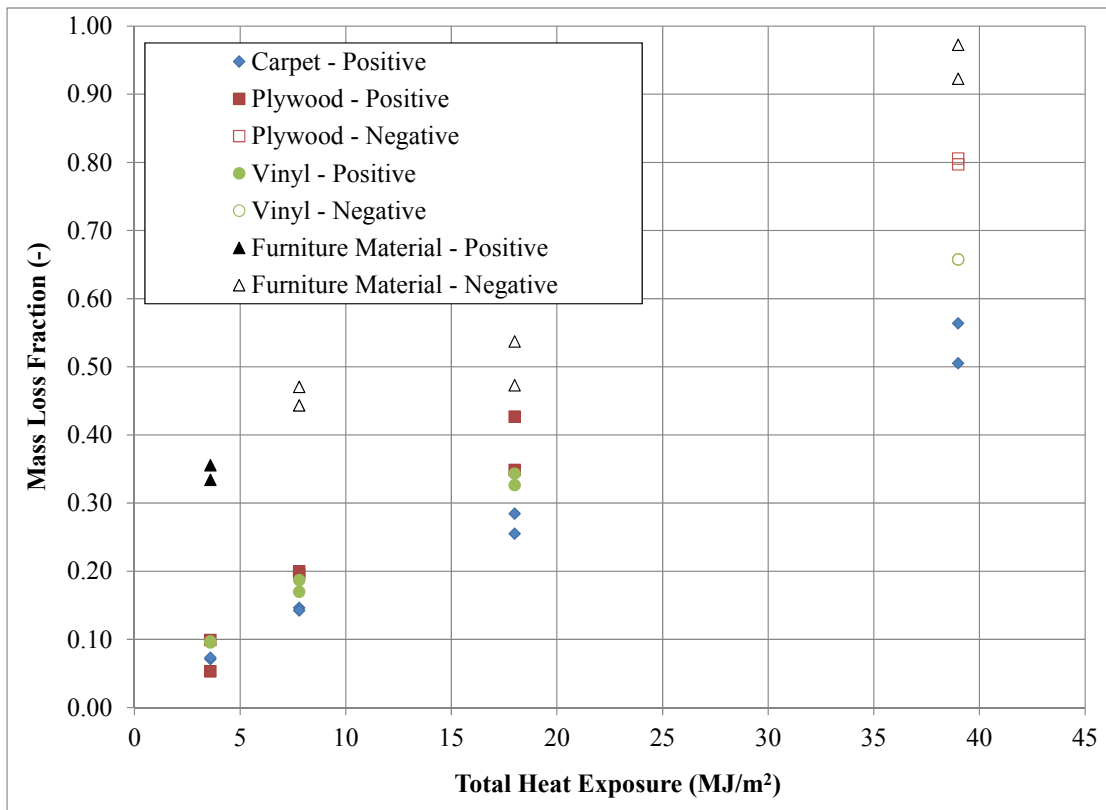
Figure 122. Persistence of ILR relative to mass loss fraction and total heat exposure (data from Table 4.3).

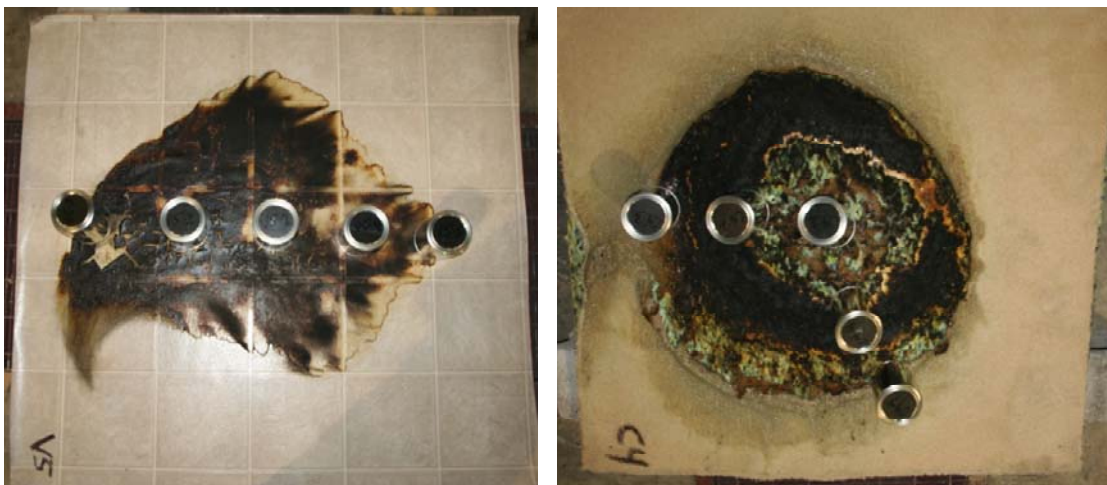
Figure 123. Representative ILR sample locations on vinyl (left) and carpet (right) flooring for open burning tests.

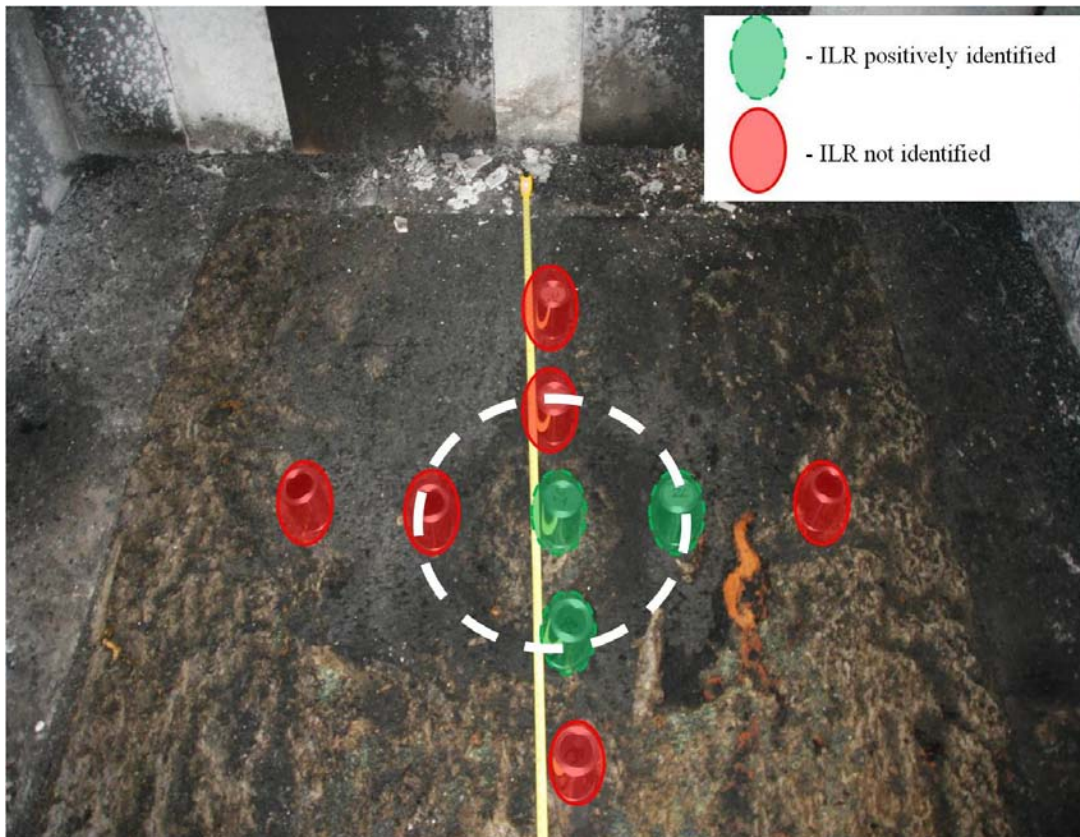
Figure 129. Locations of positive and negative ILR identification after enclosed gasoline spill fire on carpet flooring test without Class A fuels present.
