**The author(s) shown below used Federal funds provided by the U.S. Department of Justice and prepared the following final report:**

**Document Title: Forensic Analysis of Ignitable Liquid Fuel Fires in Buildings**

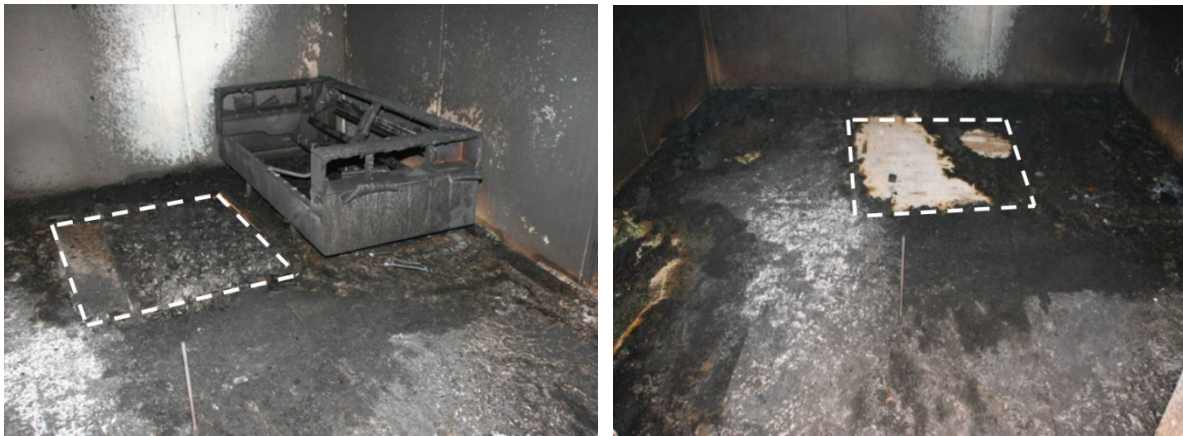
Figure 130. Condition of wooden table and flooring after Test 6-1 prior to overhaul (left) and after overhaul (right).

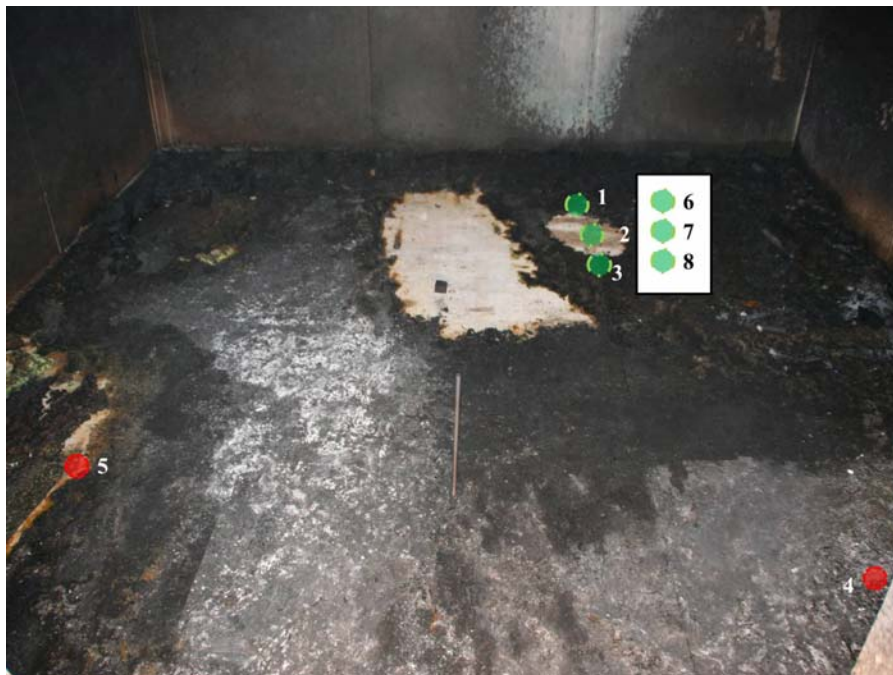
Figure 131. ILR sampling locations for Test 6-1.

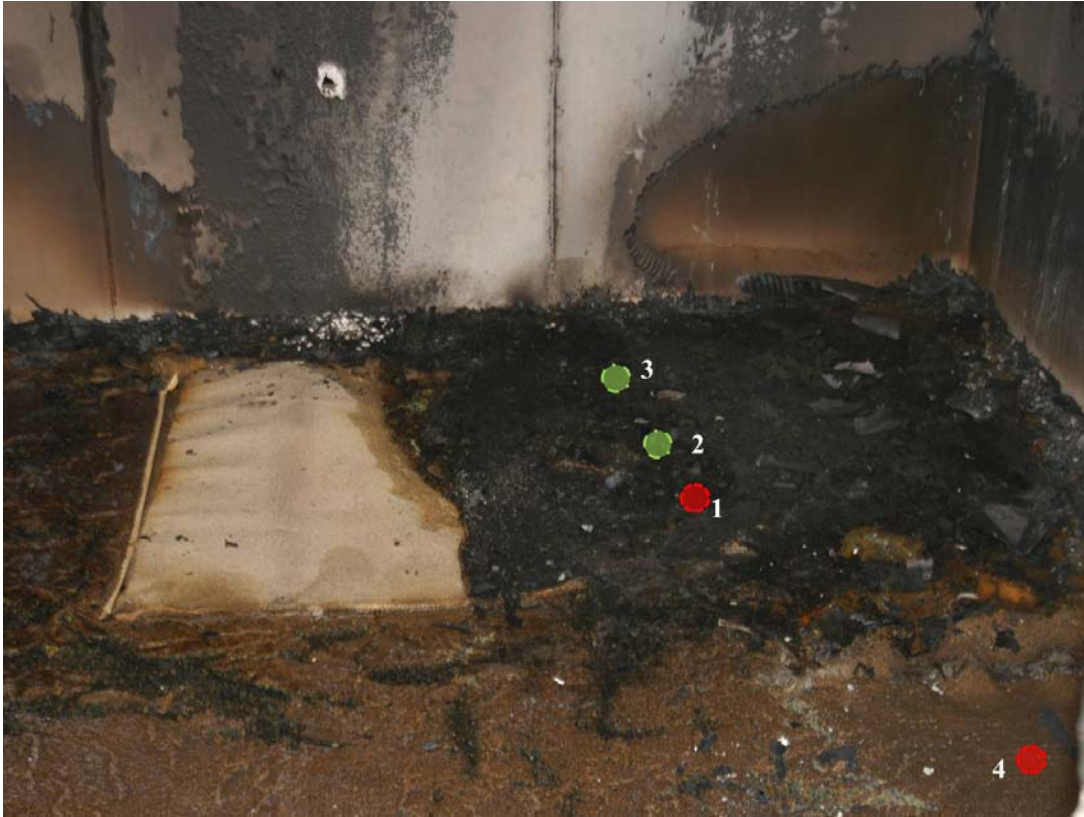
Figure 133. ILR sampling locations for Test 6-2.

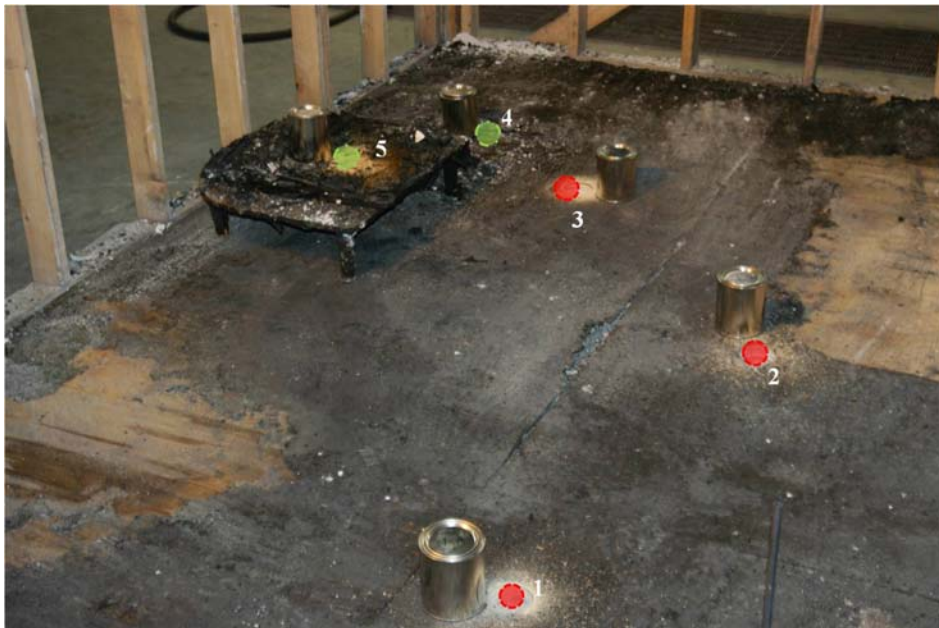
Figure 134. ILR sampling locations for Test 6-3.

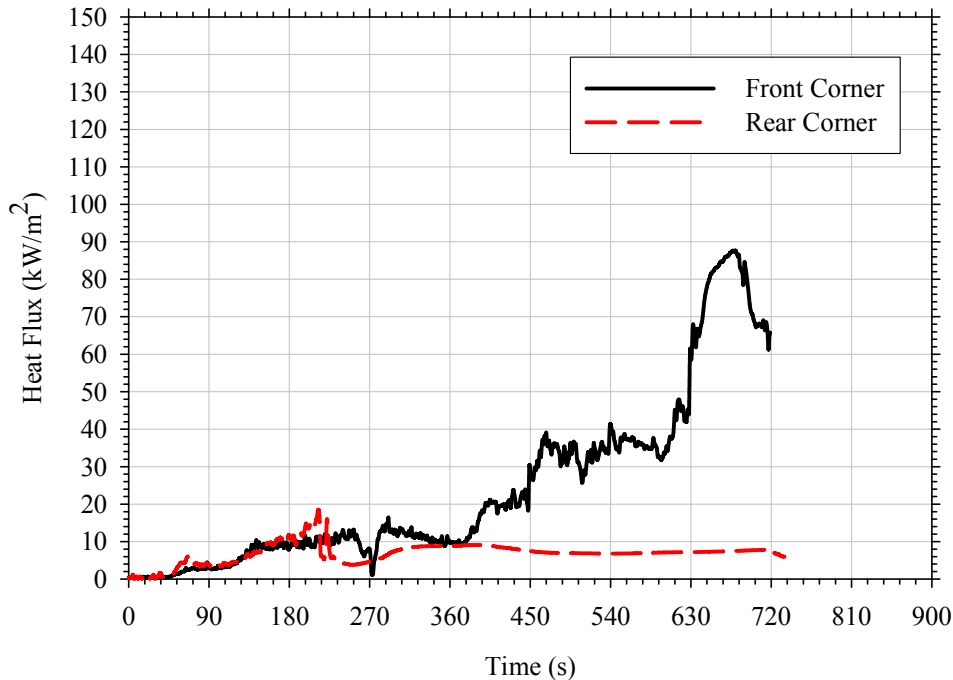
Figure 137. Floor level heat flux measurements collected during Test 6-4.

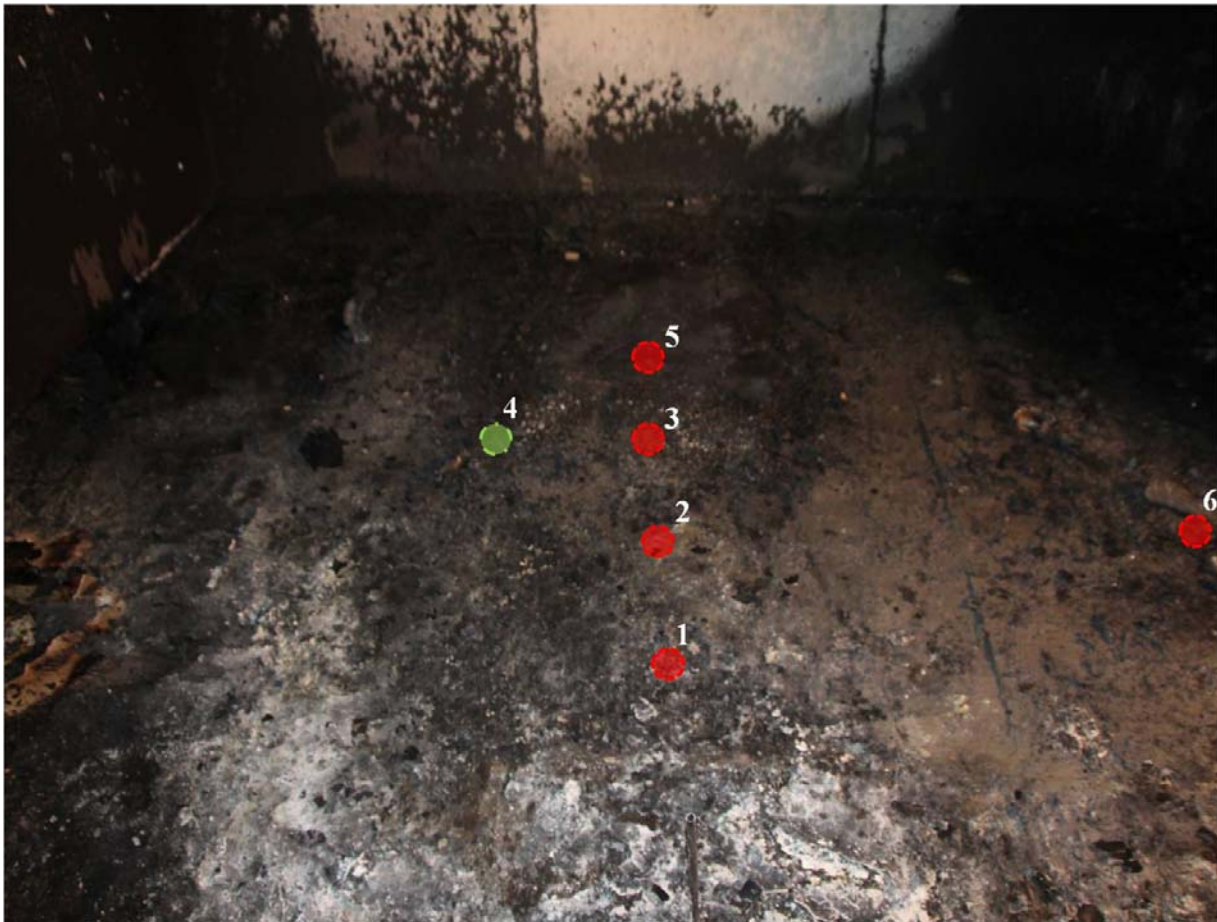
Figure 138. ILR sampling locations for Test 6-5.

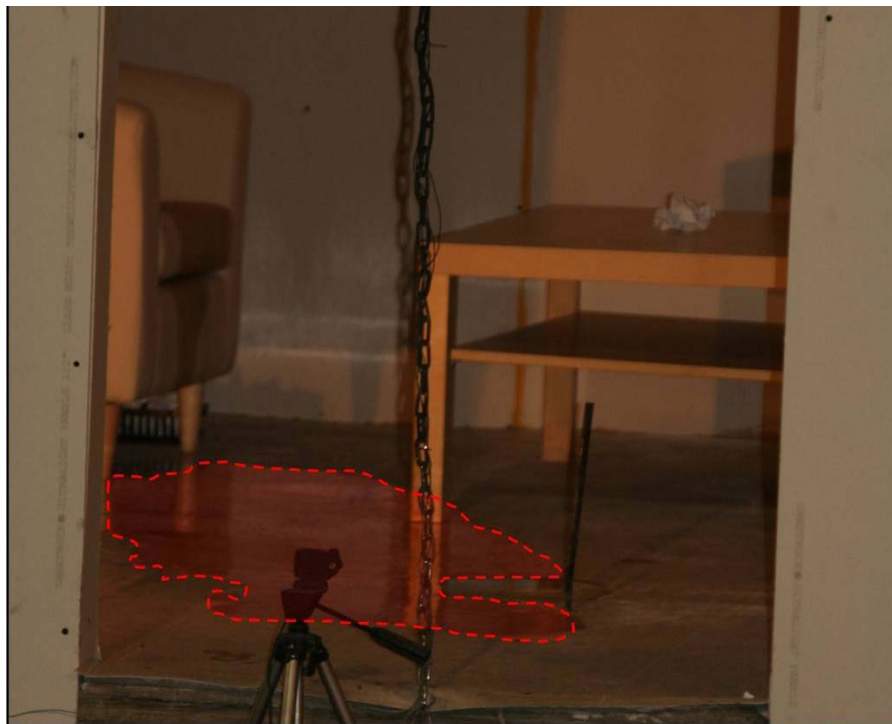
Figure 140. Annotated photograph showing representative gasoline trailer spill area on vinyl flooring.
