The author(s) shown below used Federal funds provided by the U.S. Department of Justice and prepared the following final report:

Document Title: Development and Analysis of Electrical Receptacle Fires

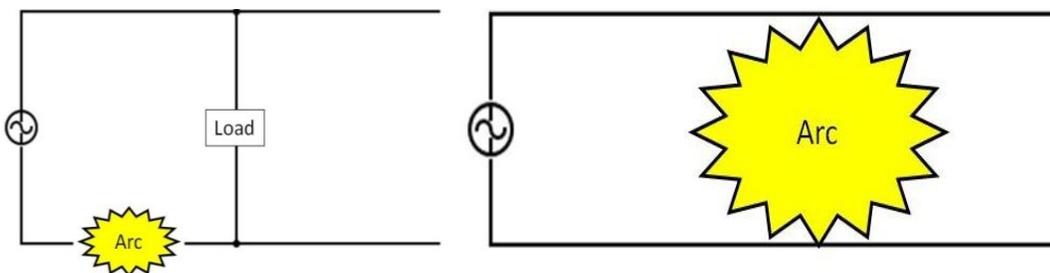
Figure 1-1. Schematic of a series arc (left) and a parallel arc (right).

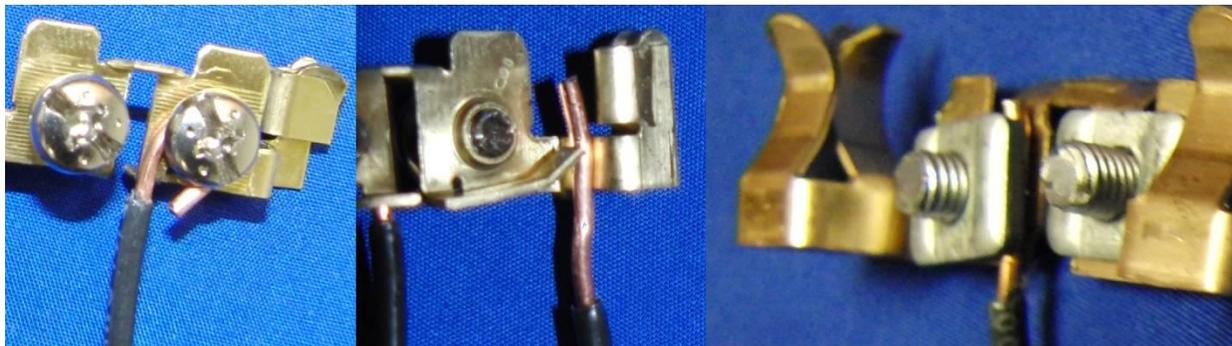
Figure 1-2. Three types of receptacle terminals (from left to right: side wired screw terminal, back wired push-in terminal, and back wired compression terminal).

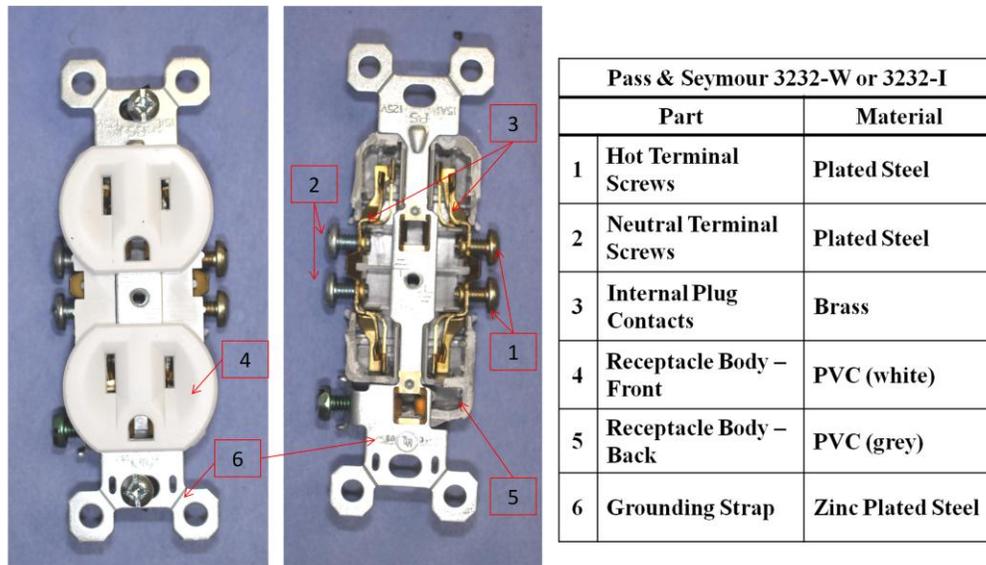
Figure 1-3. Schematic of new PVC receptacle materials and construction.

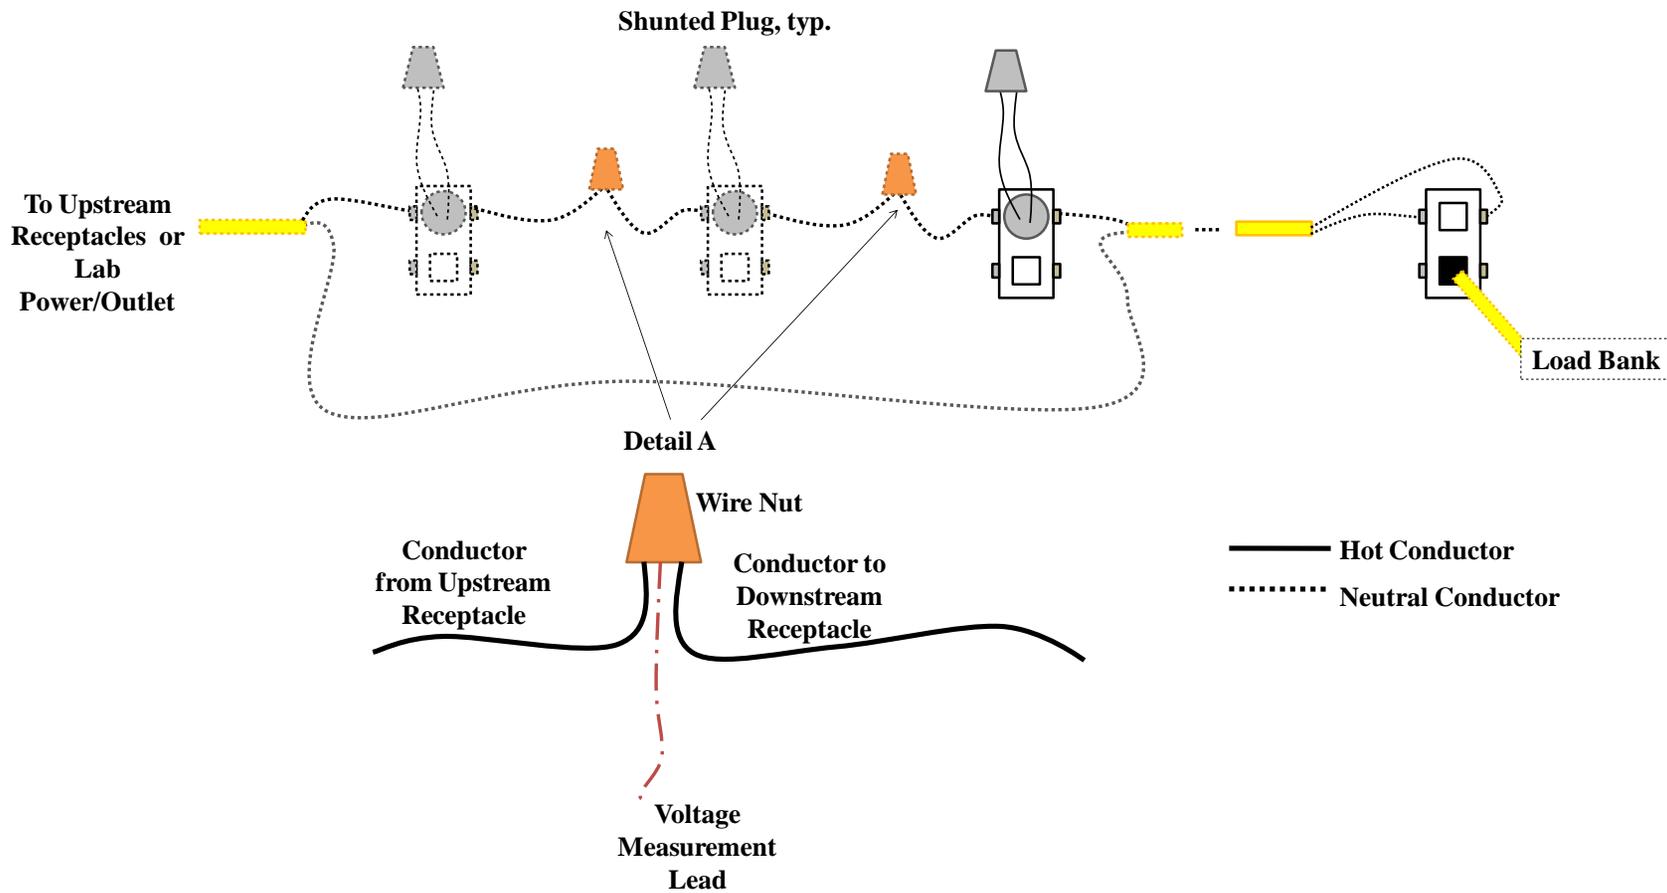
Figure 2-3. Test wiring schematic (Receptacle/Plug Connections).

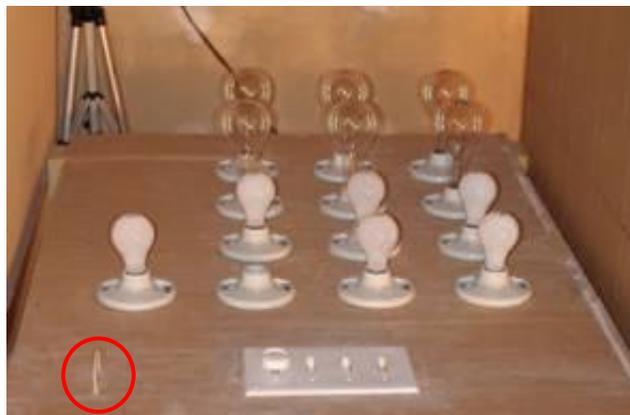
Figure 2-6. Photograph of light bulb load bank. Note: neutral wire circled.

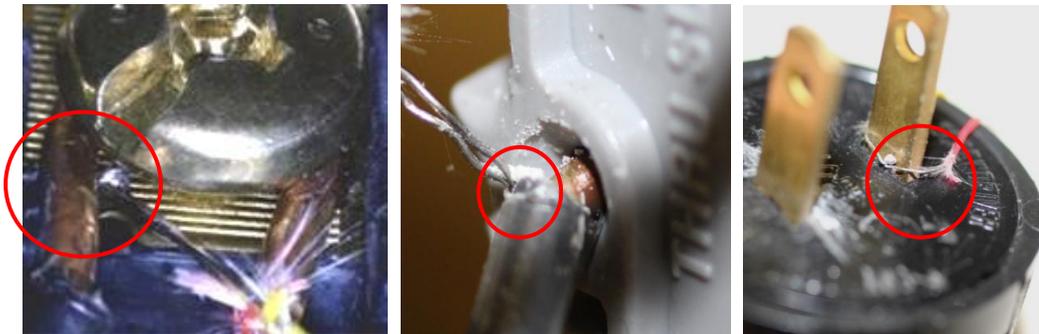
Figure 2-7. Photo of placement of thermocouple beads on side wired connection (left), back wired push-in connection (center), and plug blade (right). Note: Cement not added for visibility of bead.

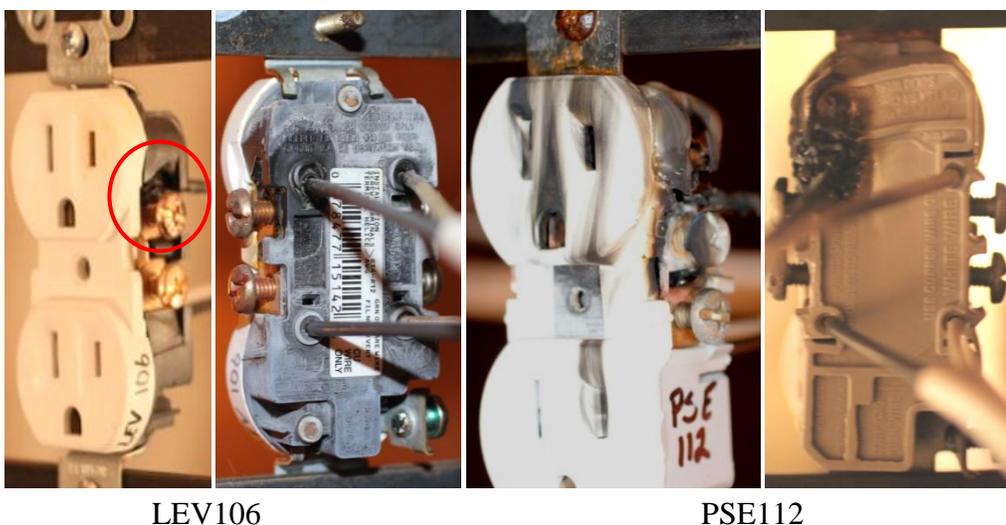
Figure 2-8. Photographs showing melting (LEV106, left) and charring (PSE112, right) of receptacles with back-wired push-in connections.

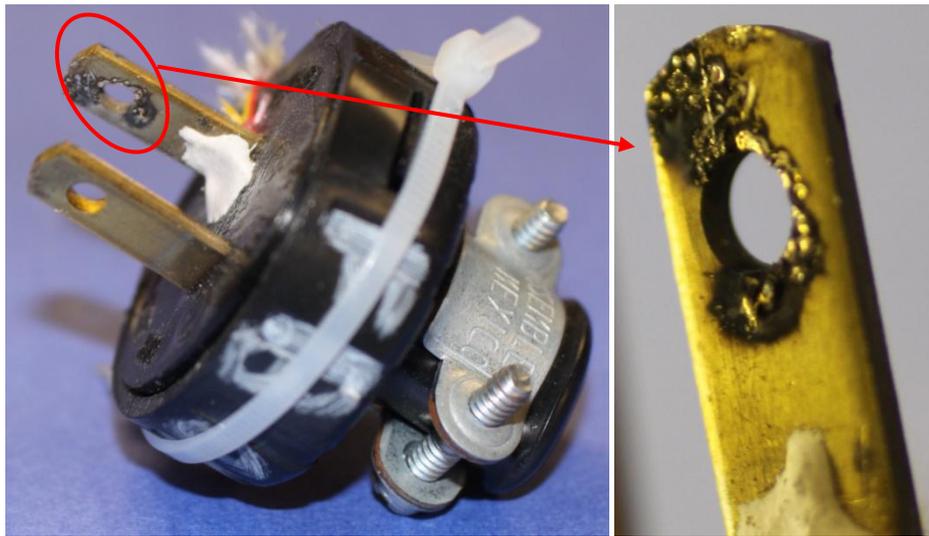
Figure 2-9. Do-it-yourself plug showing arcing damage (PSE044).

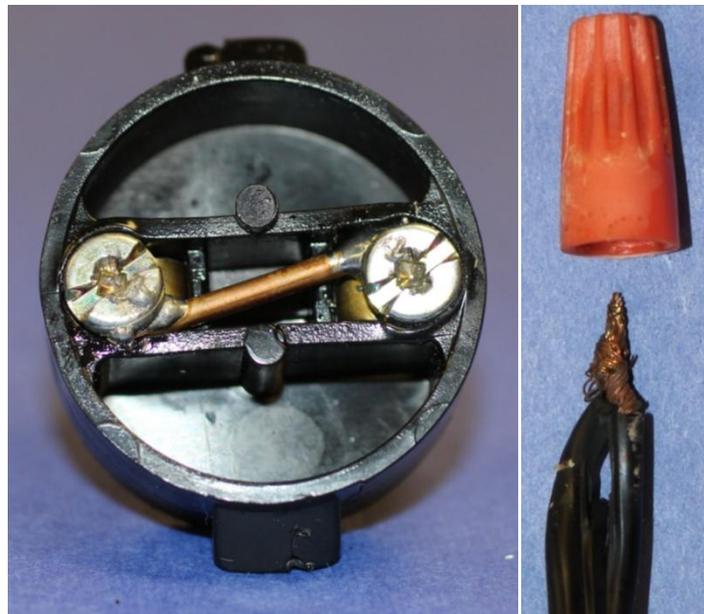
Figure 2-10. Shunting method for DIY plugs (left) and for other plugs (right).

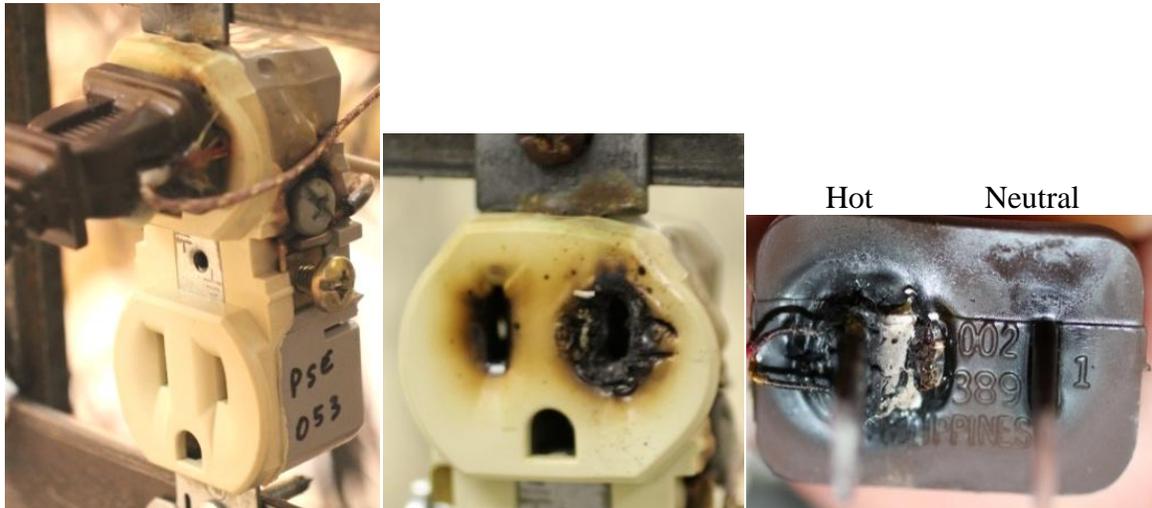
Figure 2-11 Overheating at folded plug blade connection (0.01 kg) on Receptacle PSE053.

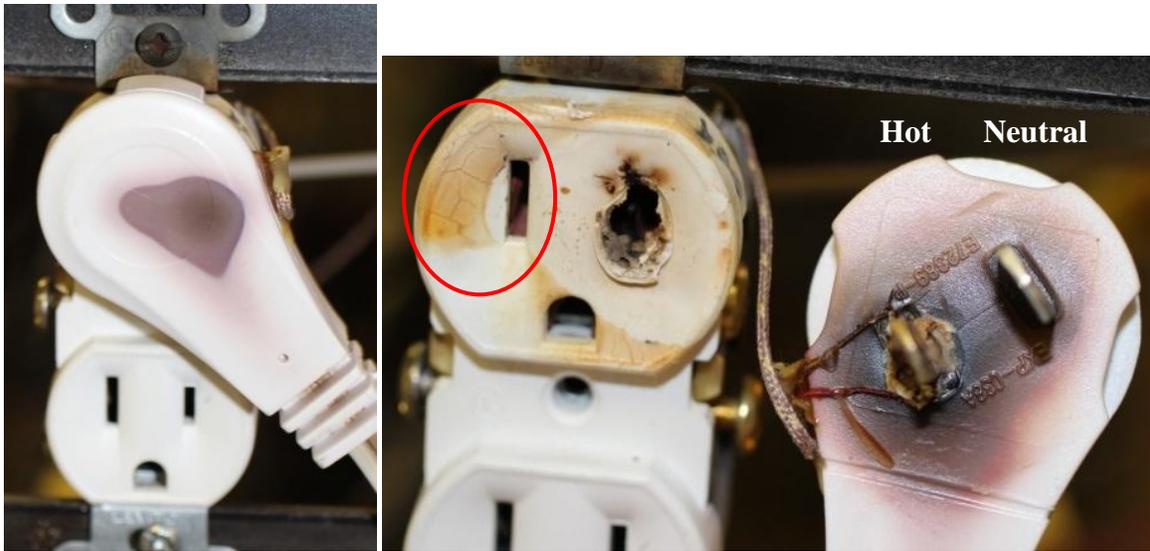
Figure 2-12. Overheating at low-profile plated plug connection on Receptacle LEV053 (0.01 kg).

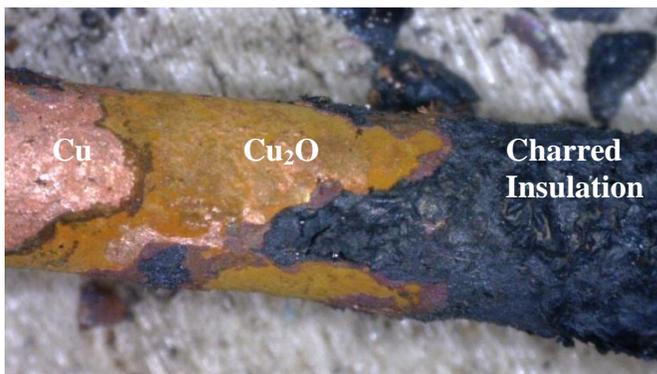
Figure 2-15. Oxidation of wire, showing layer of Cu₂O in center and underlying copper (PSE170).

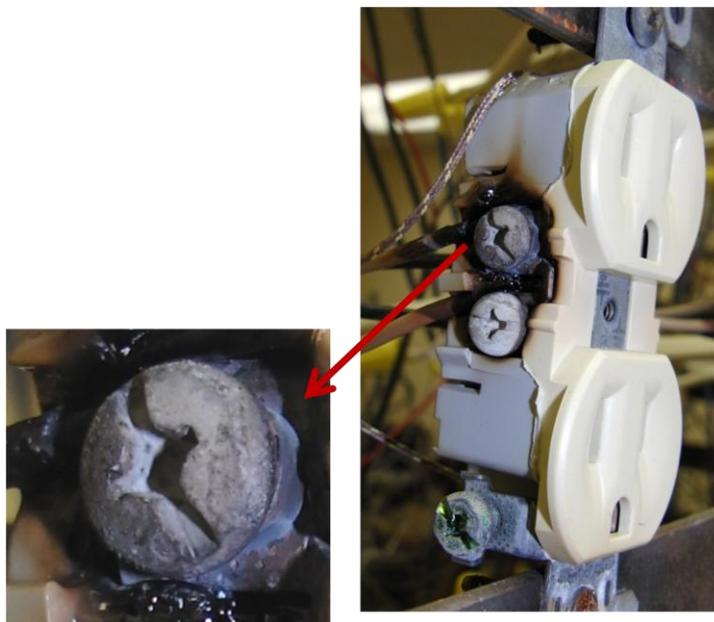
Figure 2-17. Photograph showing oxide layer on wire and loss of plating on receptacle screw on PSE016 (1/4 turn loose).

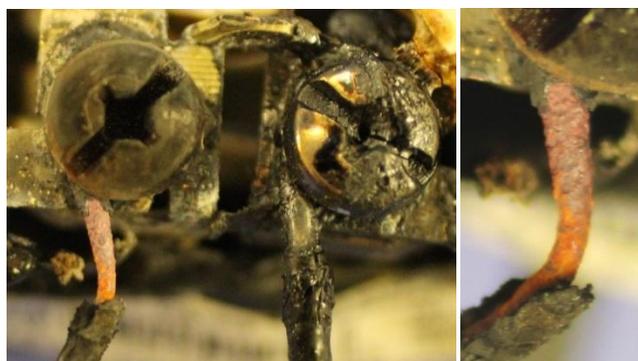
Figure 2-18. Thinned and pitted wire from oxidation (LEV009).

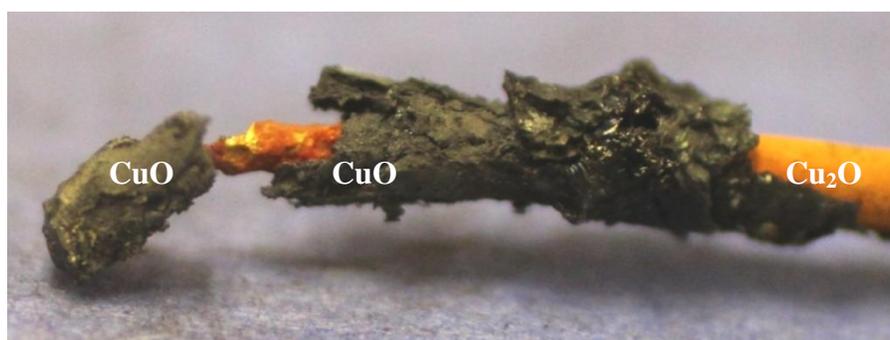
Figure 2-20. Thinned and pitted wire from oxidation (PSE133).

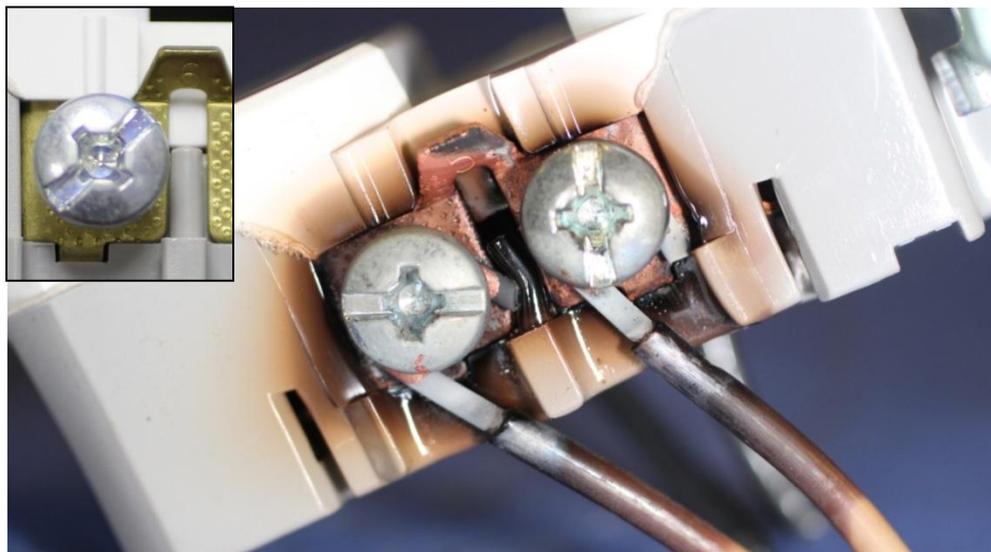
Figure 2-21. Photograph showing corrosion of wire, discoloration of plastic, and dezincification of brass components on PSE171 (exemplar photo of brass contacts shown in upper left).

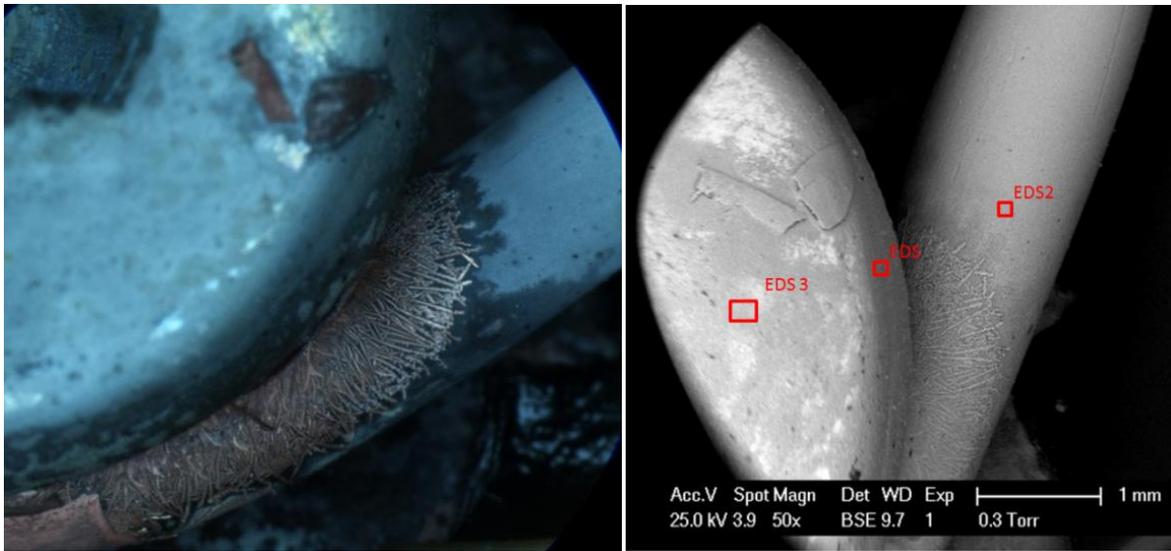
Figure 2-22. Microscopic image (left) and SEM image with EDS locations (right) of top-neutral conductor/screw from PSE171.

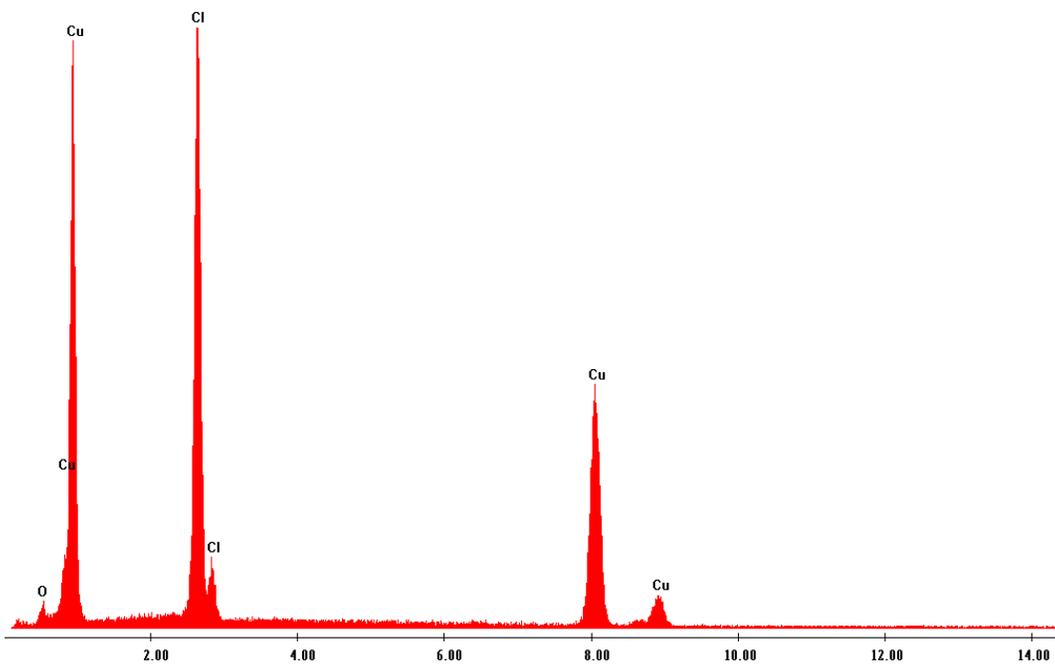
Figure 2-23. EDS Spectra for corrosion layer, "EDS2" in Figure 2-20 (right).

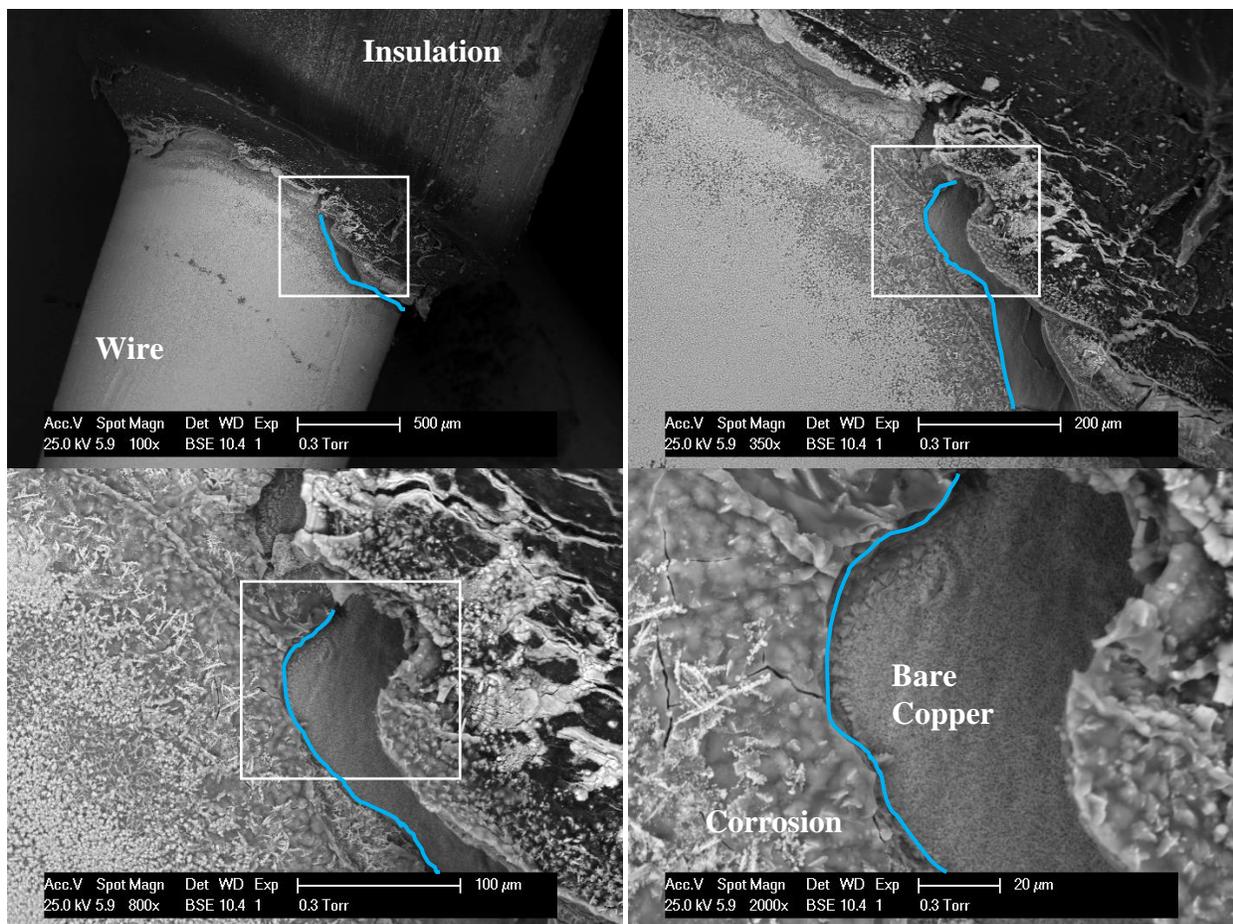
Figure 2-24. SEM images (100x–2000x) of white corrosion deposit at interface of wire and insulation for PSE 171.

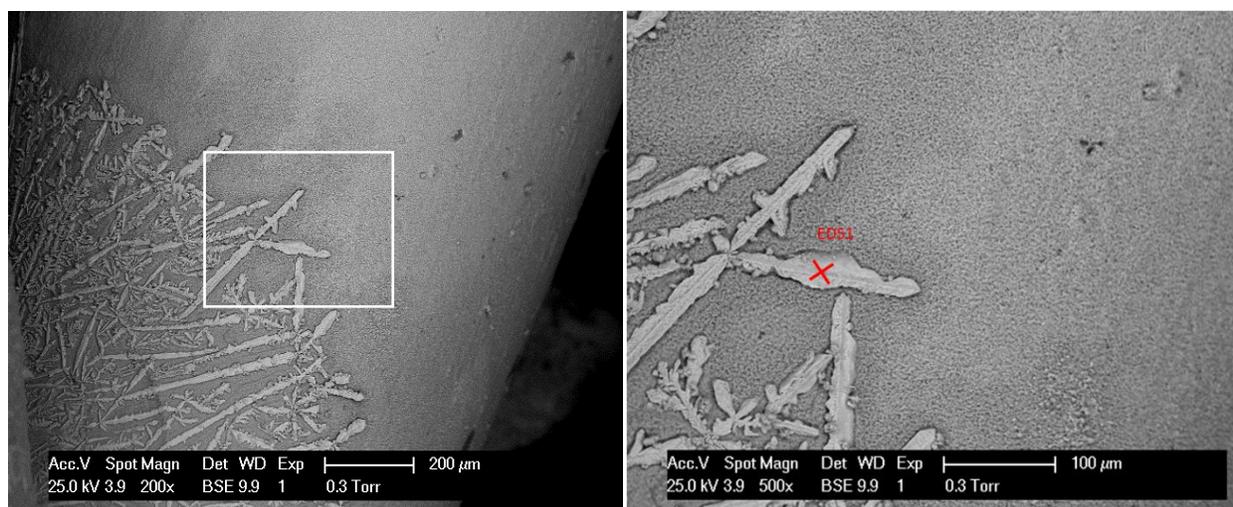
Figure 2-25. SEM images at 200x and 500x magnification of dendritic structure on PSE171; EDS location noted by an 'X'.

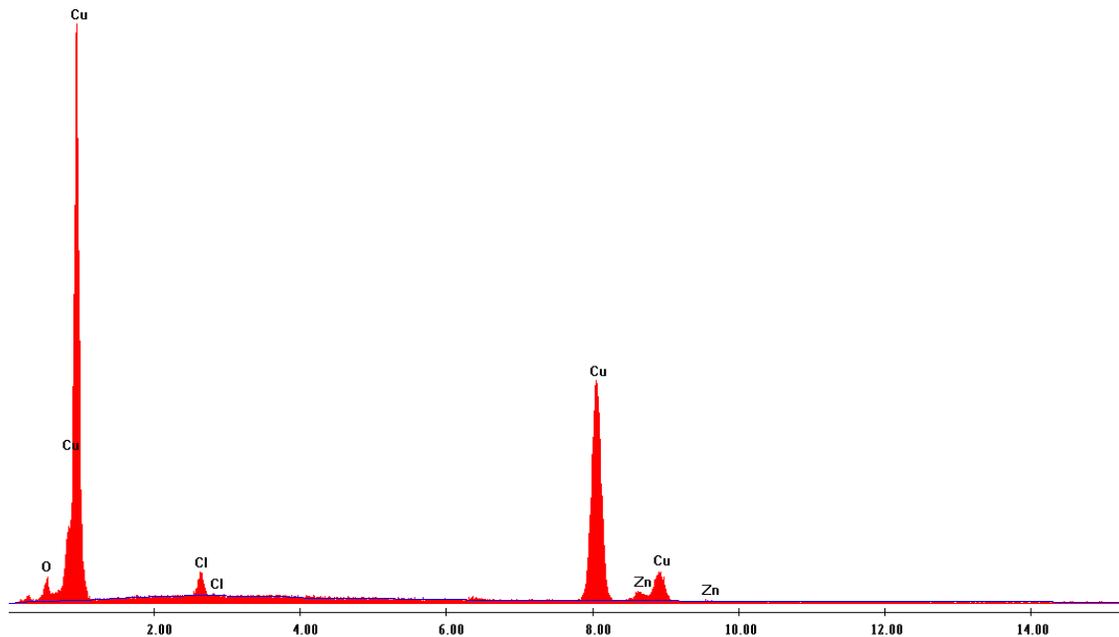
Figure 2-26. EDS Spectra for dendrite, “EDS1” in Figure 2-23 (right).

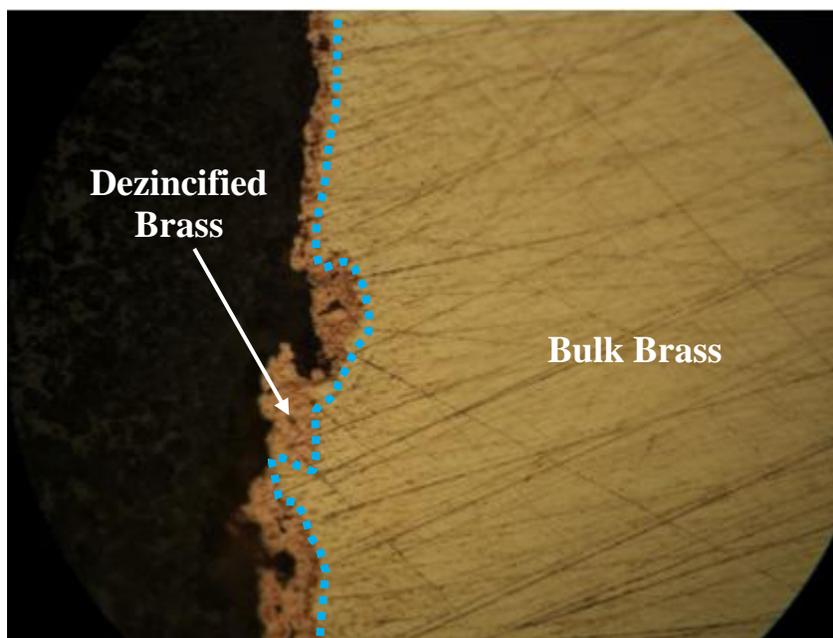
Figure 2-27. Section of brass contact from PSE170 (500x) showing dezincification (from circled area in Figure 2-64).

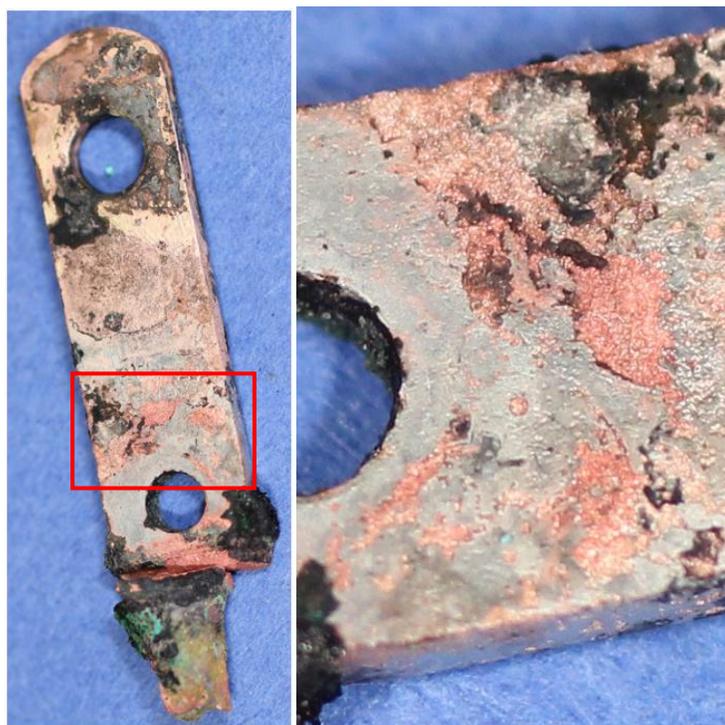
Figure 2-28. Loss of plating and dezincification of low profile plug blade; nominal retention force of 0.01 kg (LEV286).

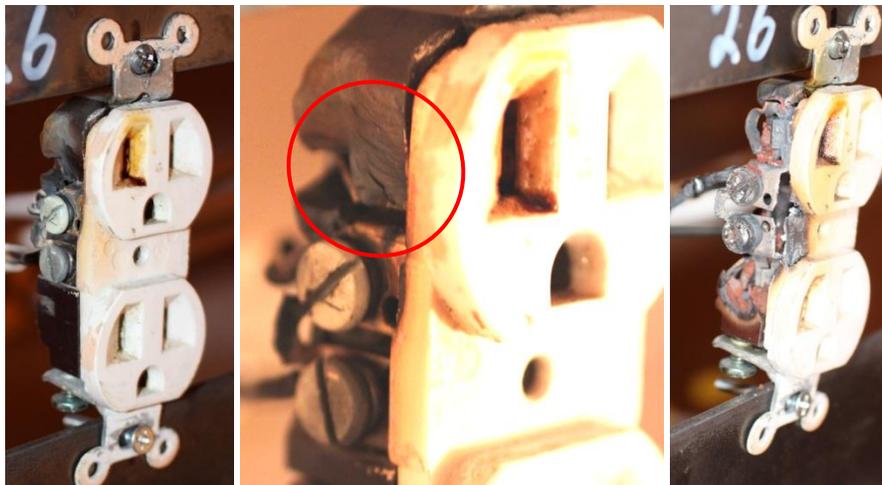
Figure 2-31. Photographs showing cracking and loss of material for a thermoset receptacle (C009).

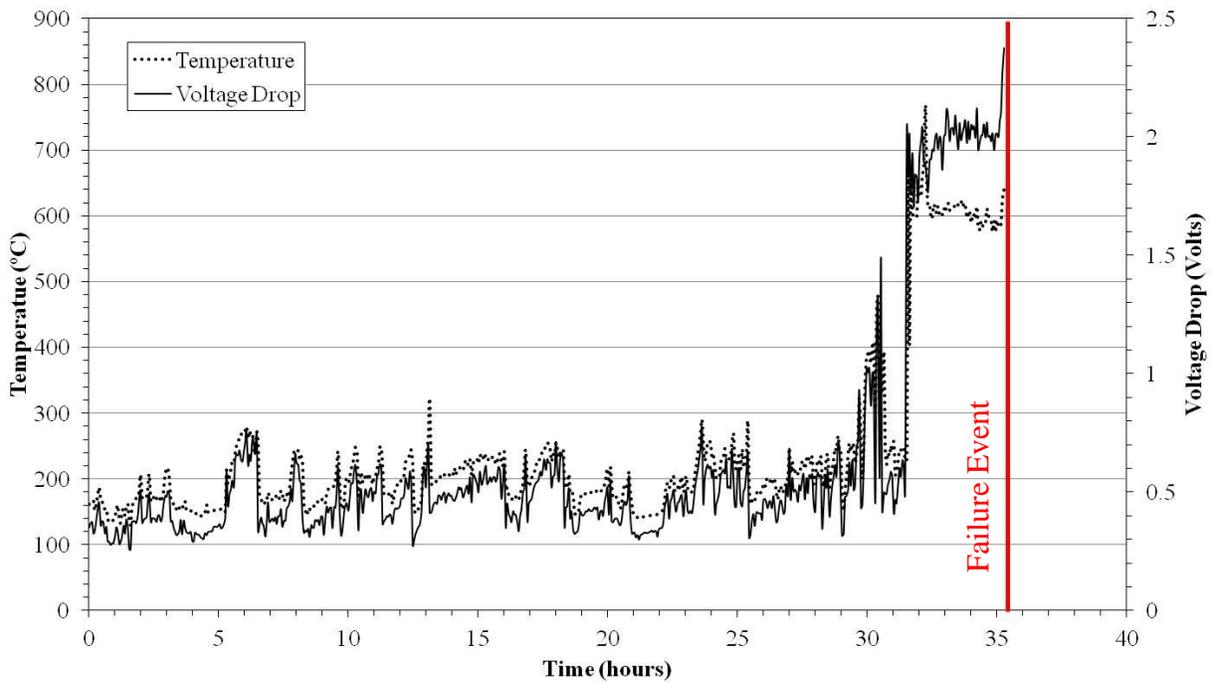
Figure 2-32. Temperature and voltage drop for PSE024 leading to failure event.

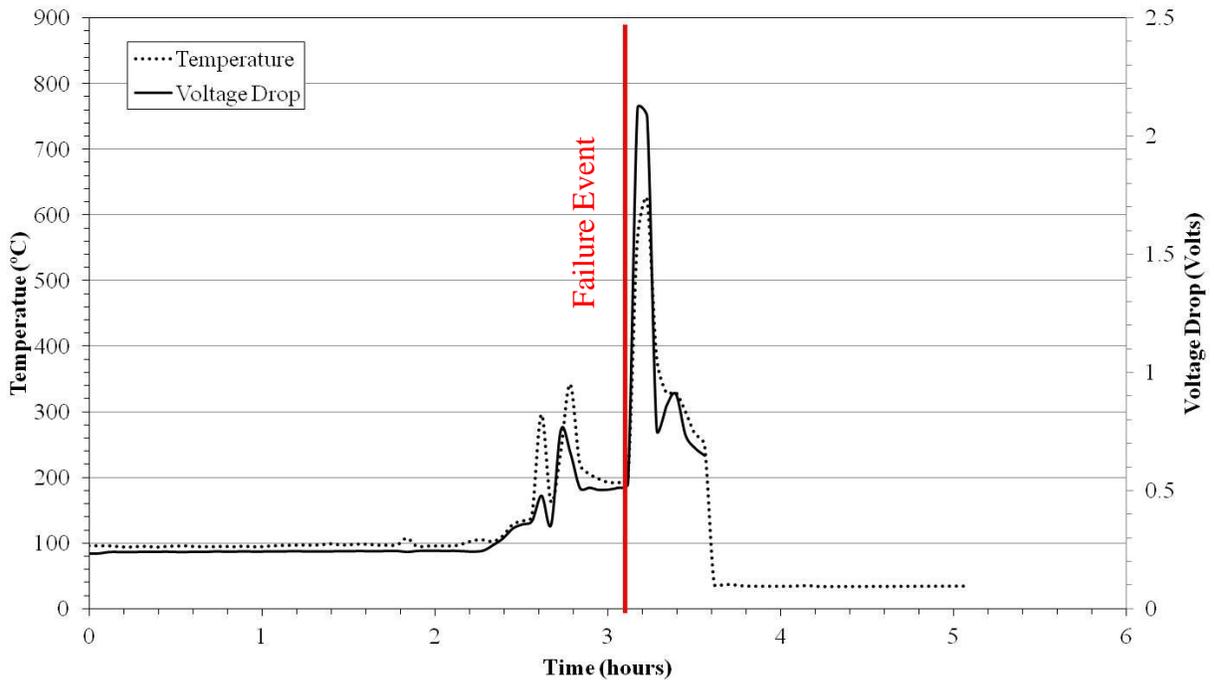
Figure 2-33. Temperature and voltage drop for LEV062 leading to failure event.

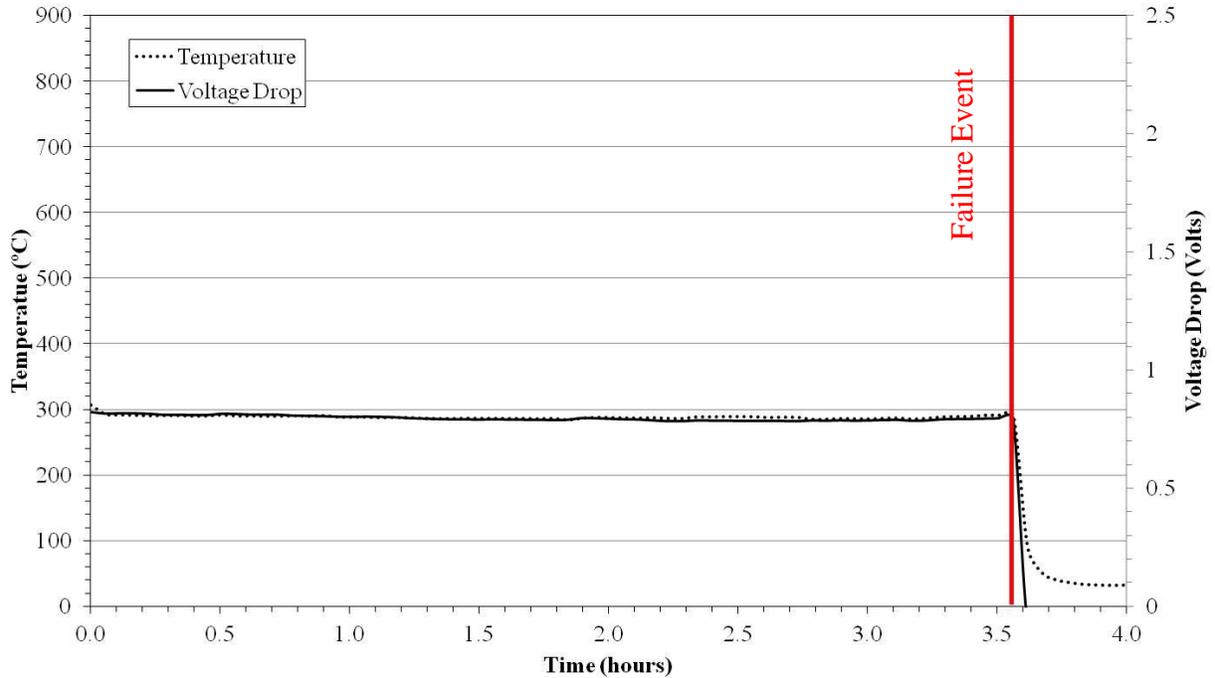
Figure 2-34. Temperature and voltage drop for LEV037 leading to failure event.

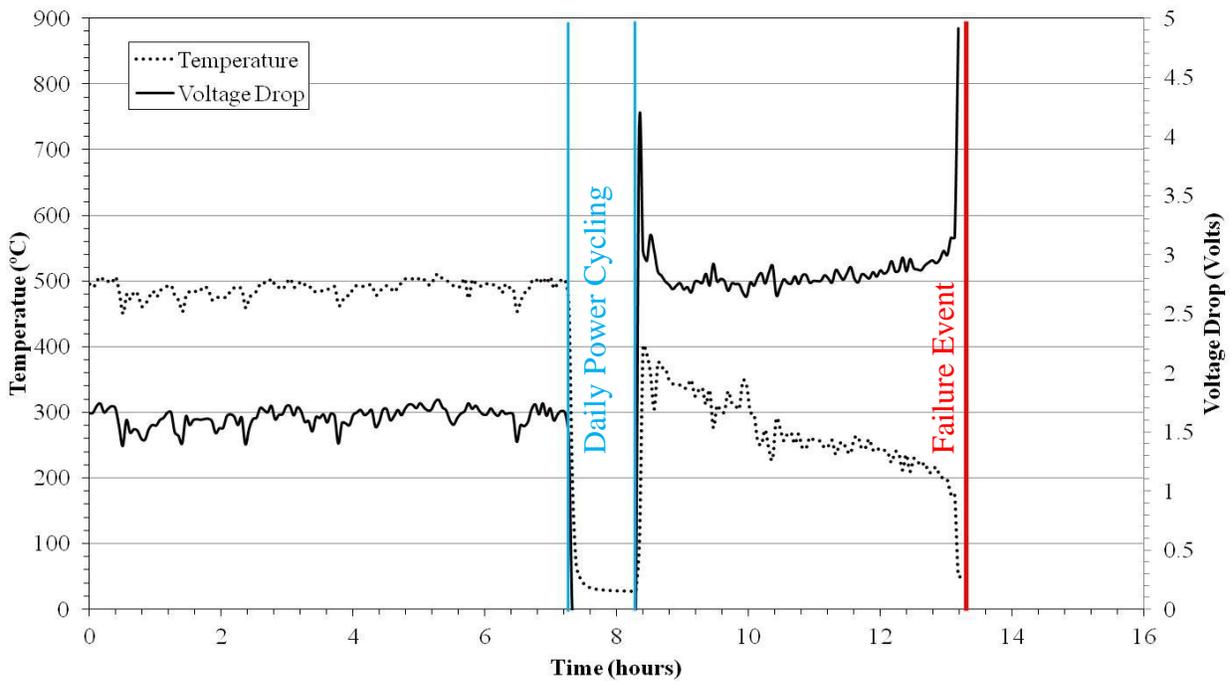
Figure 2-35. Temperature and voltage drop for LEV035 leading to severed conductor failure event.

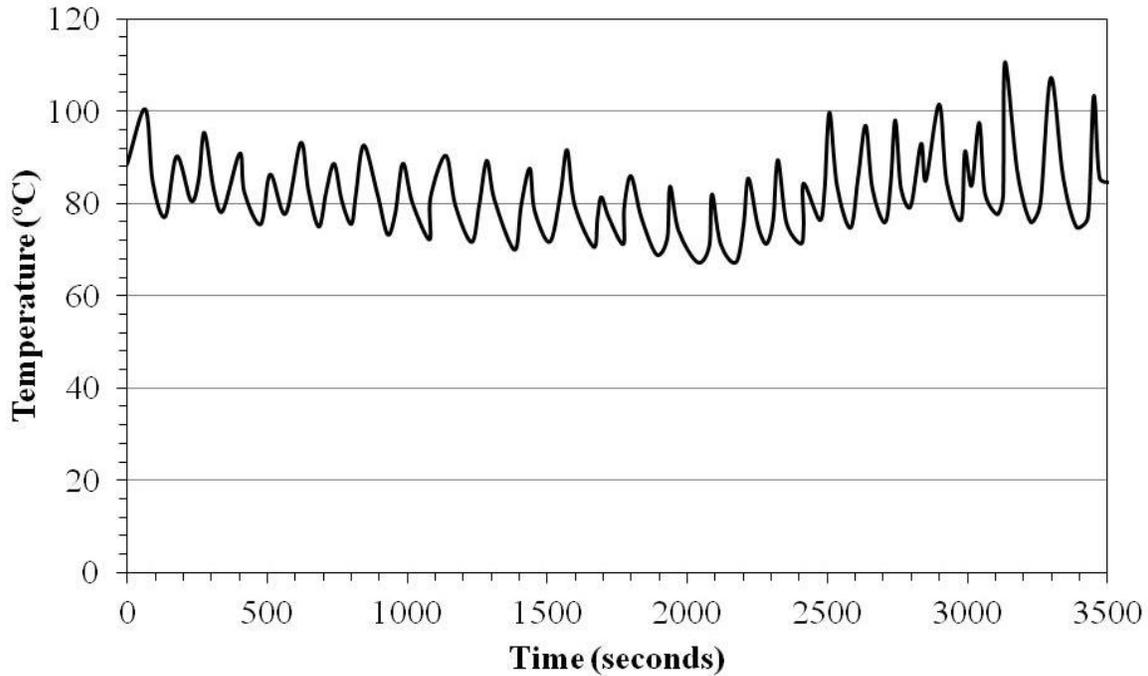
Figure 2-36. Temperature oscillations in receptacle LEV038.

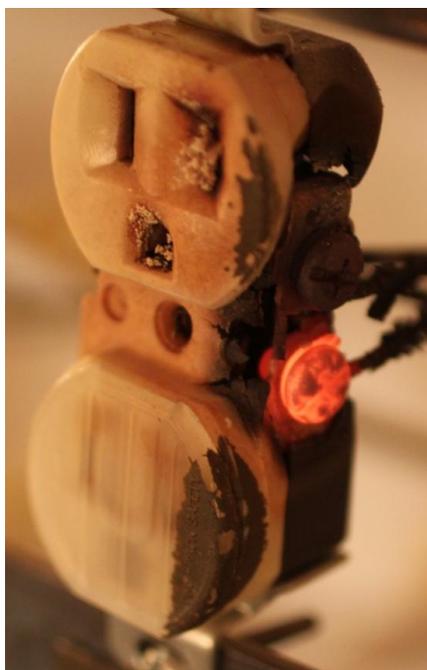
Figure 2-39. Thermoset receptacle with overall glow at ¼ turn loose connection (E010).

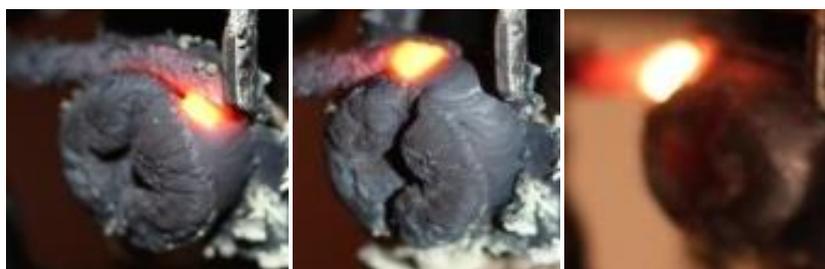
Figure 2-40. Movement of glow spot on receptacle LEV275 at 0 min (left), 164 min (center), and 329 min (right).

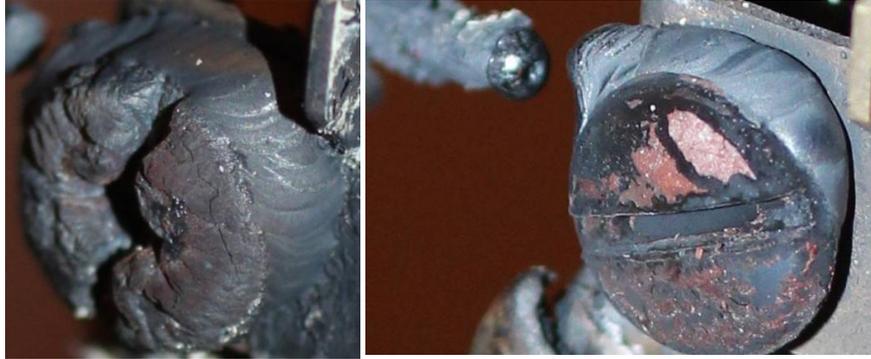
Figure 2-41. Curved striations from glow movement on receptacles, receptacle LEV275 (left) and E003 (right).

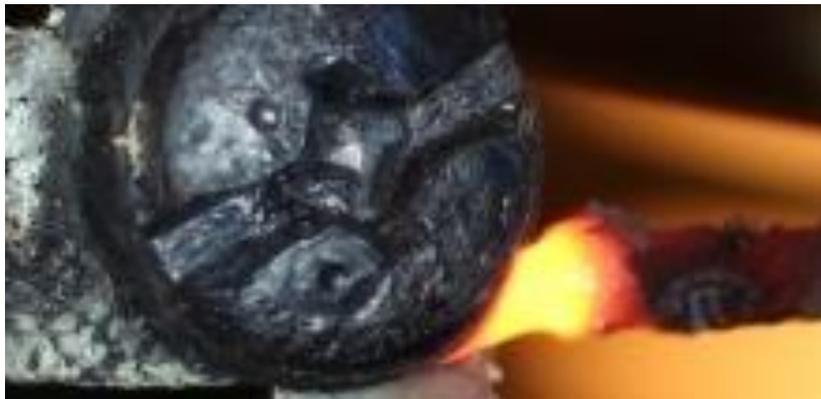
Figure 2-42. Necking of conductor at glow spot on receptacle LEV277.

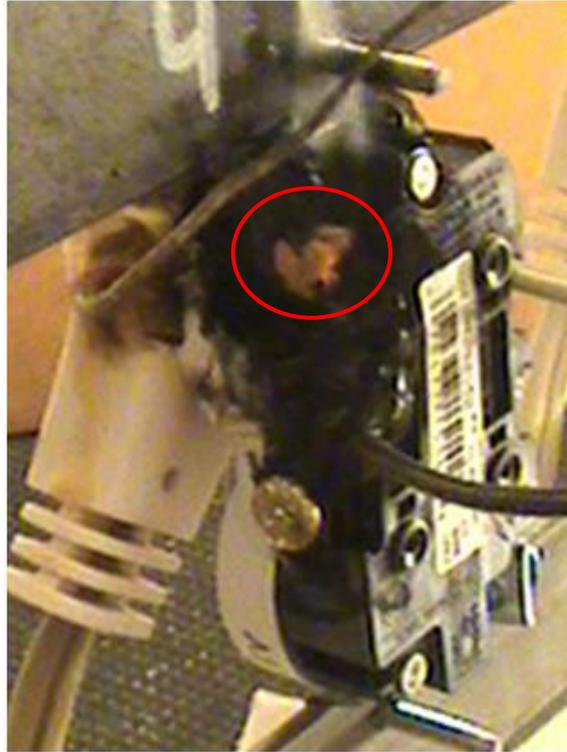
Figure 2-43. Glowing at plug blade and internal plug contact (LEV062).

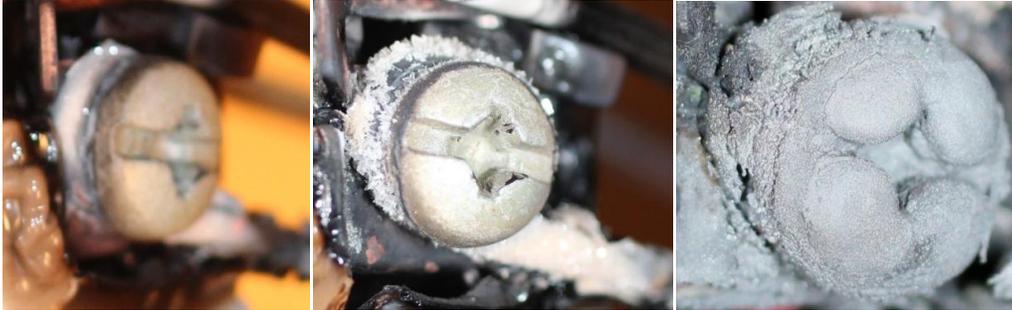
Figure 2-44. Development of enlarged screw head on receptacle PSE170 at T = 0 hours (left), T = 21.6 hours (center) and T = 29.2 hours (right).

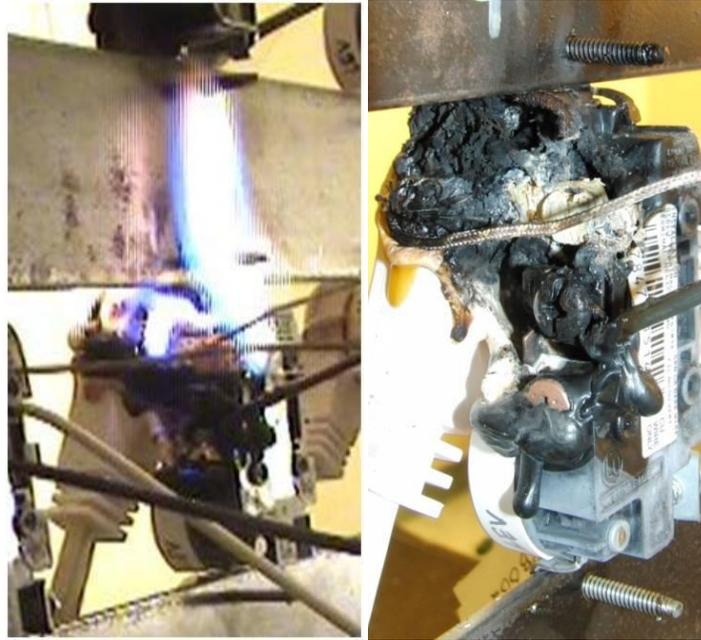
Figure 2-45. Flaming ignition in a receptacle with plug (left) and resulting damage (right).

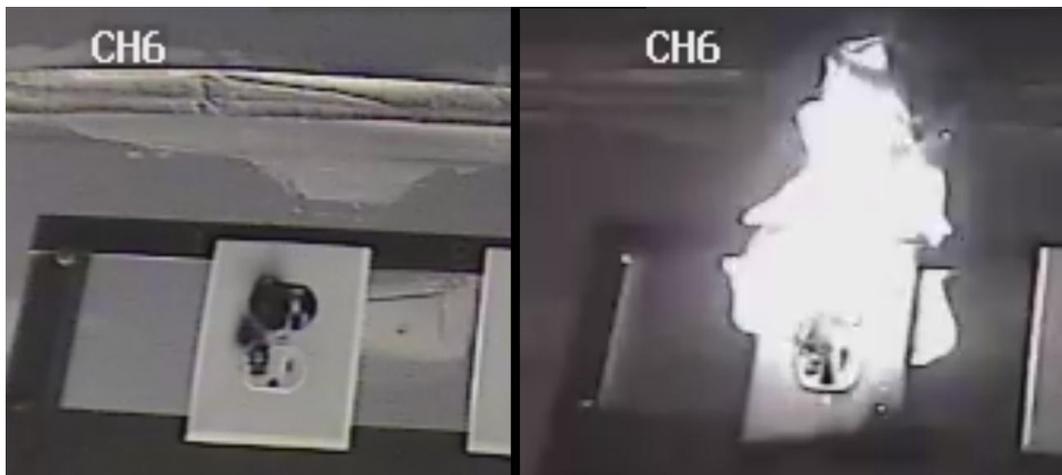
Figure 2-46. Flaming ignition of receptacle in box (before ignition (left) and 21 seconds after ignition (right)).

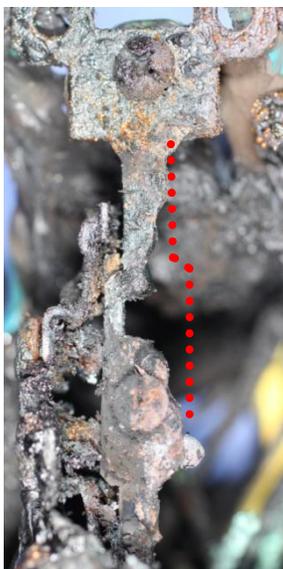
Figure 2-47. Arcing to grounding strap from internal hot brass contact (not pictured) during flaming ignition event (PSE166).

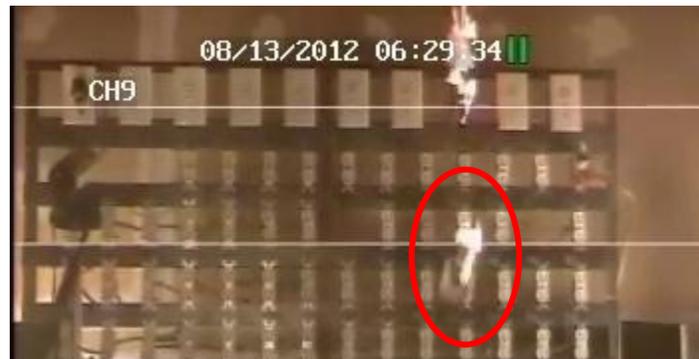
Figure 2-48. Flaming faceplate drops to ground (PSE166).

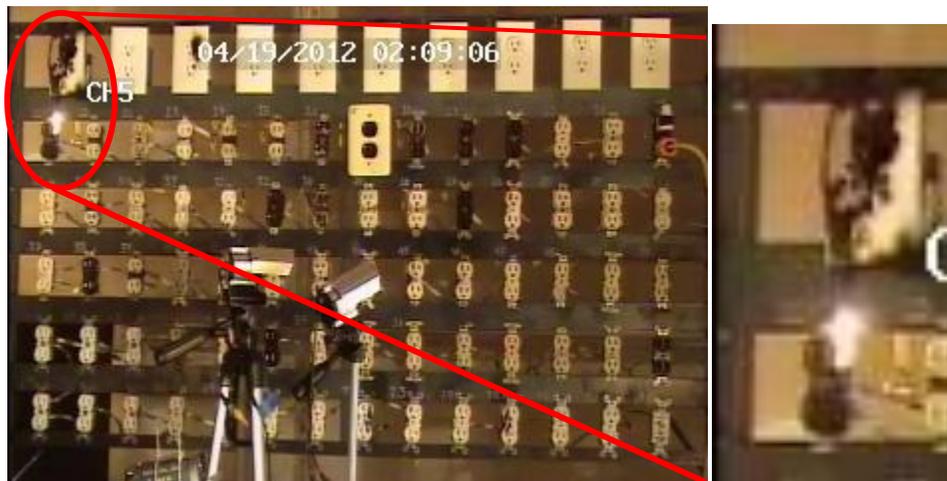
Figure 2-49. Flaming droplet falls to receptacle below (LEV269).

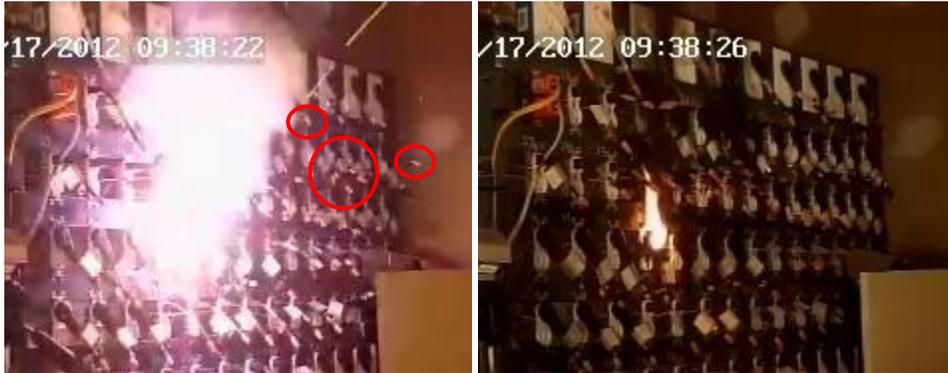
Figure 2-50. Flaming ignition of plug/receptacle with ejected material (LEV286).

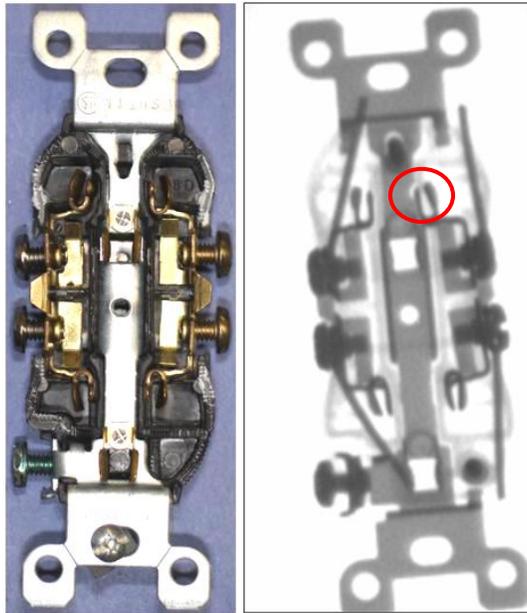
Figure 2-53. Exemplar receptacle and X-ray of arcing between hot contact and grounding strap, notch in grounding strap (LEV126).

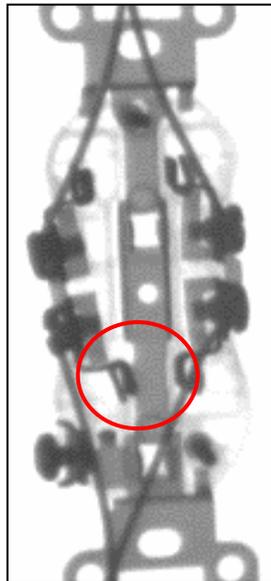
Figure 2-54. X-ray showing apparent contact between neutral terminal and grounding strap (LEV129).
