The author(s) shown below used Federal funds provided by the U.S. Department of Justice and prepared the following final report:

Document Title: Development and Analysis of Electrical Receptacle Fires

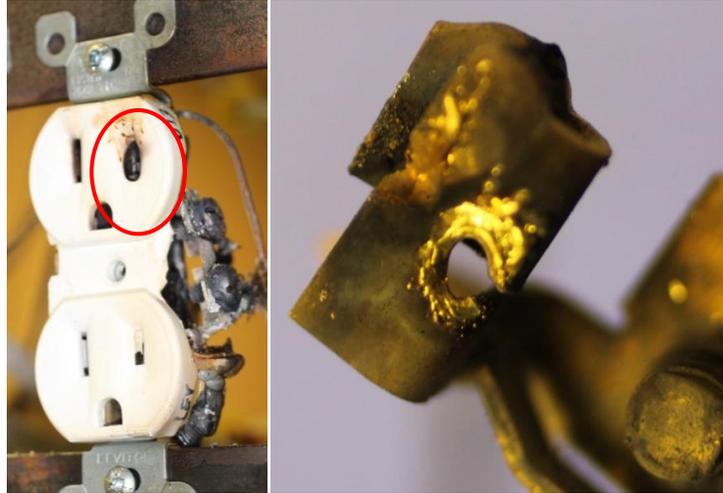
Figure 2-55. Arcing in receptacle LEV013 (left) between hot contact (right) and grounding strap (Figure 2-56).

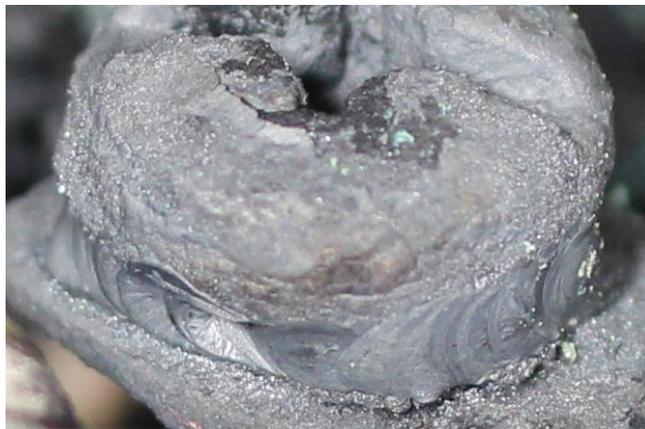
Figure 2-58. Welded conductor showing curved striations (PSE023).

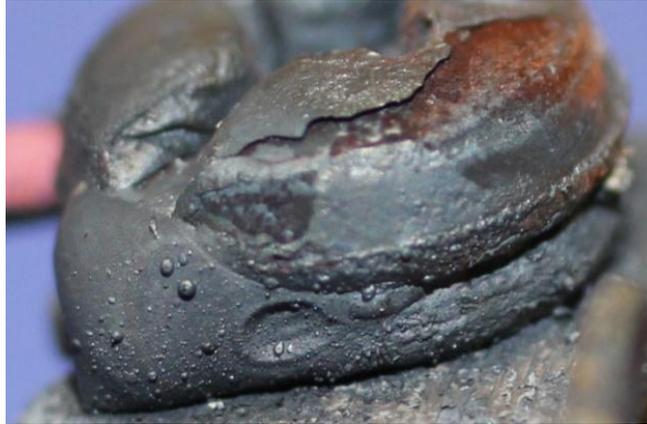
Figure 2-59. Partially welded conductor; no curved striations (LEV127).

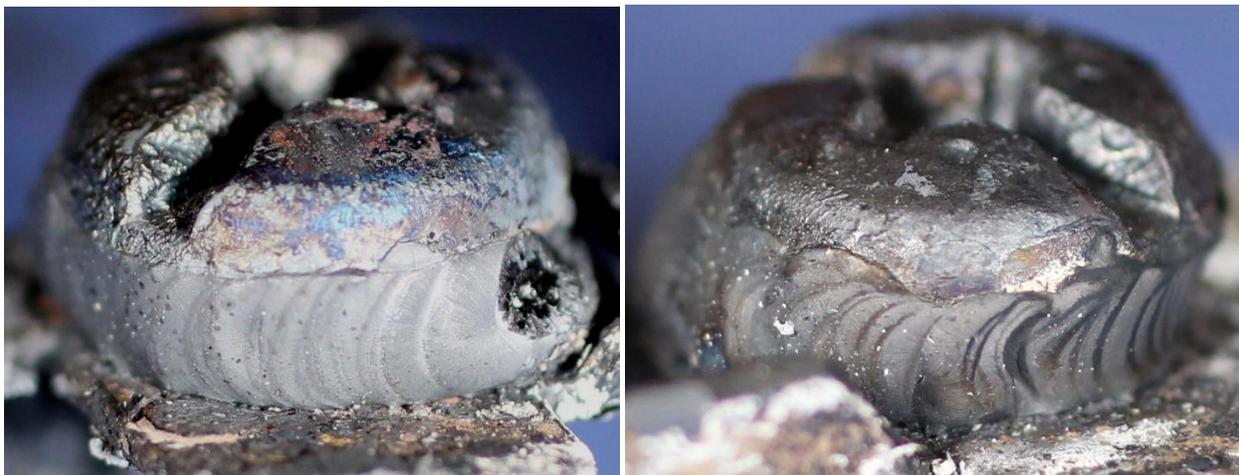
Figure 2-60. Two welded conductors showing curved striations from the same receptacle (LEV277).

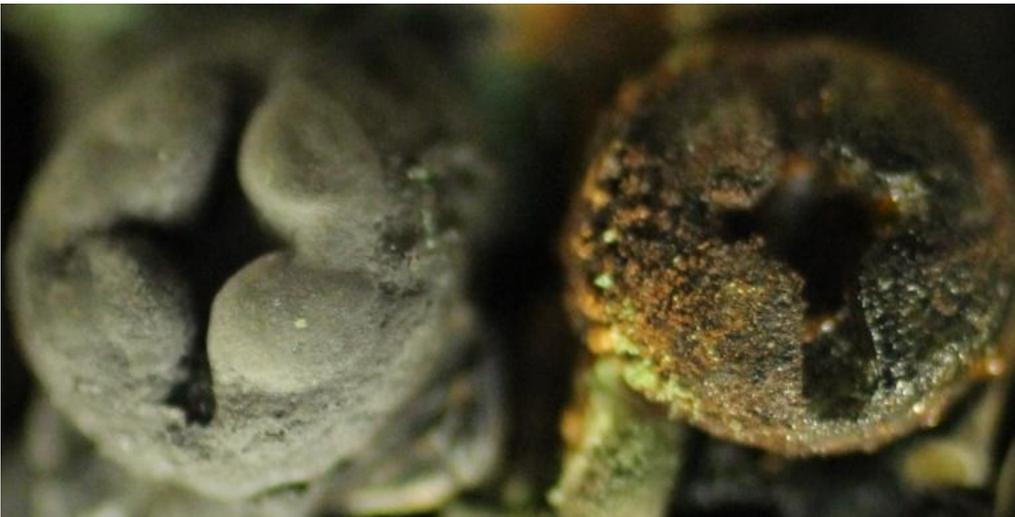
Figure 2-63. Enlarged screw head from receptacle PSE170.

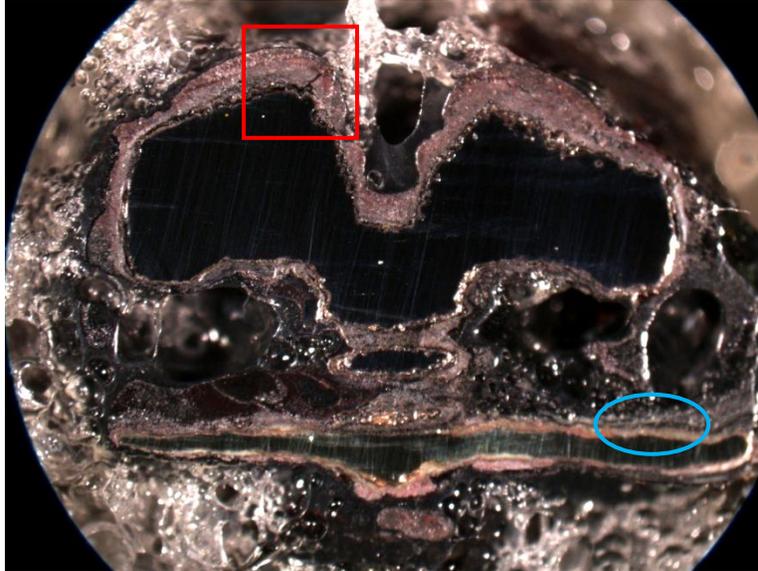
Figure 2-64. Sectioned and polished enlarged screw head from PSE170.
 Note: Square indicates area of EDS mapping; section of brass terminal with dezincification circled.

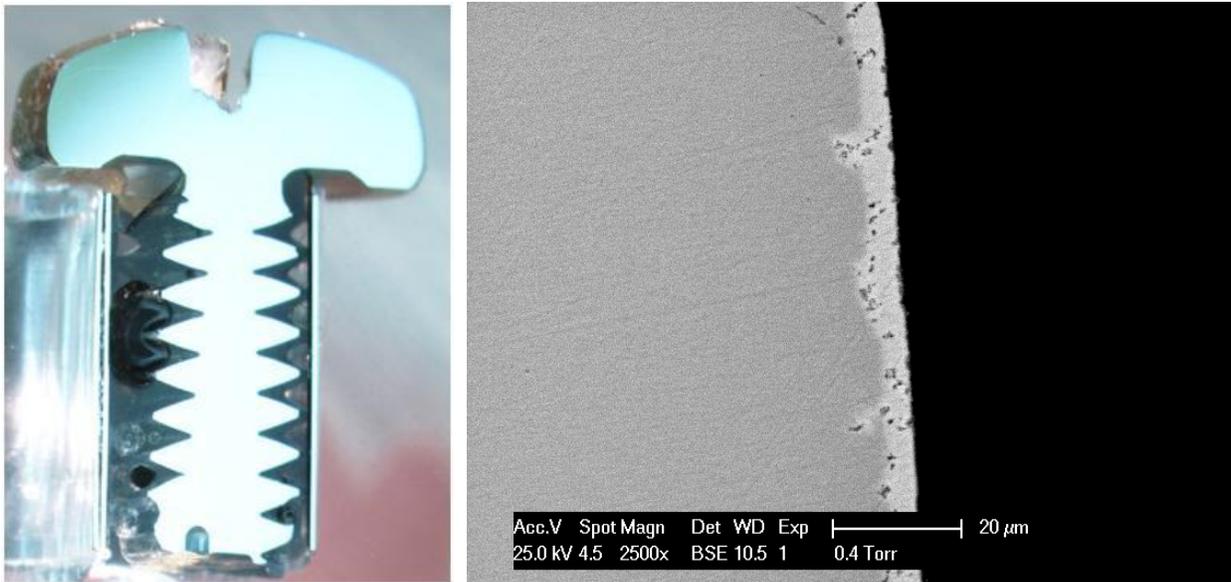
Figure 2-65. Sectioned exemplar PSE screw (hot).
 Note: Plating thickness approx 4-5 microns.

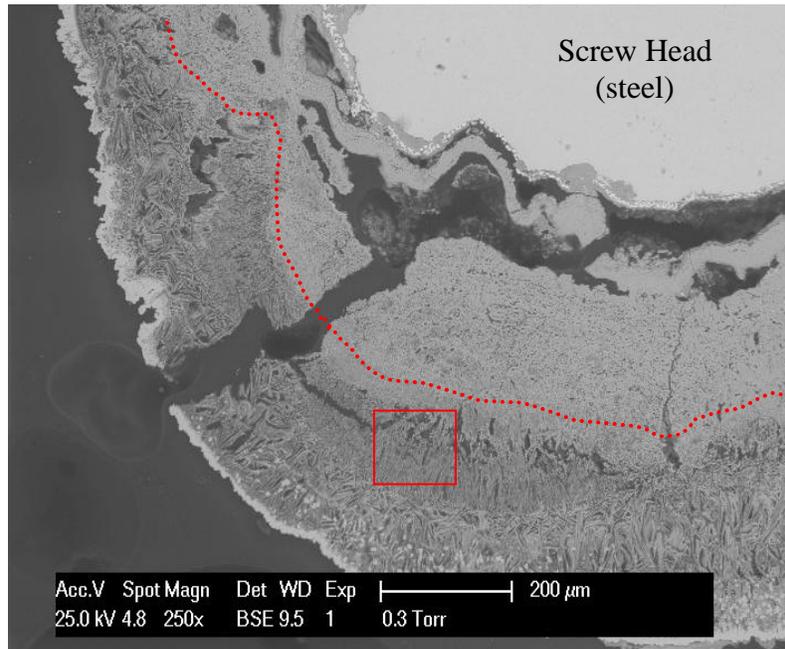
Figure 2-66. SEM image (250x) showing different layers of corrosion for sectioned PSE170 enlarged screw.

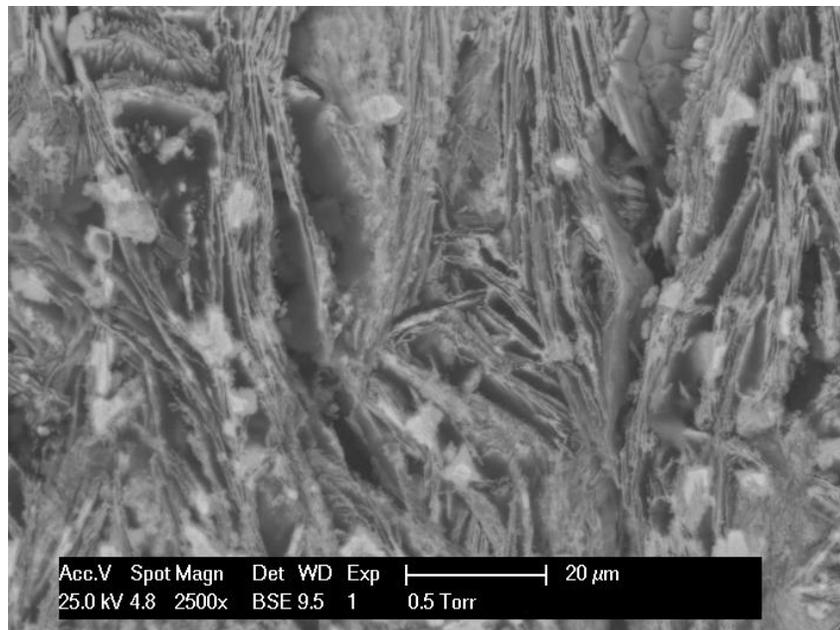
Figure 2-67. SEM image (2500x) showing grain structure of corrosion layer for sectioned PSE170 enlarged screw. Note: Image location noted as red box in Figure 2-66.

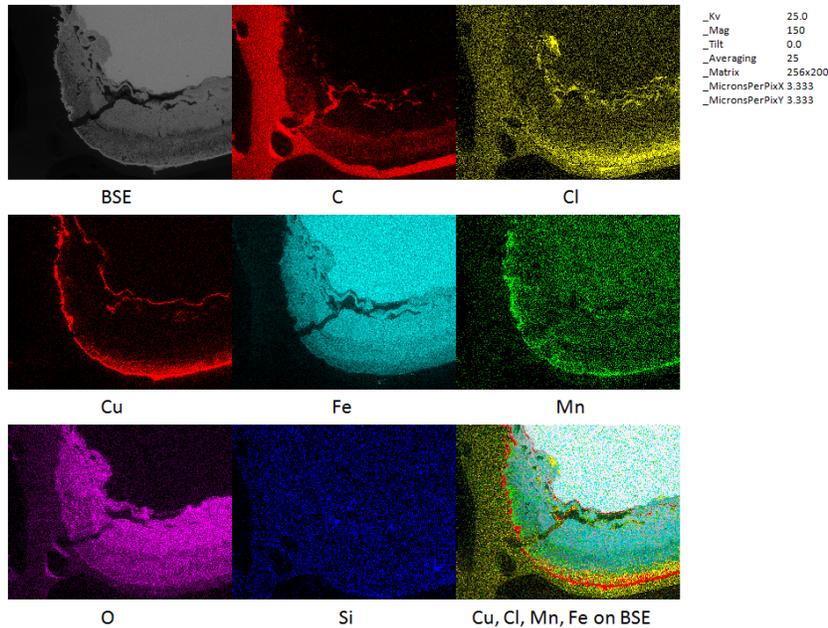
Figure 2-68. EDS Mapping of Oxide Layer for sectioned screw from PSE170.

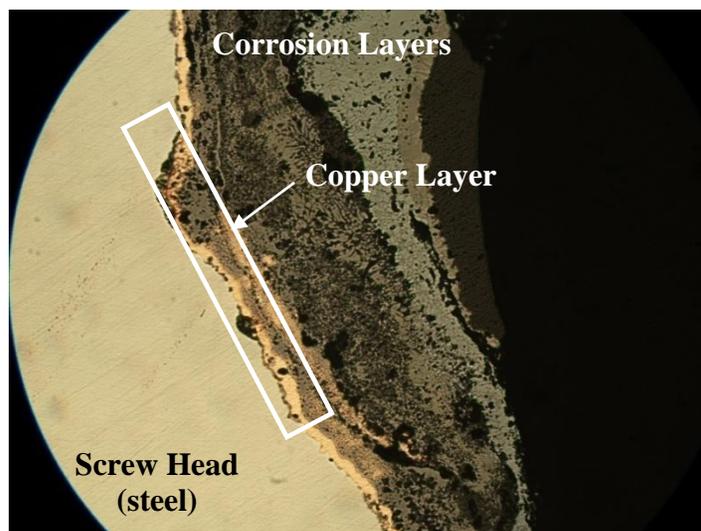
Figure 2-69. Microscope image (200x) of PSE170 showing copper at surface of screw beneath corrosion layer.

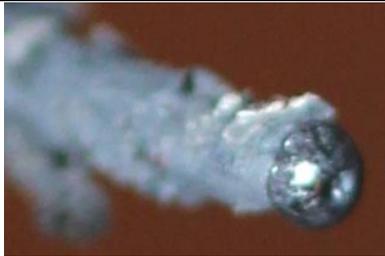
<p data-bbox="207 562 570 632">E003 –with dimple <i>Conductor Severed w/o Arc</i></p>

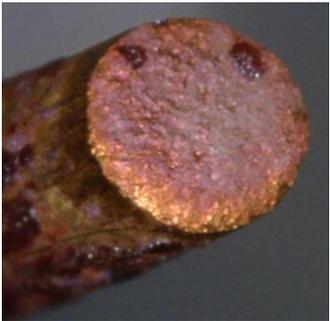
<p data-bbox="630 1320 992 1430">LEV173 (initially observed as round) <i>Flaming Ignition</i></p>

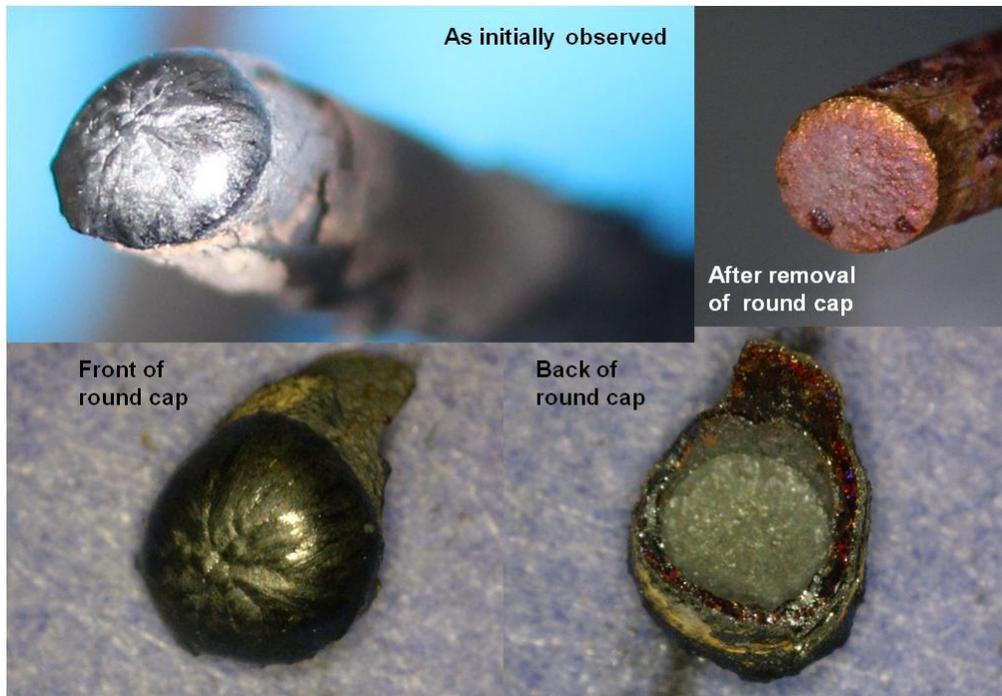
Figure 2-70. Round, shiny severed conductor end showing round cap and flat underneath (LEV173).

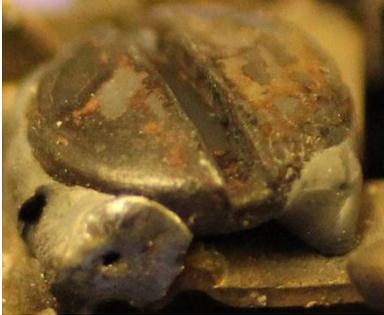
<p data-bbox="219 646 578 709">E003 <i>Conductor Severed w/o Arc</i></p>

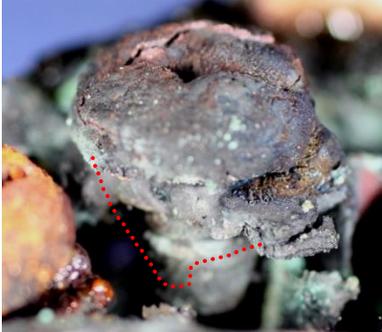
<p data-bbox="1047 982 1429 1129">PSE263 <i>Conductor Severed w/ Arc (approximate area of missing material outlined)</i></p>

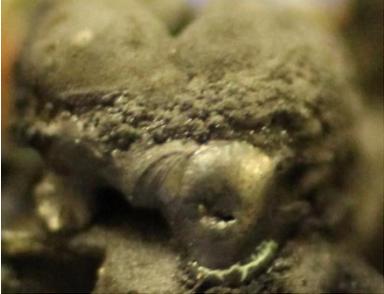
<p data-bbox="219 1377 578 1440">PSE133 <i>Conductor Severed w/o Arc</i></p>

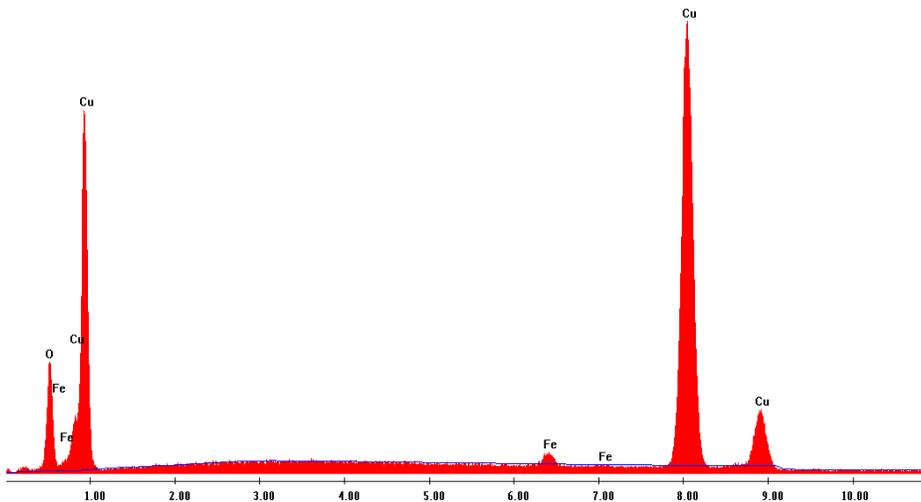
Figure 2-74. EDS spectra for surface of welded conductor (LEV275).

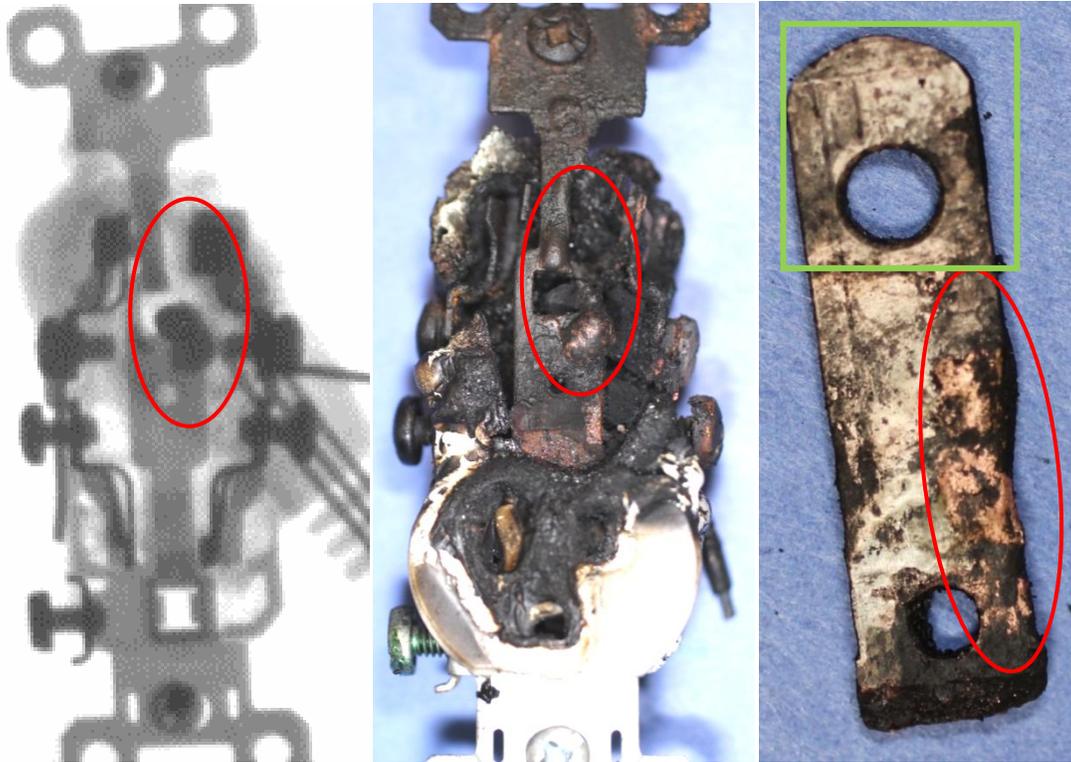
Figure 2-75. Arcing between grounding strap (left, center) and hot plug blade (right) from PSE285.

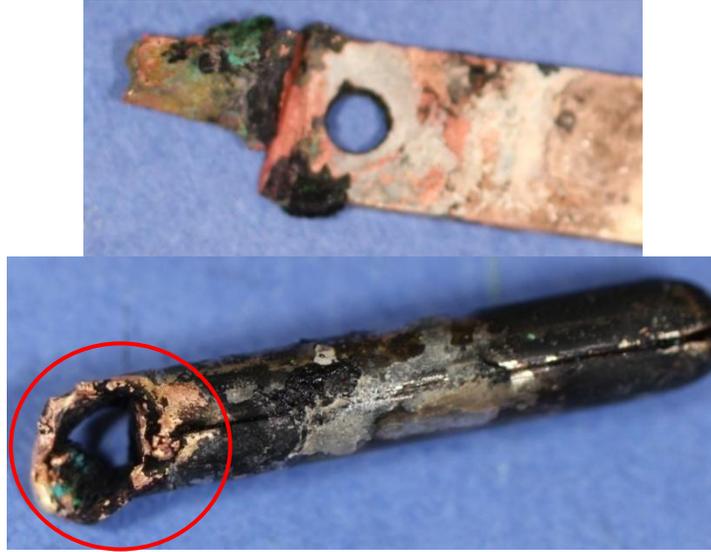
Figure 2-77. Arcing damage at back of ground pin (bottom); hot blade (top) from plug in receptacle LEV286.

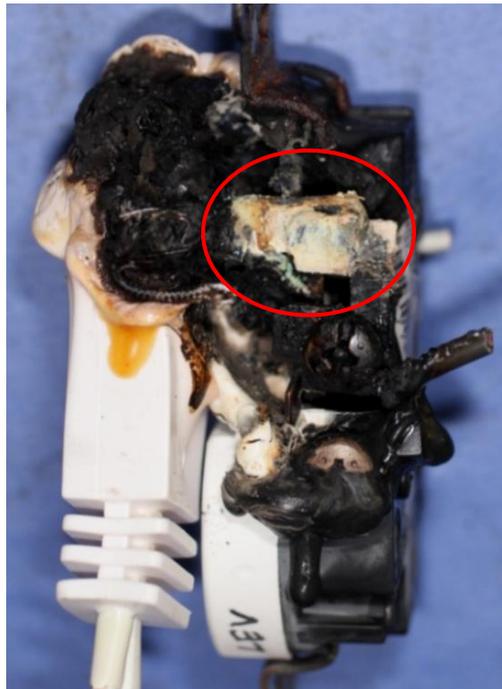
Figure 2-78. White residue (corrosion) at plug/receptacle connection (LEV060).

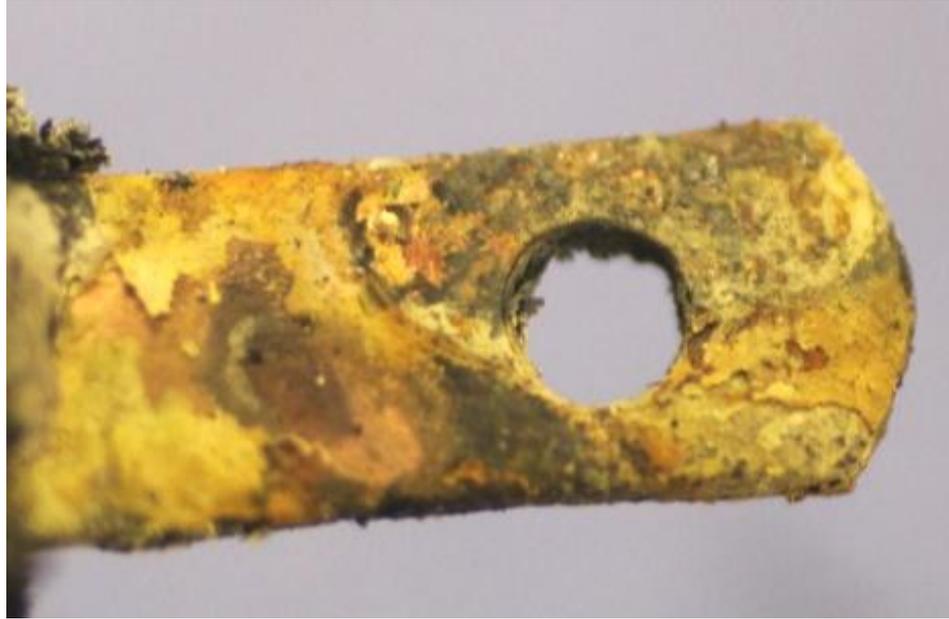
Figure 2-79. Loss of plating and dezincification on hot plug blade (LEV060).

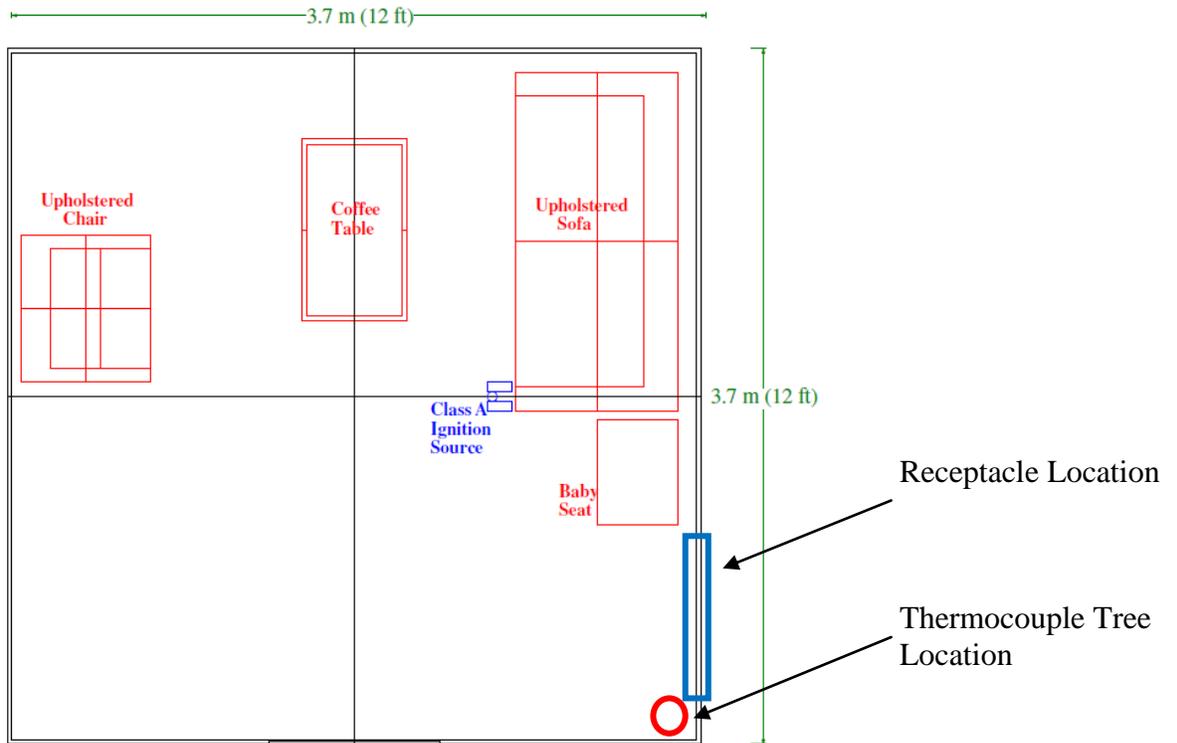
Figure 3-1. Test compartment and location of receptacles.

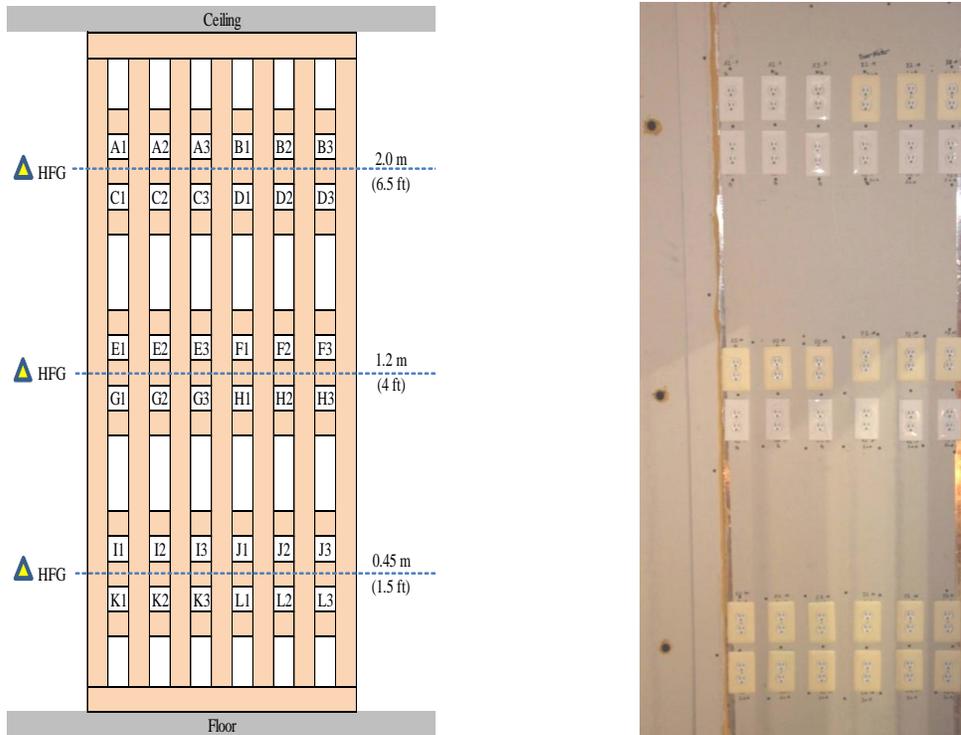
Figure 3-3. Diagram and photograph of receptacles in wall assembly (inside view).

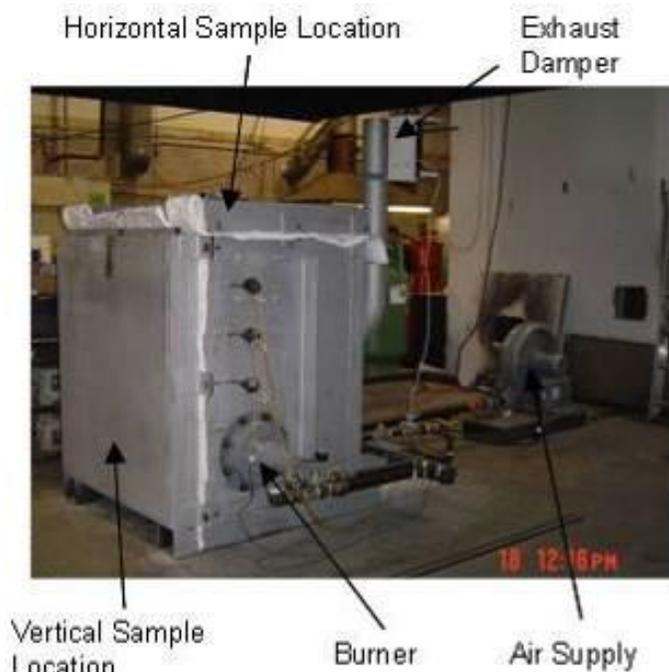
Figure 3-5. Photograph of intermediate scale furnace.

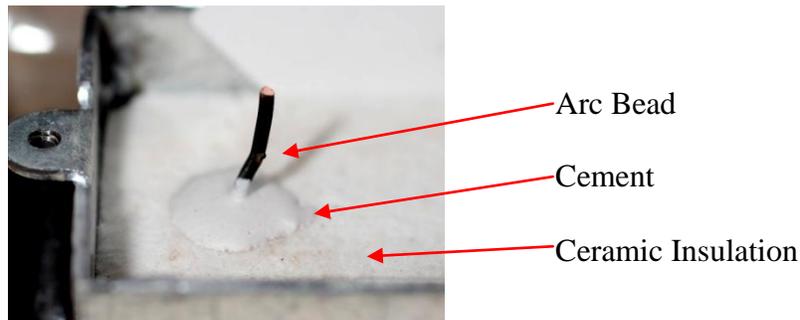
Figure 3-7. Photograph of typical installation of wire sections with arc bead.

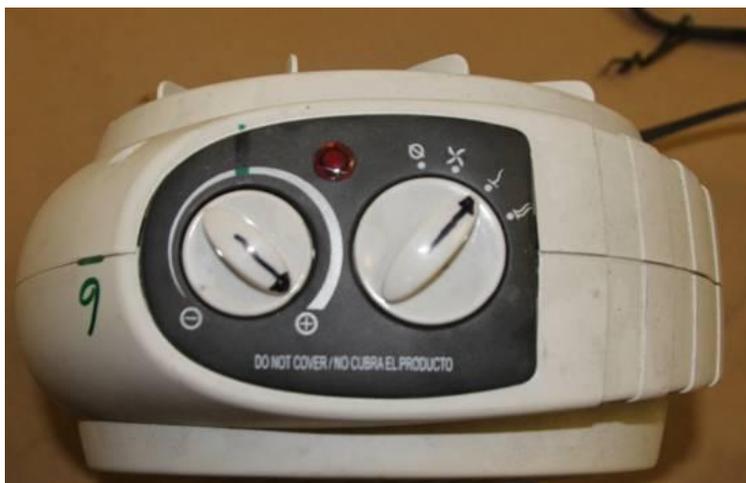
Figure 3-9. Heater setting for compartment fire tests.

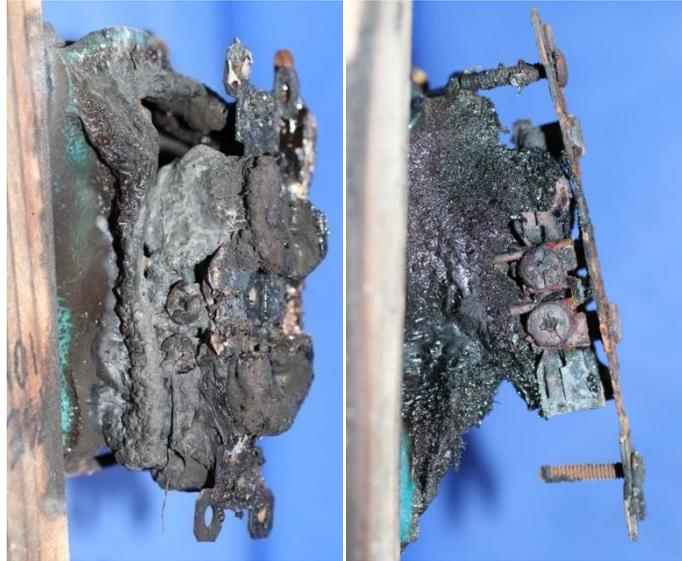
Figure 3-10. Thermal damage to PVC receptacles: mostly consumed (PSE101, left) and totally consumed (PSE137, right).

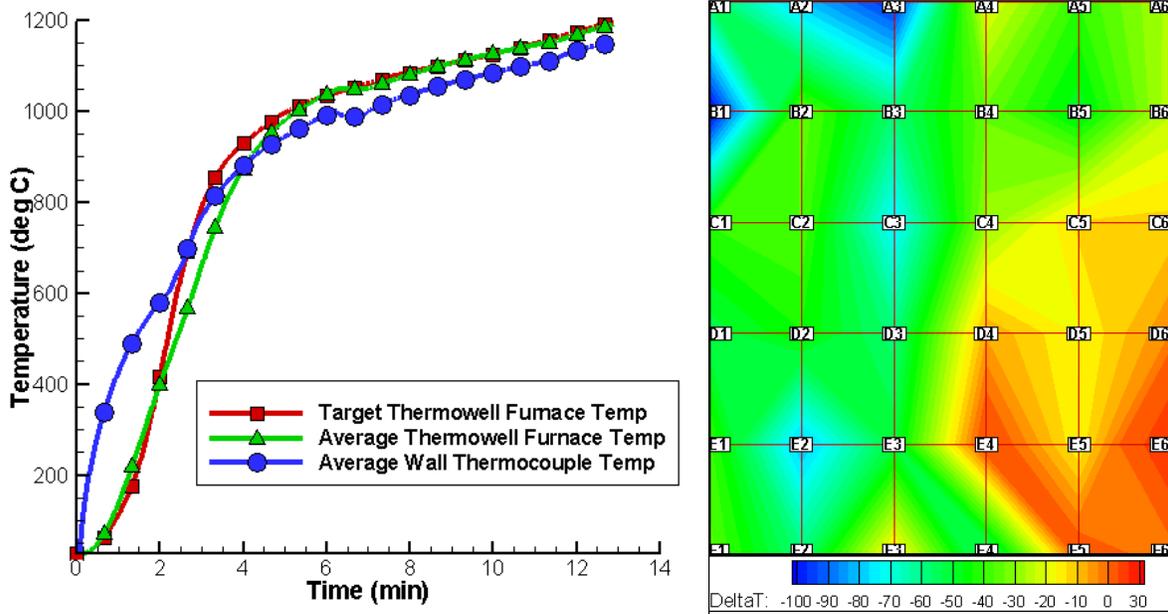
Figure 3-11. Furnace temperature characterization for furnace exposure Test 2: average temperatures (left) and contour plot of temperature differences (right).

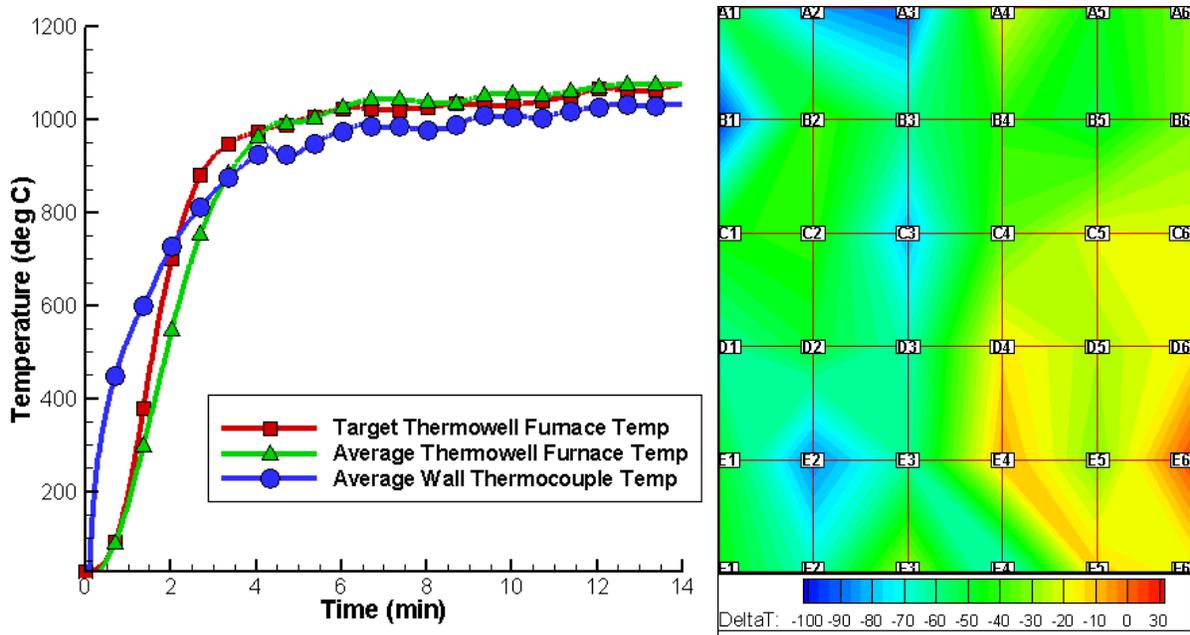
Figure 3-13. Furnace temperature characterization for furnace exposure Tests 1 and 5: average temperatures (left) and contour plot of temperature differences (right).

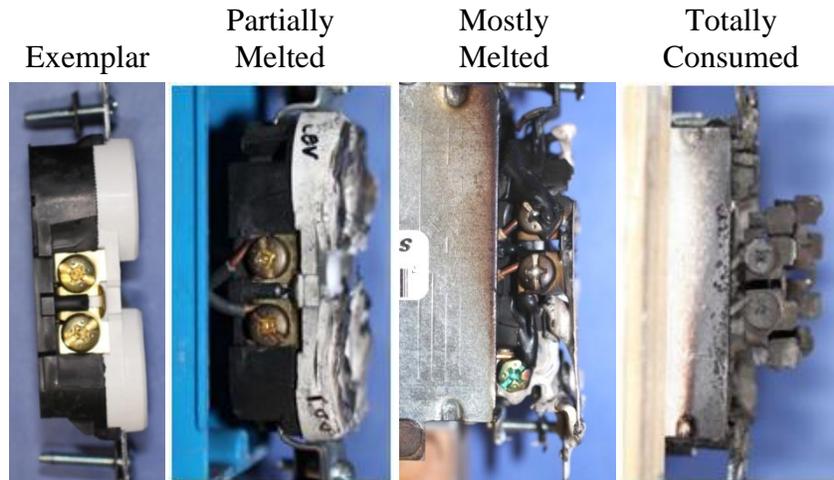
Figure 3-14. Photographs of damage progression in polypropylene receptacles, left most photograph is exemplar receptacle.

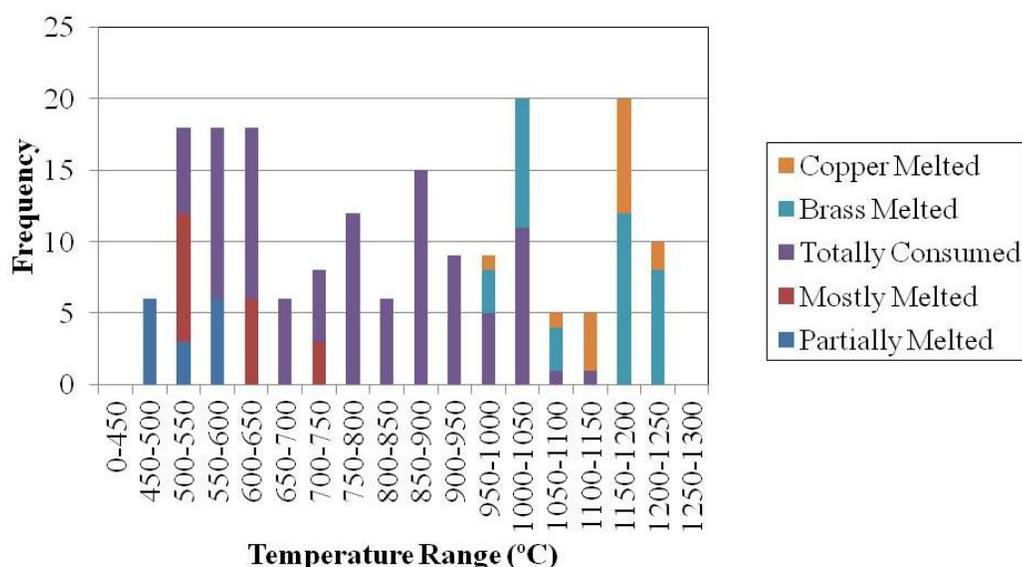
Figure 3-15. Histogram plot of damage category frequency for polypropylene receptacles as a function of the maximum exposure temperature range.

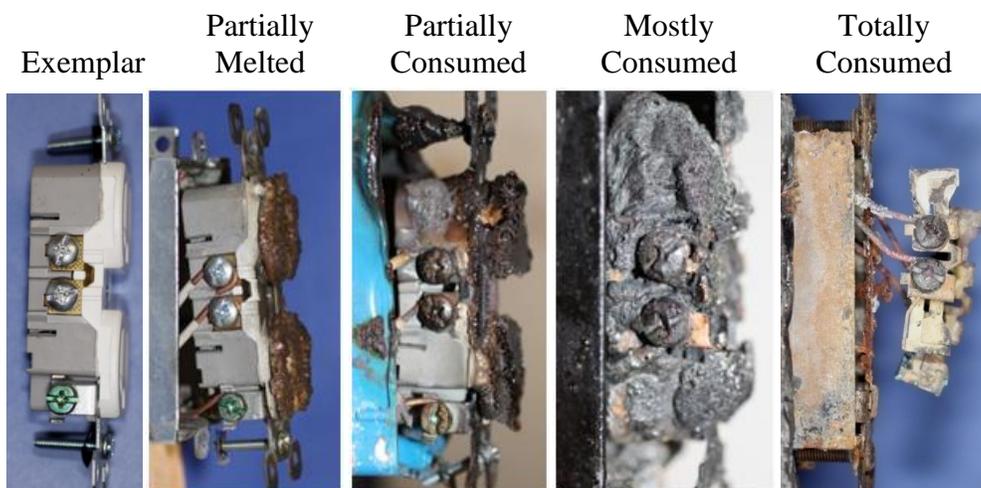
Figure 3-16. Photographs of damage progression in PVC receptacles, left most photograph is exemplar receptacle.

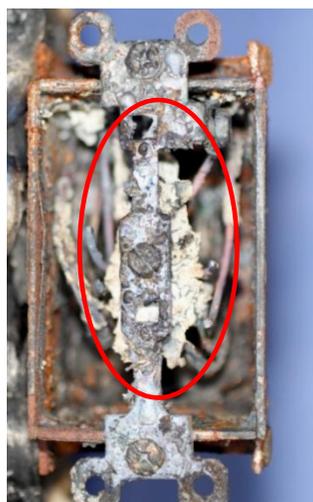
Figure 3-17. Photograph of totally consumed PVC receptacle with copper melting (PSE385) showing remaining char.

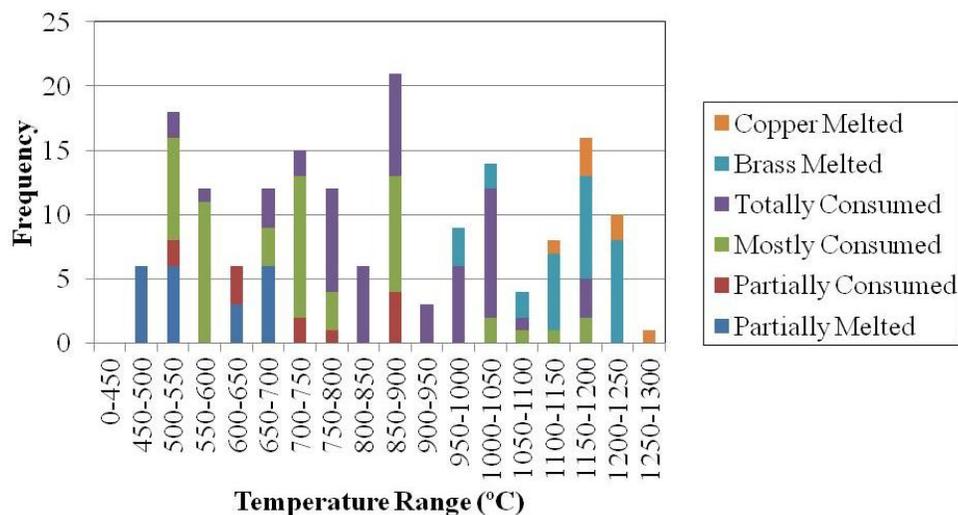
Figure 3-18. Histogram plot of damage category frequency for PVC receptacles as a function of the maximum exposure temperature range.

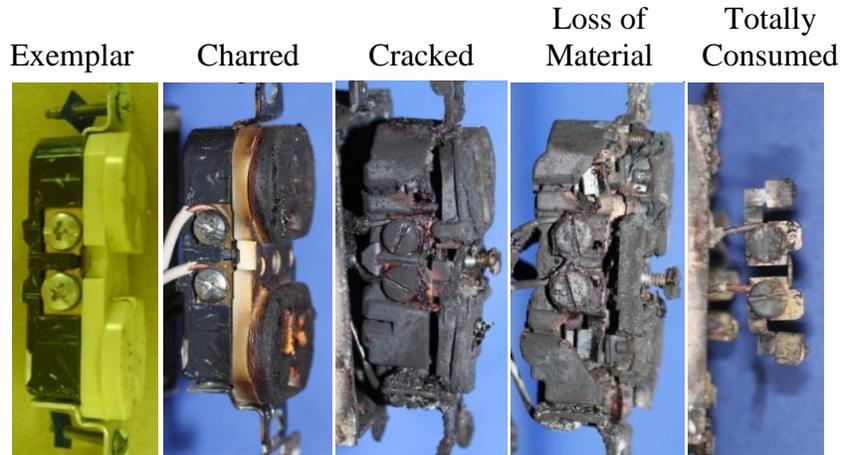
Figure 3-19. Photographs of damage progression in thermoset receptacles, left most photograph is exemplar receptacle (E021).

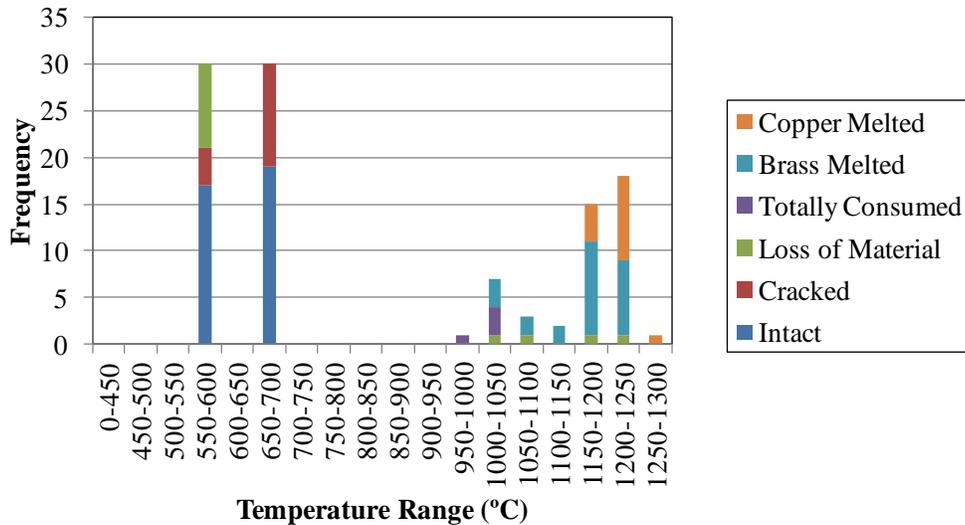
Figure 3-20. Histogram plot of damage category frequency for thermoset receptacles as a function of the maximum exposure temperature range.

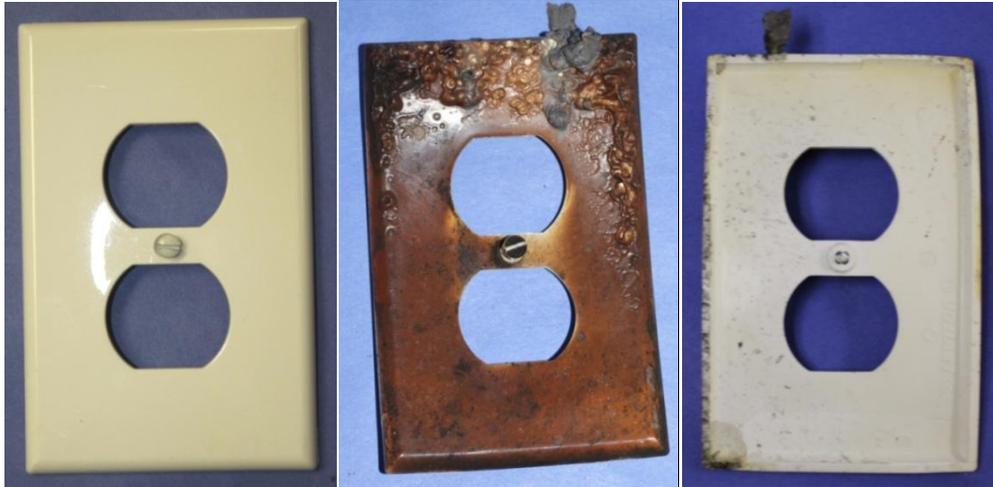
Figure 3-21. Photographs of damage progression in nylon faceplates, exemplar (left) and blistered/partially melted front (center) and back (right).

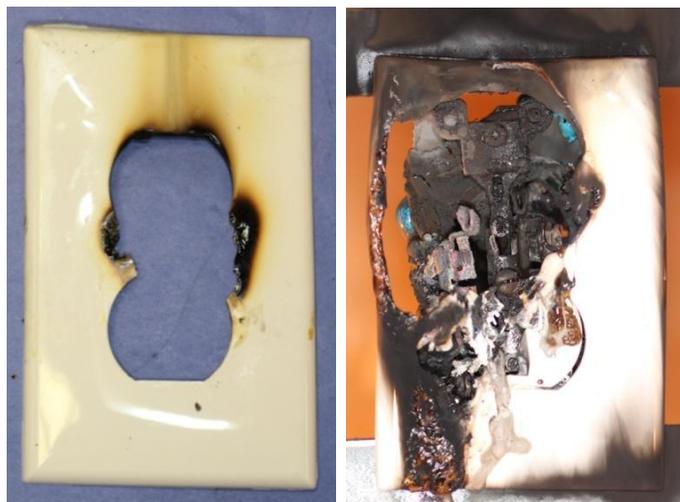
Figure 3-22. Photographs of typical faceplate damage from overheating connections: LEV171 (left) and LEV269 (right).

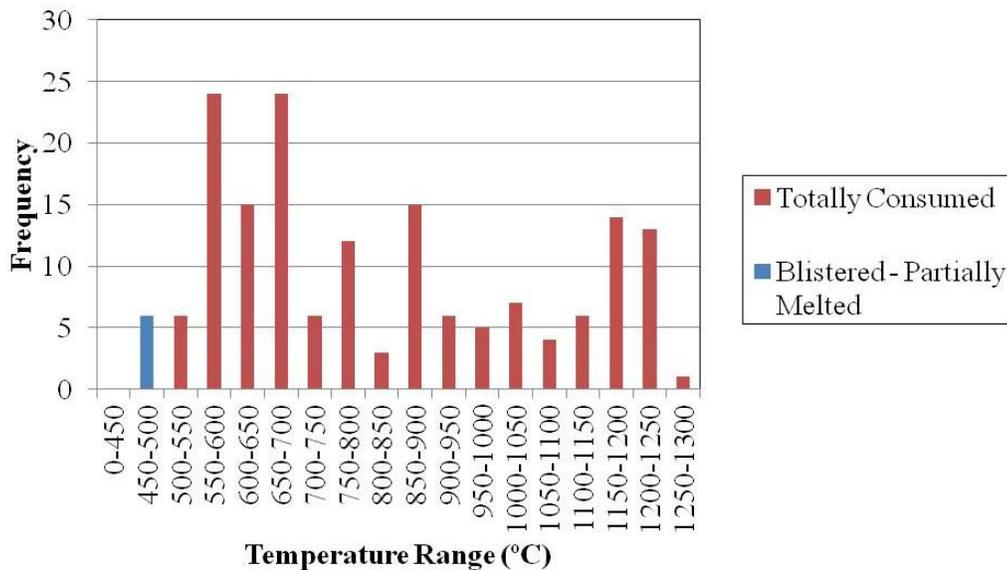
Figure 3-23. Histogram plot of damage category frequency for nylon faceplates as a function of the maximum exposure temperature range.

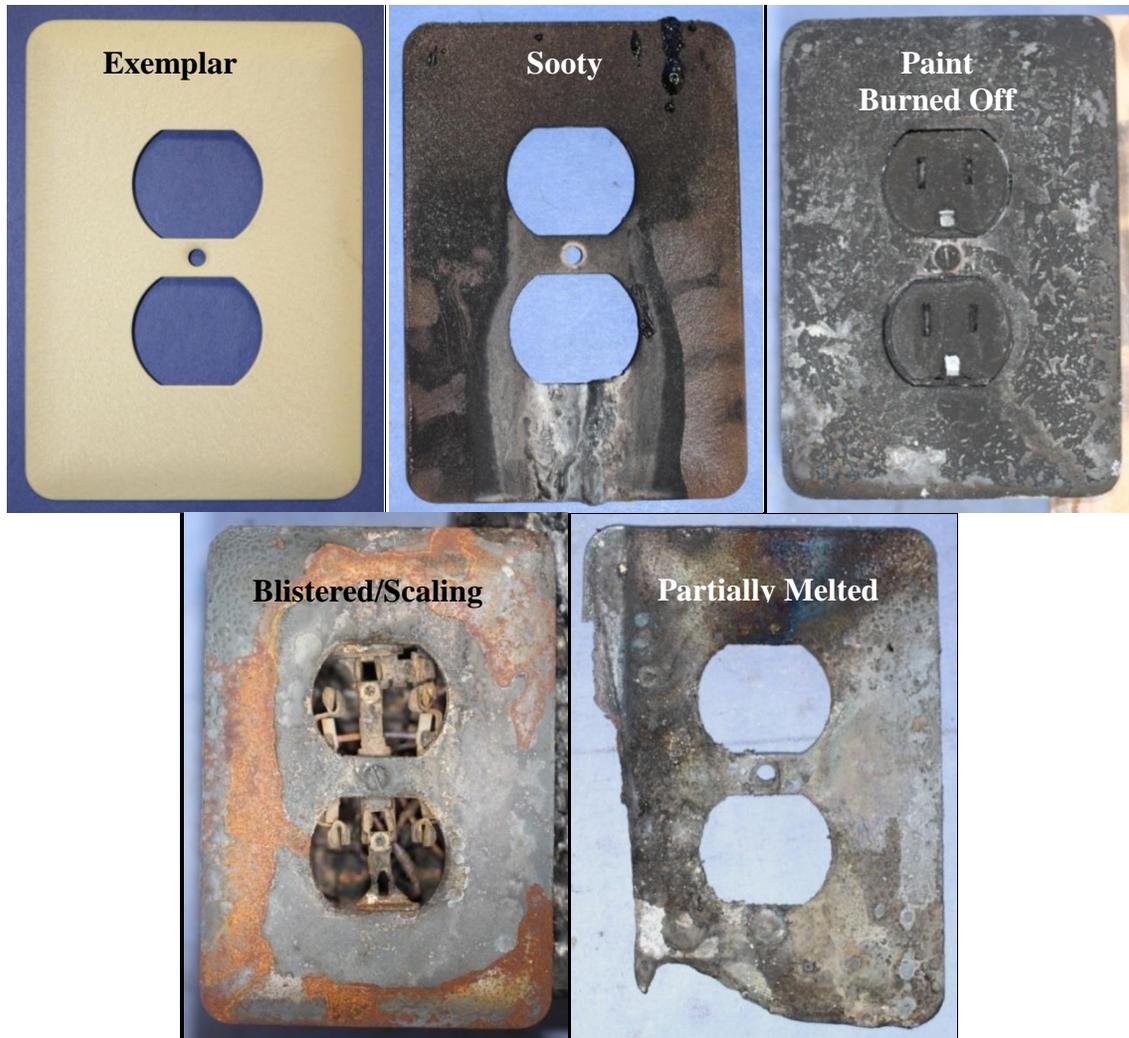
Figure 3-24. Photographs of damage progression in steel faceplates.

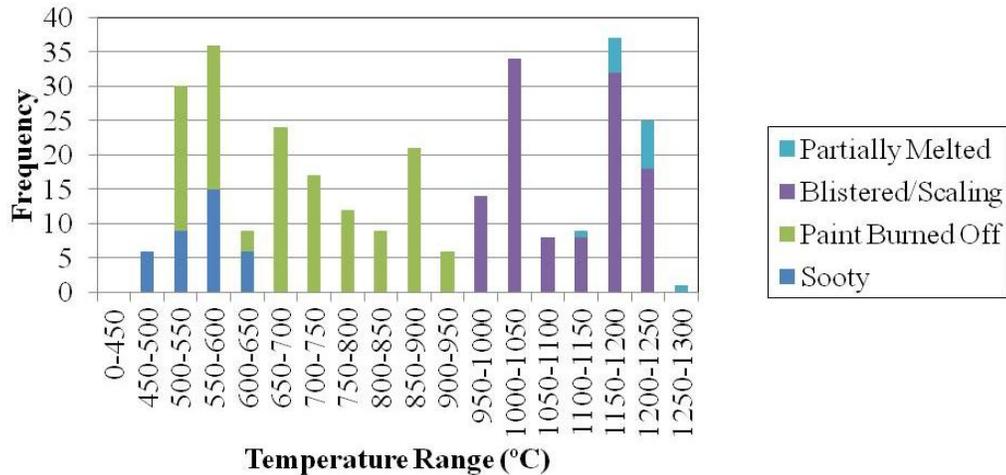
Figure 3-25. Histogram plot of damage category frequency for steel faceplates as a function of the maximum exposure temperature range.

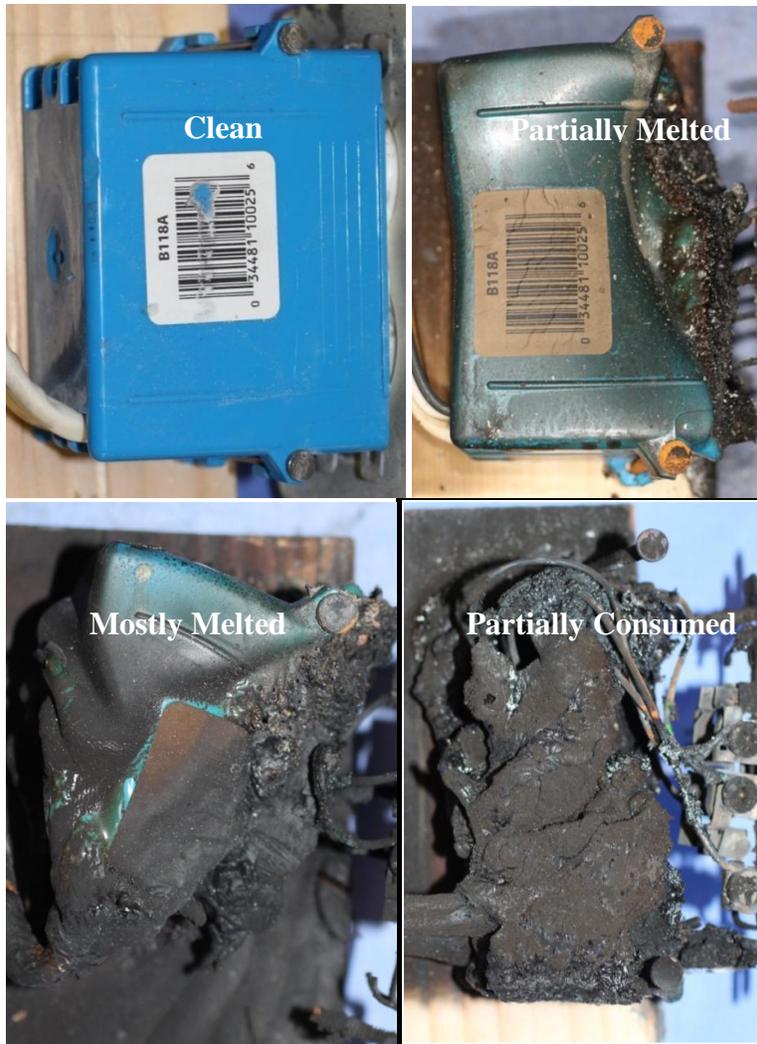
Figure 3-26. Photographs of damage progression in PVC outlet boxes (increasing thermal insult from top left to bottom right).

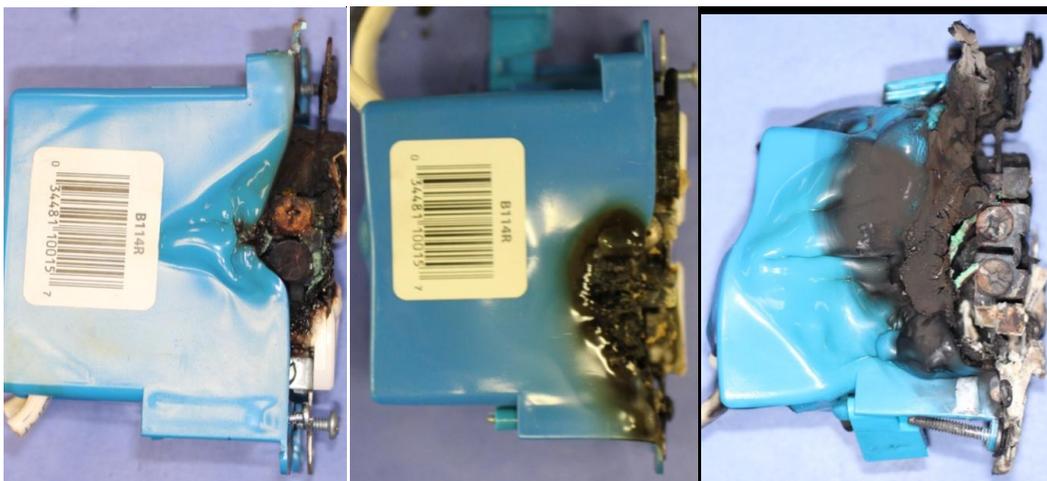
Figure 3-27. Photographs of damaged PVC outlet boxes from selected laboratory tested receptacles: PSE263 (left), LEV267 (center), and LEV269 (right).

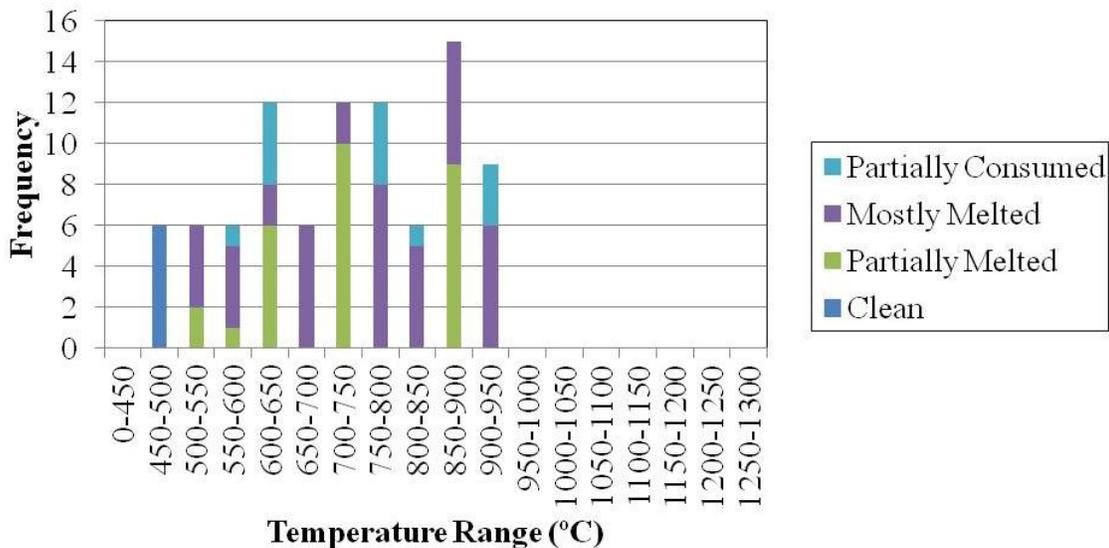
Figure 3-28. Histogram plot of damage category frequency for PVC outlet boxes as a function of the maximum exposure temperature range.
