The author(s) shown below used Federal funds provided by the U.S. Department of Justice and prepared the following final report:

Document Title: Development and Analysis of Electrical Receptacle Fires

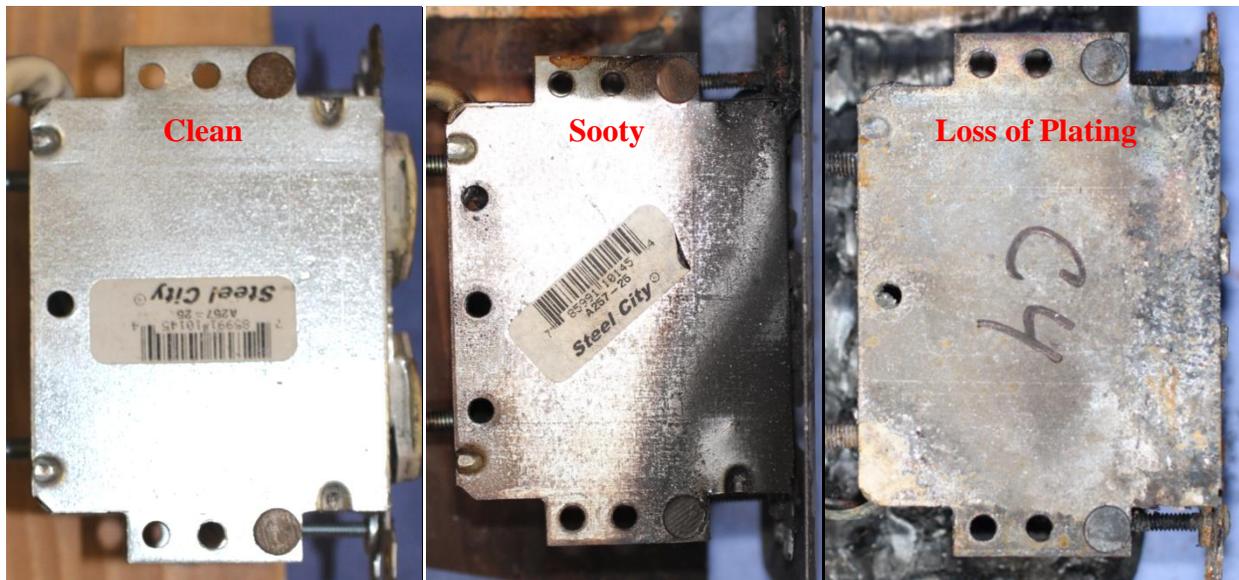
Figure 3-29. Photographs of damage progression in steel outlet boxes (increasing thermal insult from left to right).

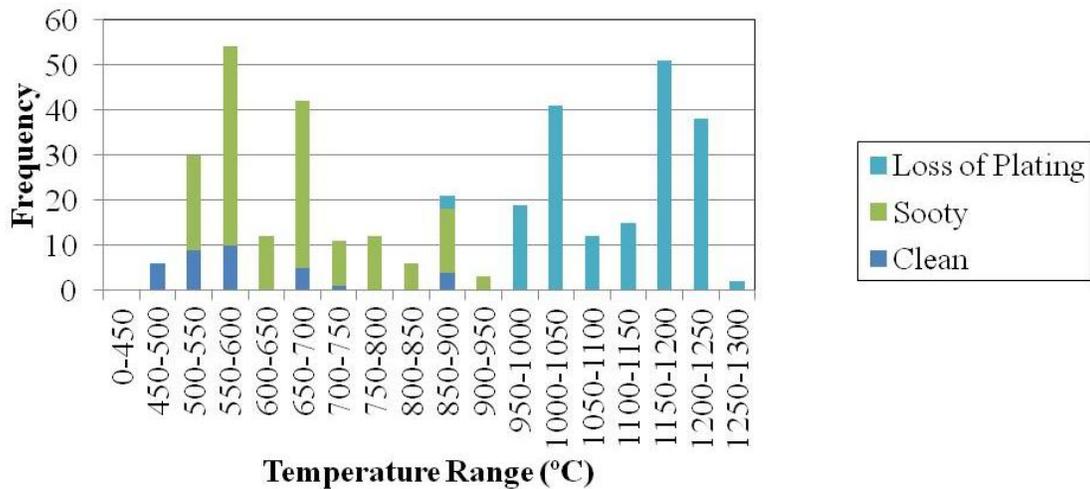
Figure 3-30. Histogram plot of damage category frequency for steel outlet boxes as a function of the maximum exposure temperature range.

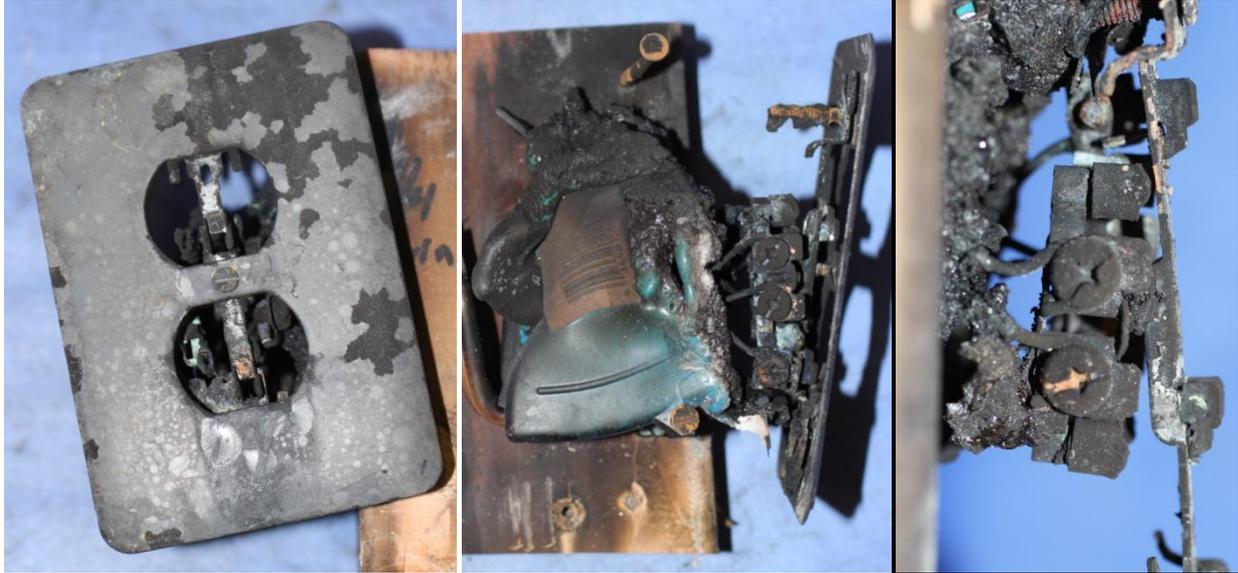
Figure 3-31. Photographs of steel faceplate (left), PVC outlet box (center) and poly propylene receptacle (LEV160, right).

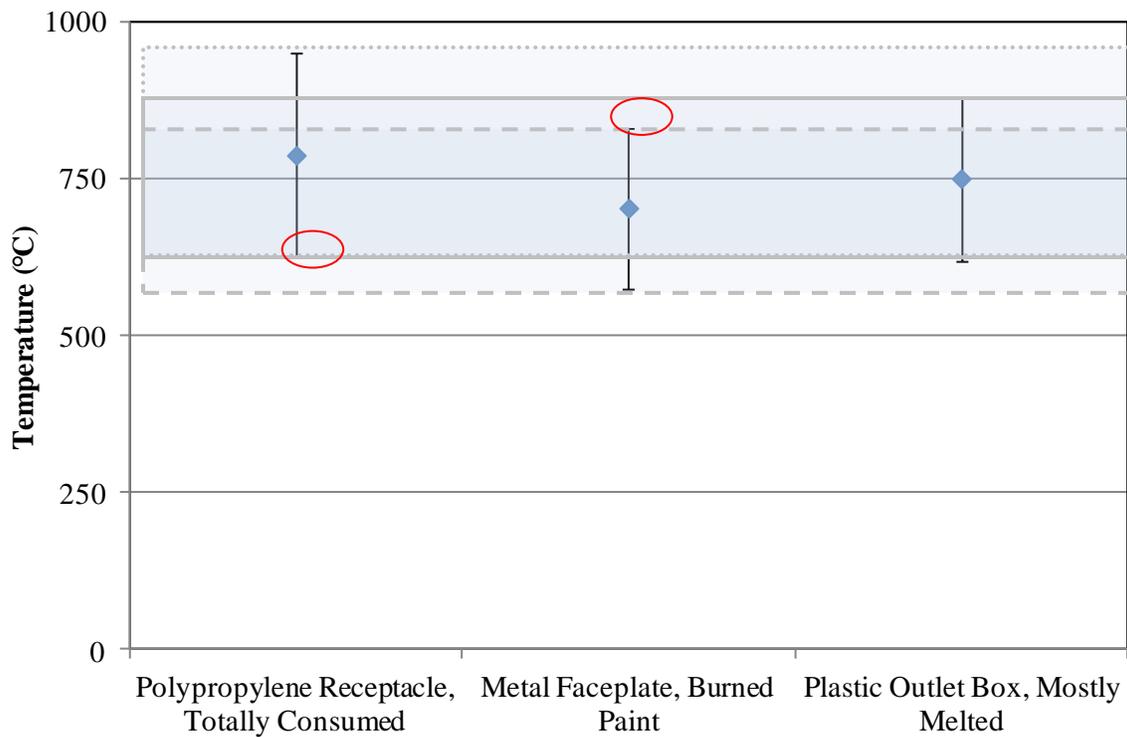
Figure 3-32. Plot of the thermal insult temperature ranges for components making up the LEV160 receptacle installation.

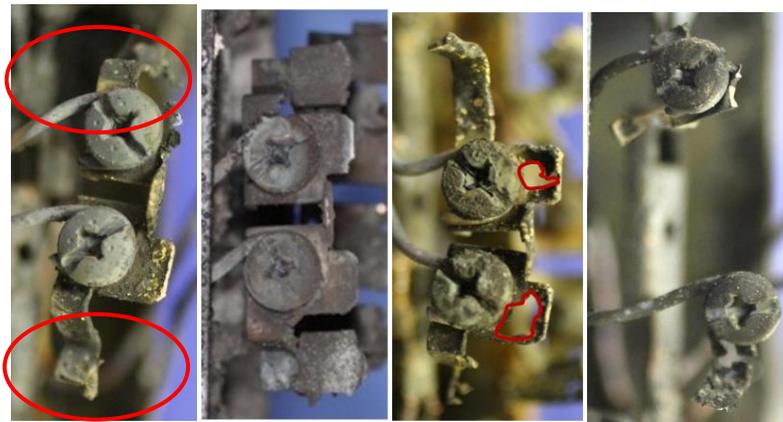
Figure 3-33. Progression of melting of brass receptacle components from non-energized receptacles; no melting observed in left most photo.

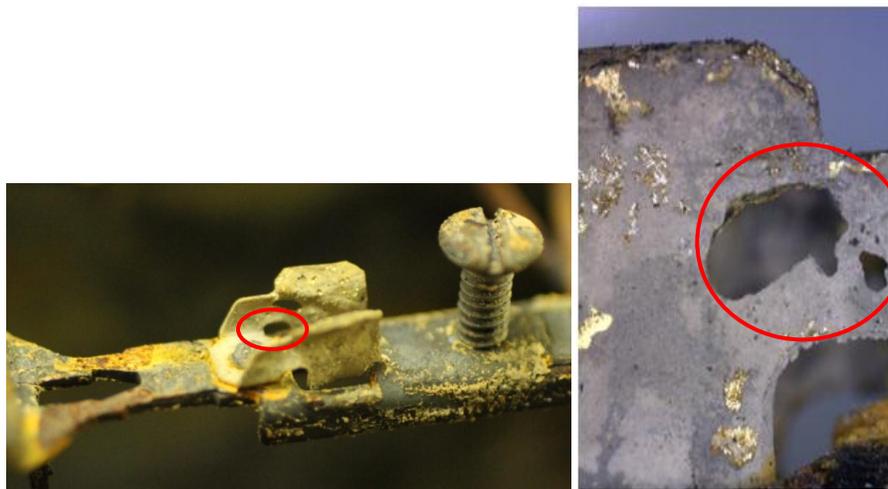
Figure 3-34. Melting of ground pin contacts; pitting and holes shown (LEV347, energized).

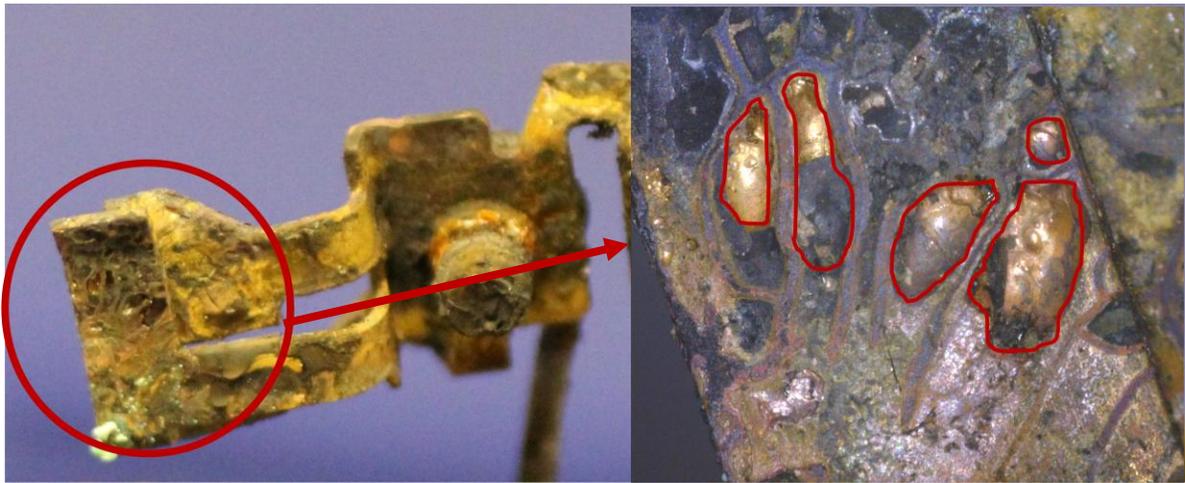
Figure 3-35. Photographs of melted brass receptacle contacts showing surface pitting (PSE364, non-energized).

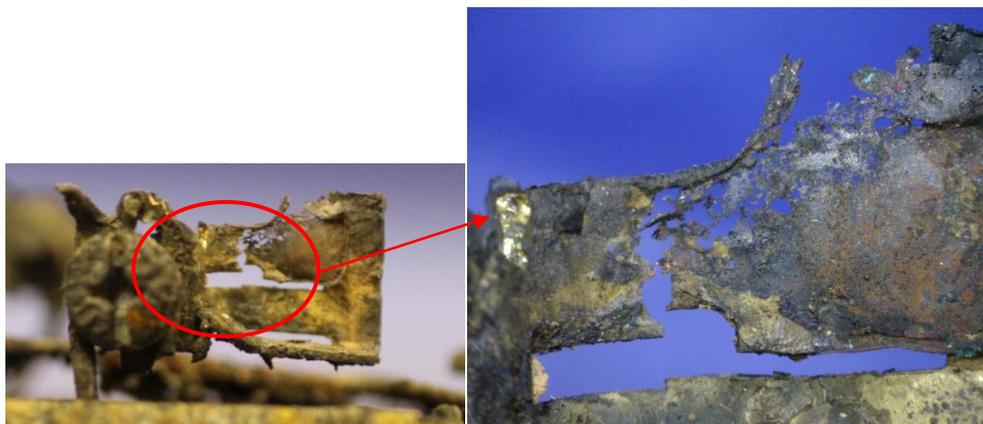
Figure 3-36. Photograph of melted brass receptacle contact showing thinning of contacts and holes (PSE373, non-energized).

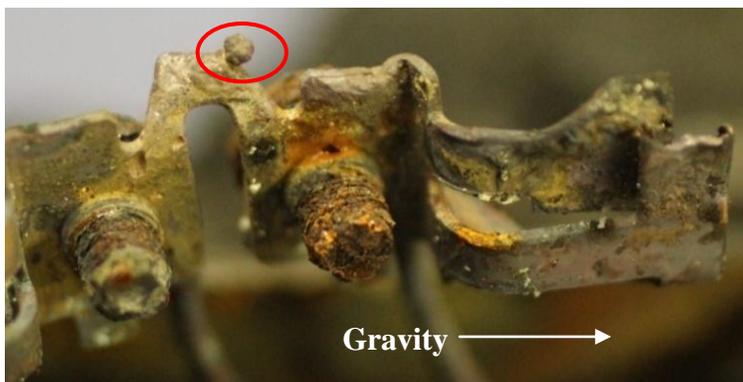
Figure 3-37. Photograph of melted brass receptacle neutral contact showing round globule and effects of gravity (PSE337, energized).

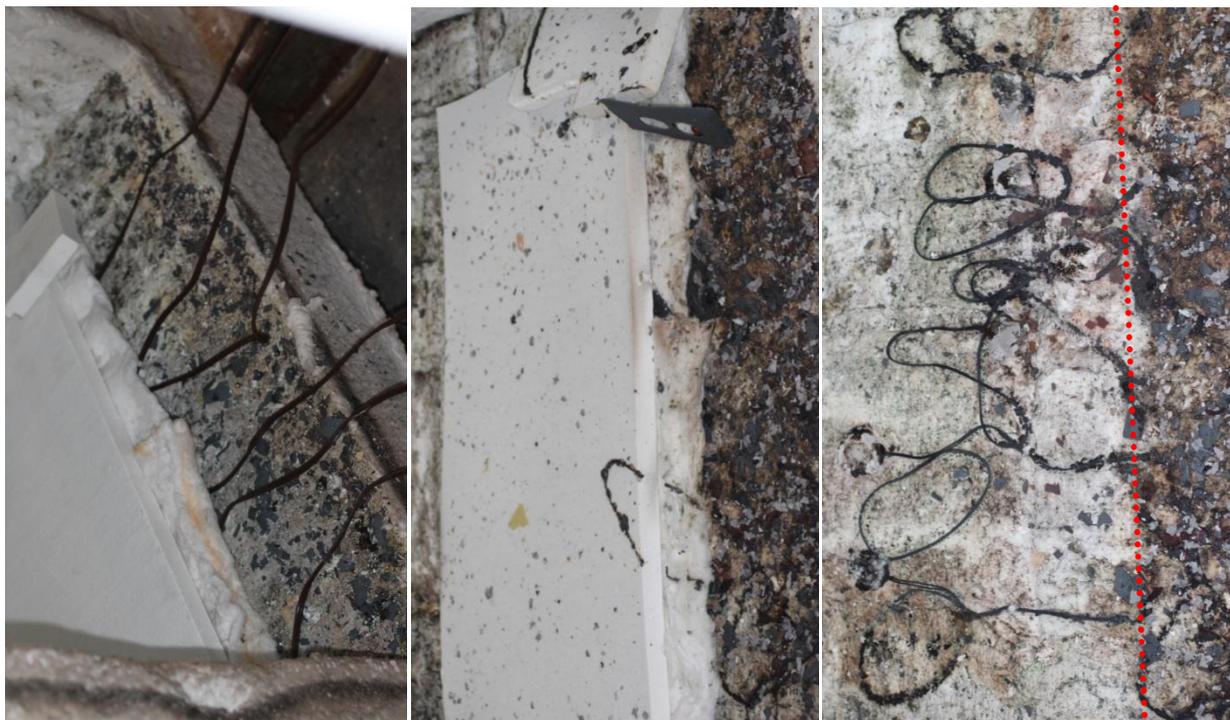
Figure 3-40. Extension cord wiring covered with insulation prior to test (left), with insulation after test (center) and with insulation removed (right) after furnace Test 4.

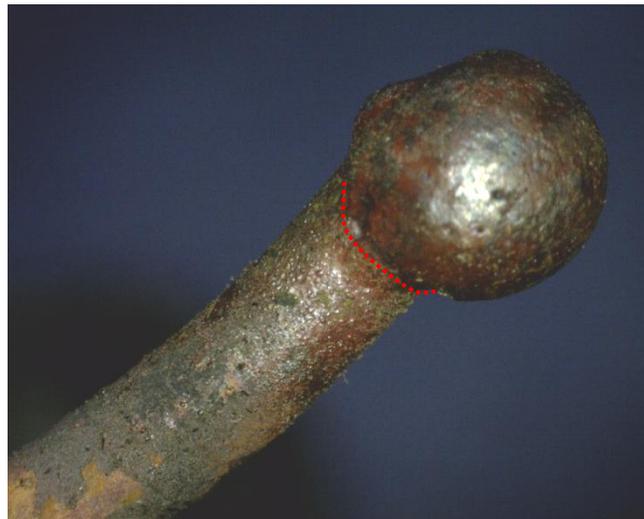
Figure 3-41. Melted copper wiring from a non-energized polypropylene receptacle showing line of demarcation (LEV389).

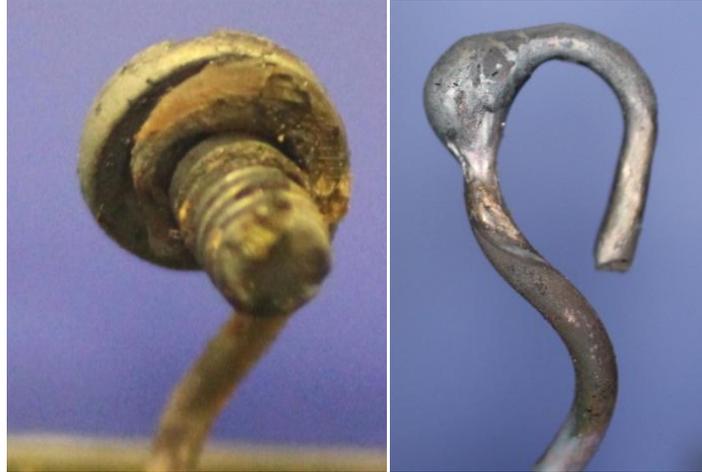
Figure 3-42. Tapering of melted copper wiring on a polypropylene receptacle (energized, LEV365, left) and a thermoset receptacle (non-energized, C023, right).

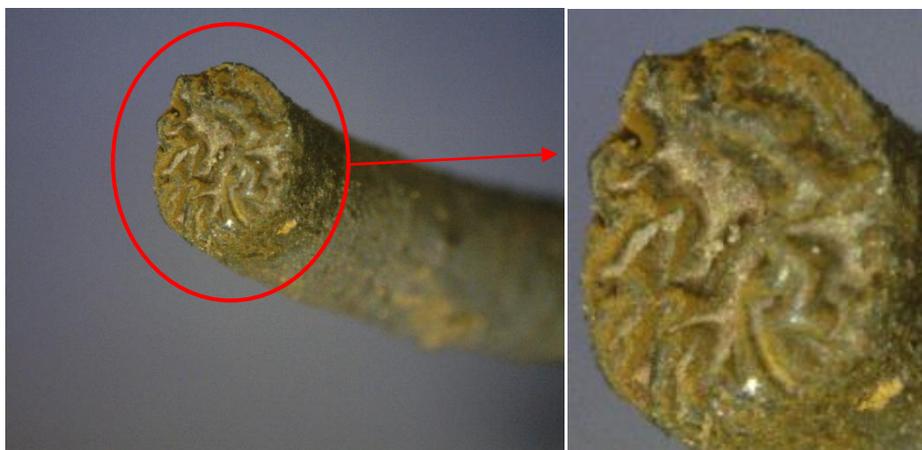
Figure 3-45. Photograph of melted copper wiring showing a flat end with pitting from a non-energized PVC receptacle (PSE384).

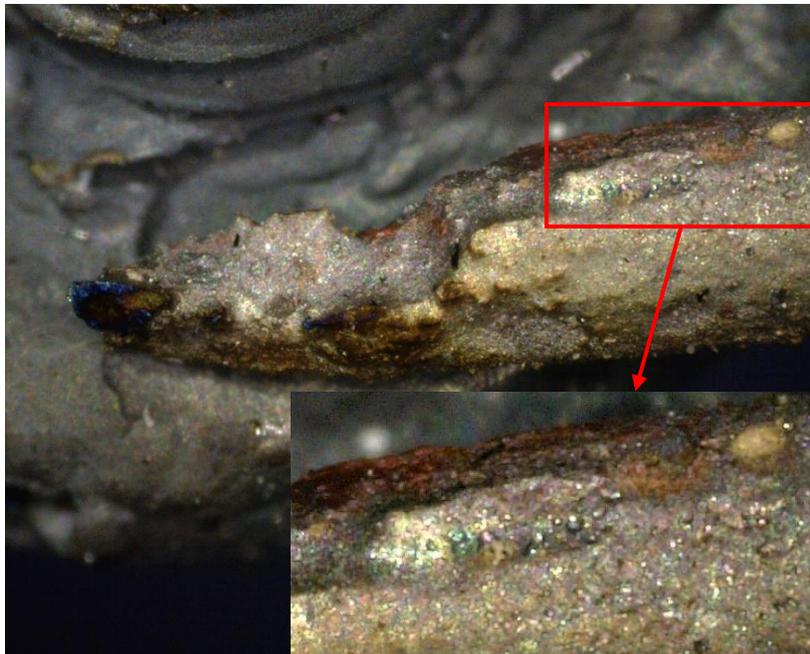
Figure 3-46. Photograph of melted copper wiring showing irregular, tapered end and pitting from an energized thermoset receptacle (E041).

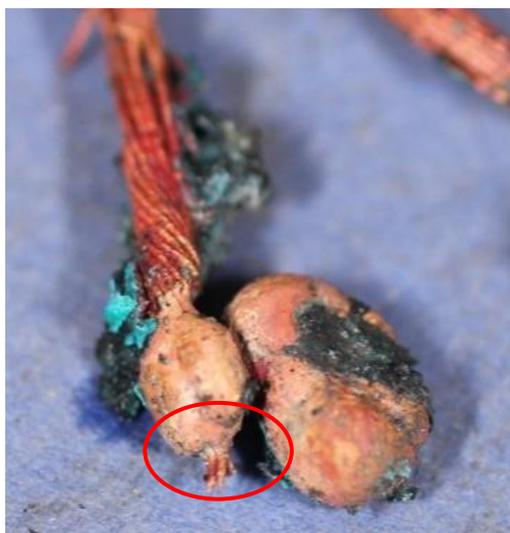
Figure 3-50. Photograph of melted stranded copper wiring for an energized extension cord from a thermoset receptacle; wire strands running through melt globule circled in red (E098).

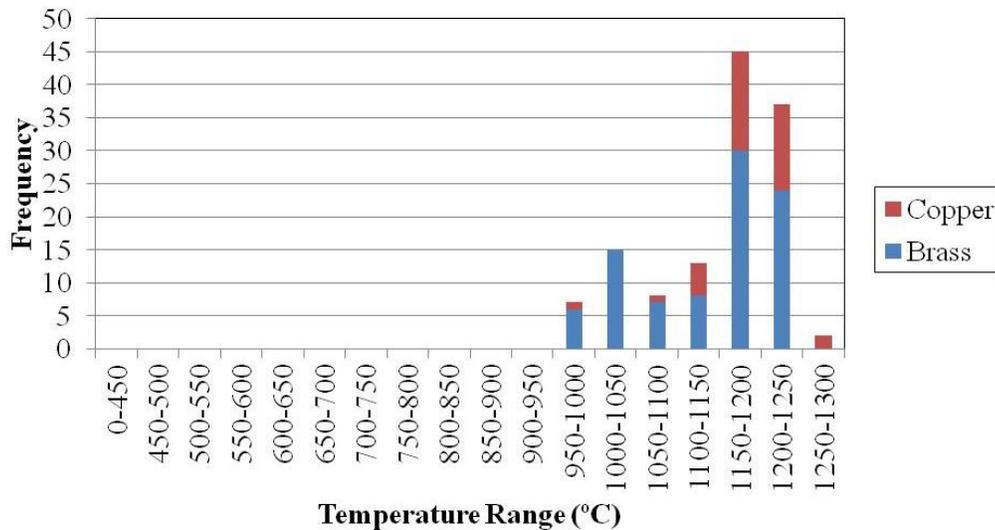
Figure 3-52. Histogram plot of the number of receptacles with metal melting as a function of the maximum exposure temperature range.

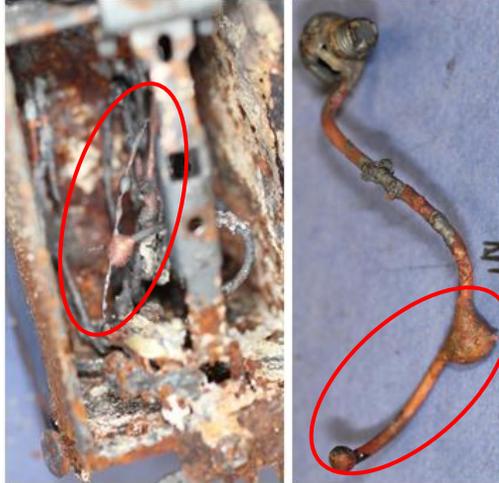
Figure 3-53. Photographs of melted copper wiring from energized polypropylene receptacles LEV398 (left) and LEV400 (right).

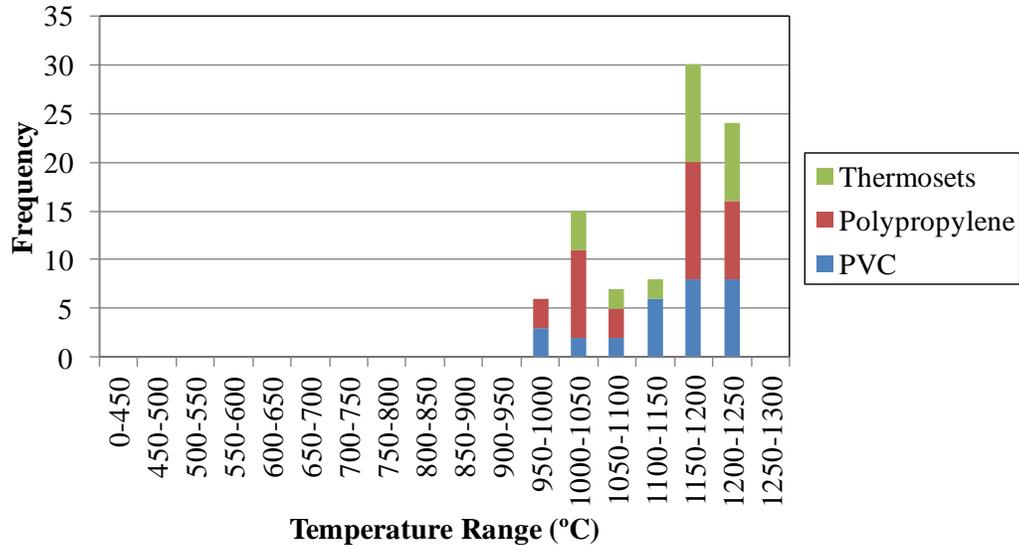
Figure 3-54. Histogram plot of brass receptacle components melting as a function of the maximum exposure temperature range.

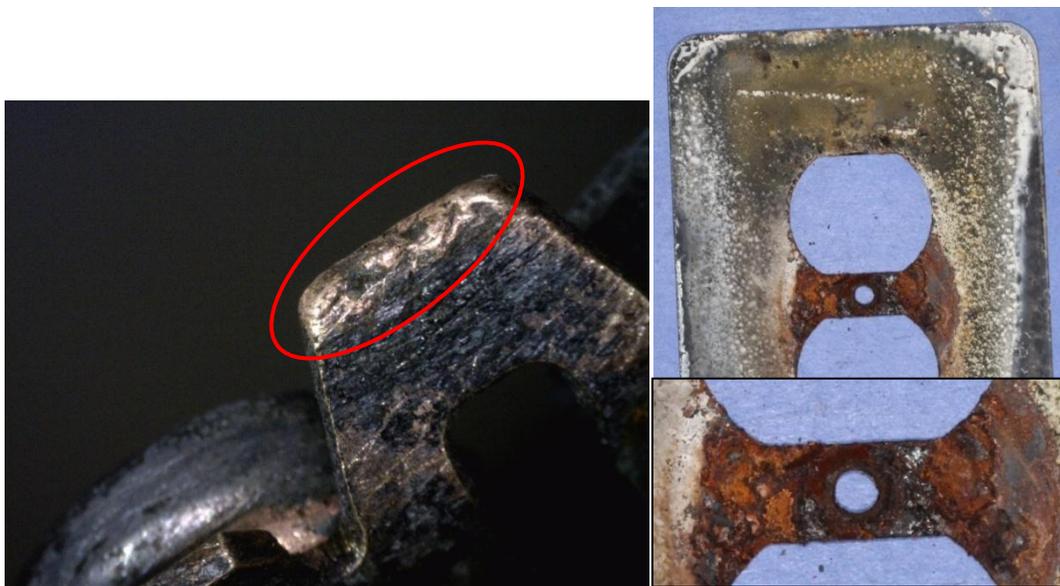
Figure 3-56. Photos of possible arcing damage on break off tab of energized PVC receptacle (PSE251, left) and rusted steel faceplate (right).

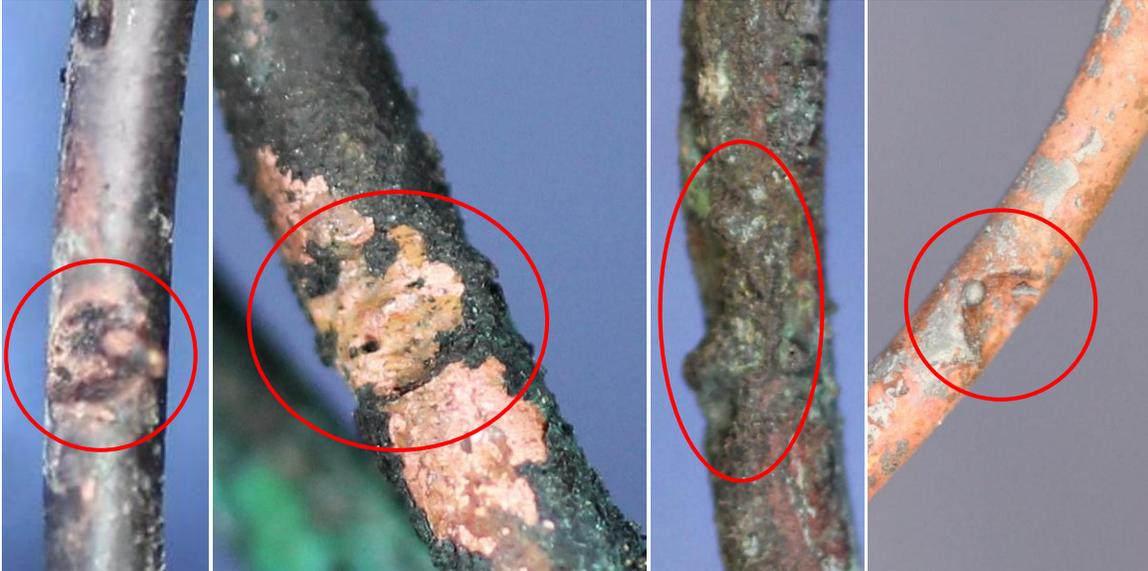
Figure 3-57. Arcing evidence on wiring from four thermostet receptacles
(From left to right: B010, D035, E078, and E083).

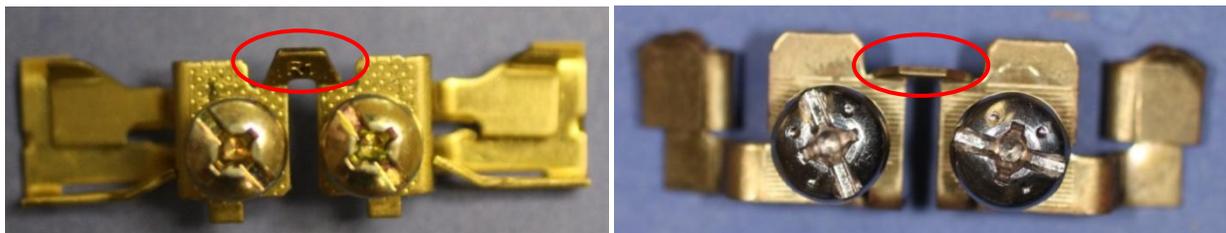
Figure 3-58. Exemplar PVC internal plug contacts (left) and polypropylene internal plug contacts (right); break off tabs circled.

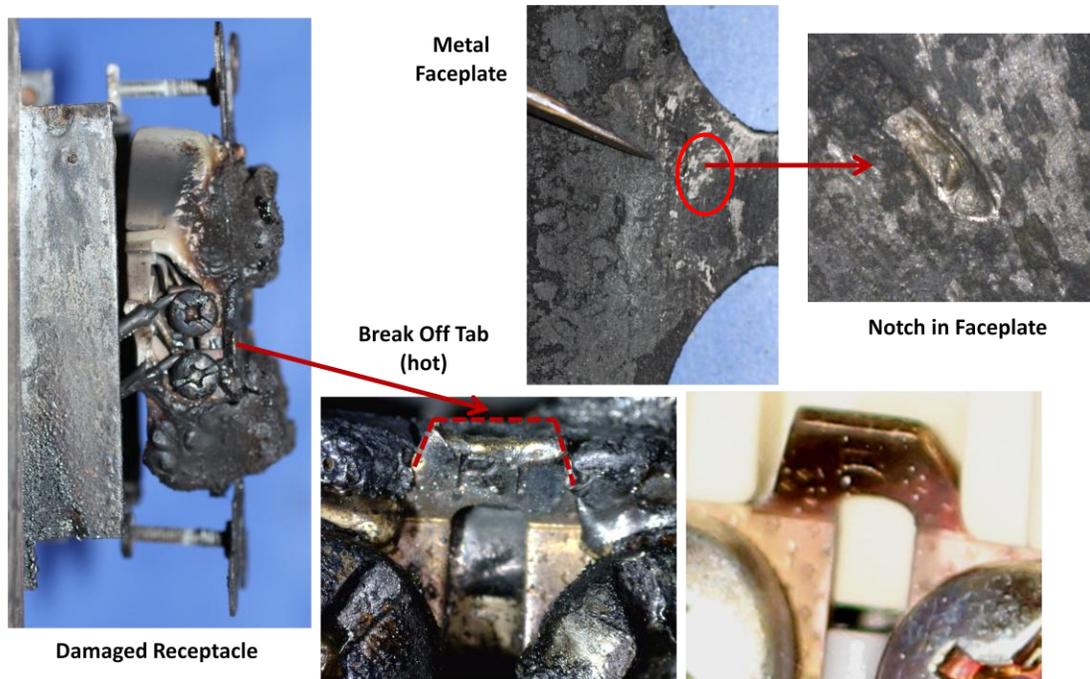
Figure 3-59. Photographs of damaged PVC receptacle (PSE085) showing arcing damage on the hot break off tab and steel faceplate; exemplar break off tab also shown.

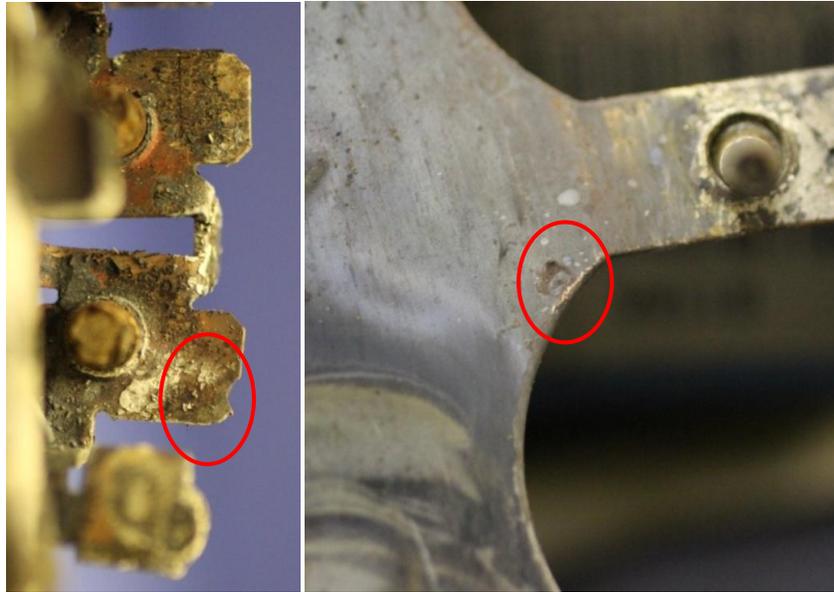
Figure 3-60. Photographs of arcing damage on hot female plug contacts (left) and steel faceplate (right) from a polypropylene receptacle (LEV336).

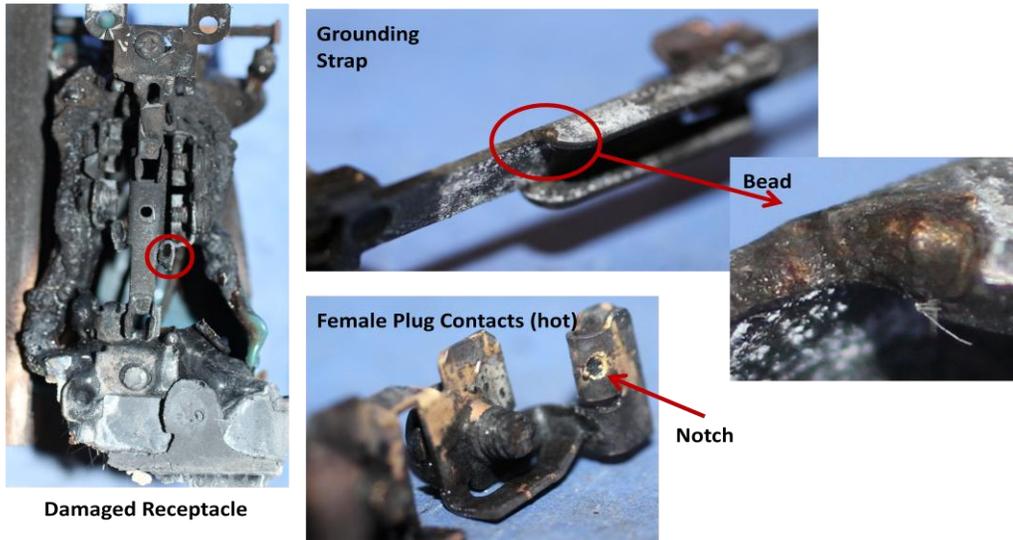
Figure 3-61. Photographs of damaged polypropylene receptacle (LEV082) showing arcing damage on the hot female plug contact and grounding strap.

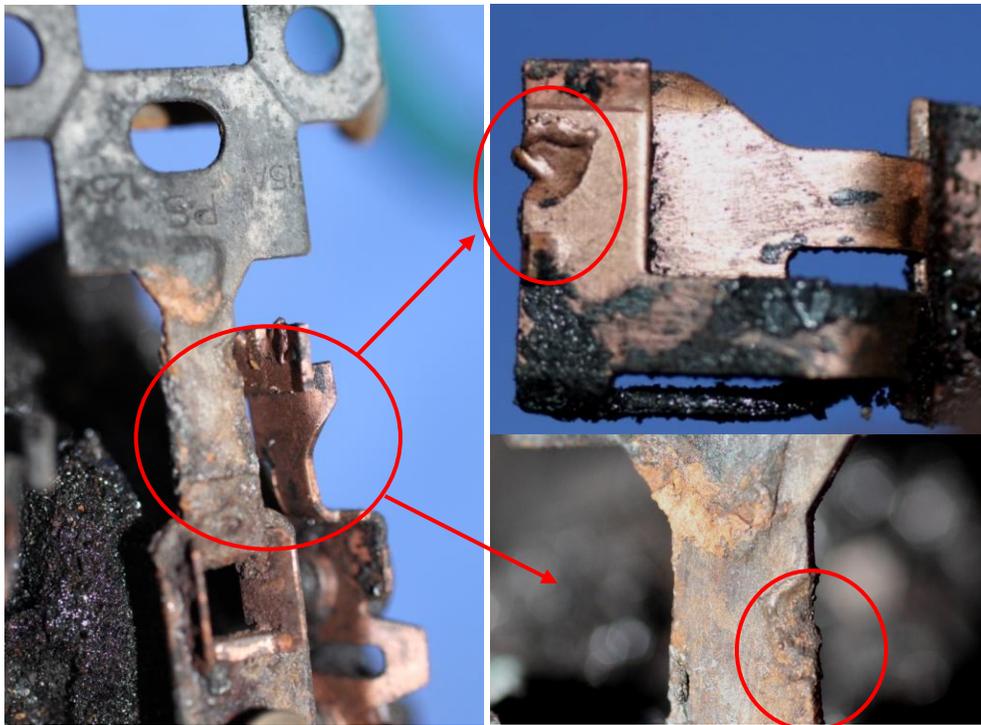
Figure 3-62. Photographs of arcing damage between hot female plug contacts (top right) and grounding strap (bottom right) from a PVC receptacle (PSE142).

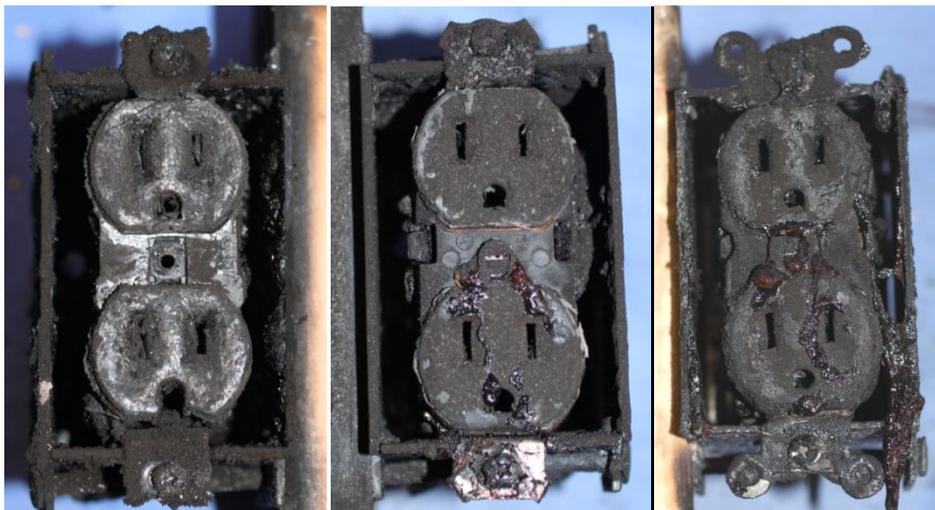
Figure 3-63. Photographs of three thermoset receptacles with arcing damage on wiring (left to right: B010, D016, and E033)

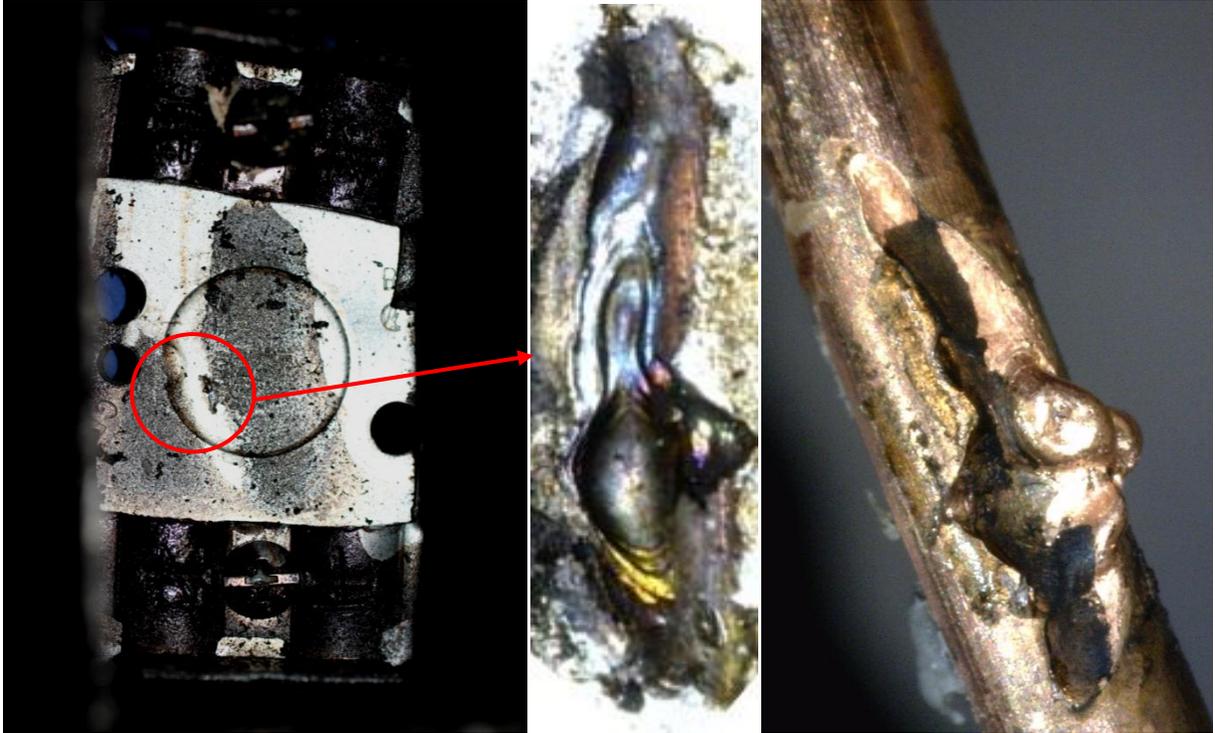
Figure 3-64. Photographs of damage from arcing between the hot copper conductor (right) and grounded steel outlet box (left and center) for a thermoset receptacle (D012).

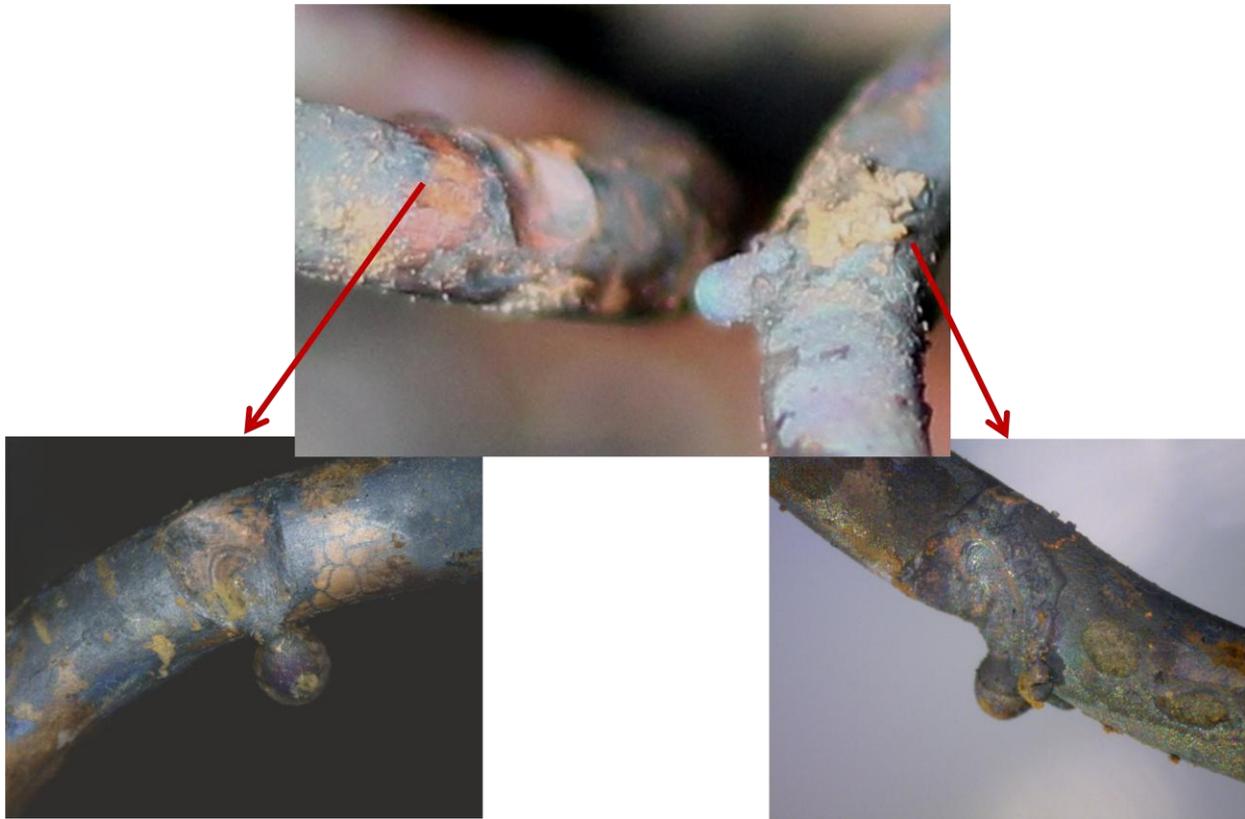
Figure 3-65. Photographs of arcing between solid hot and ground wires from a polypropylene receptacle (LEV366).

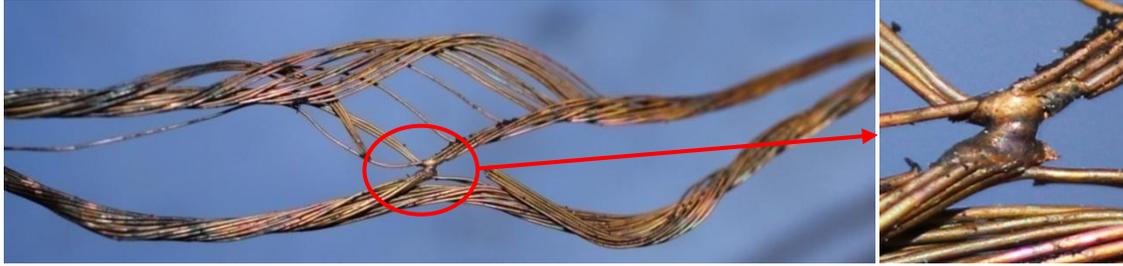
Figure 3-66. Photographs of arcing between stranded hot and neutral wires from an extension cord attached to a polypropylene receptacle (LEV319).

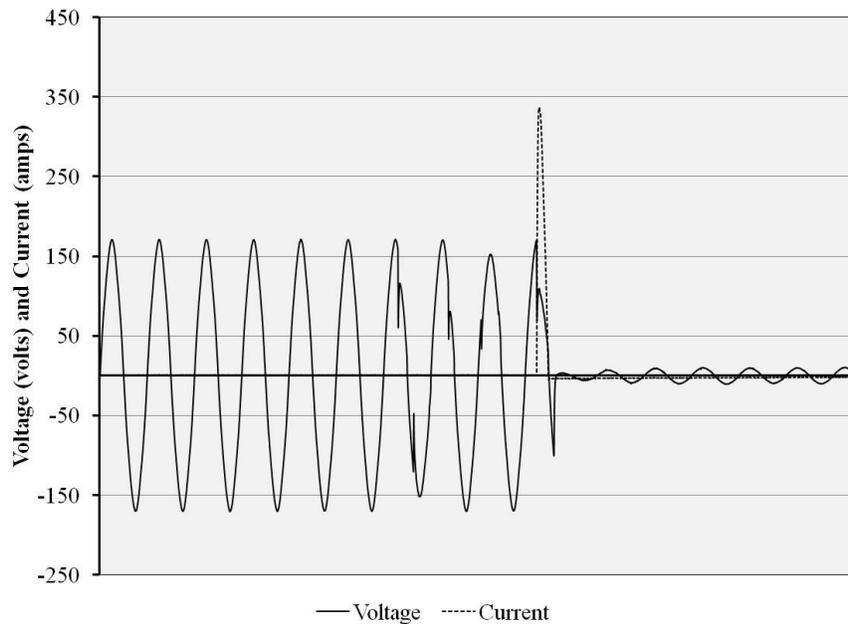
Figure 3-74. Voltage and current for receptacle B010 for single arc fault; leakage current after circuit breaker tripped.

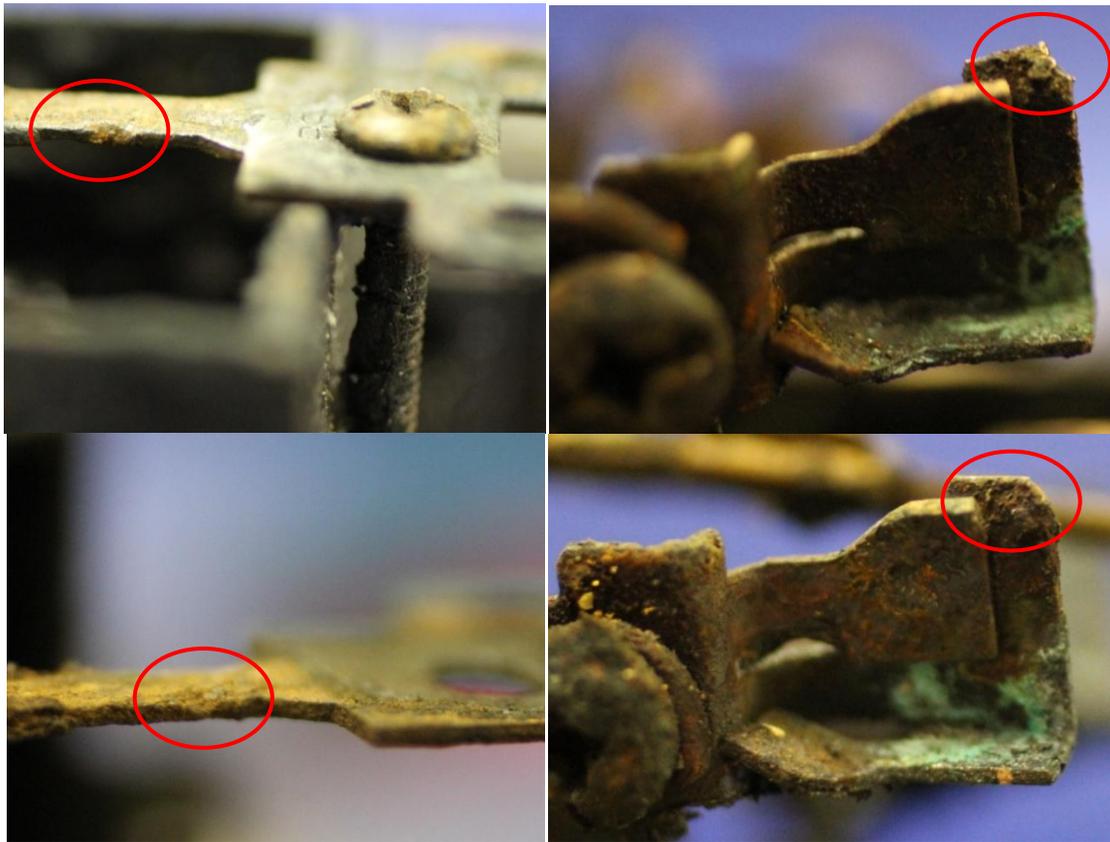
Figure 3-75. Arcing damage from PVC receptacles PSE248 (top left and right) and PSE249 (bottom left and right).

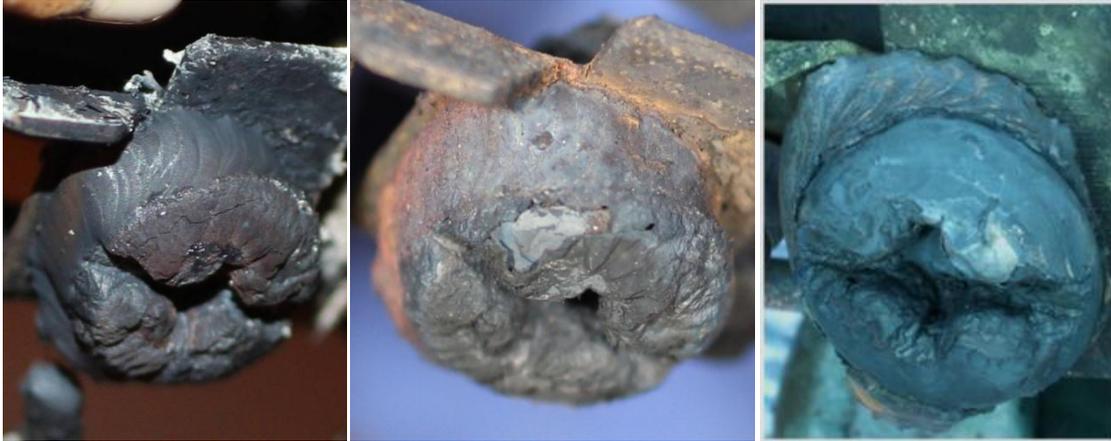
Figure 3-78. Welded conductor with curved striations before furnace exposure (left), after furnace exposure (center), and after furnace exposure with ultrasonic cleaning (right), (LEV275).

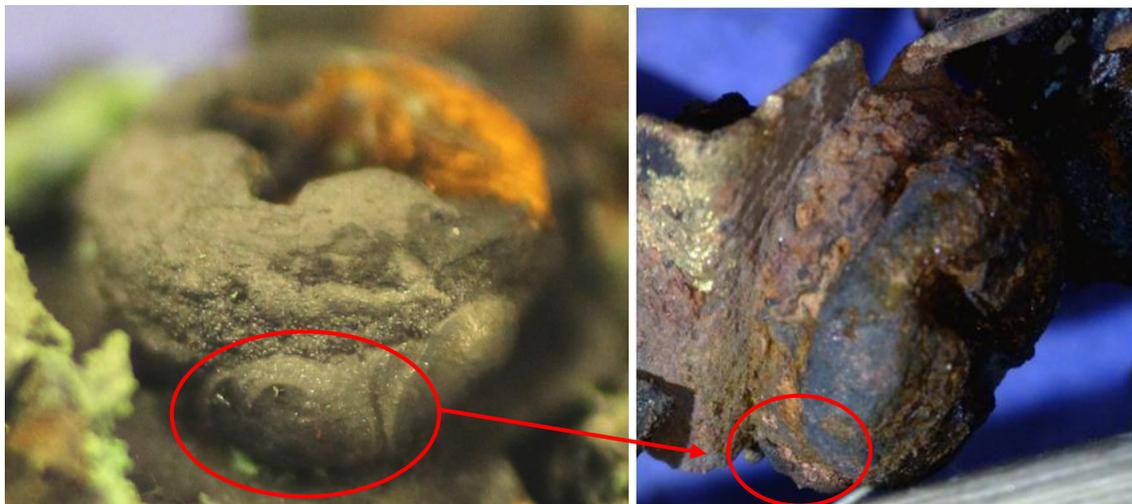
Figure 3-79. Welded conductor with curved striations before (left) and after (right) furnace fire exposure (PSE021).

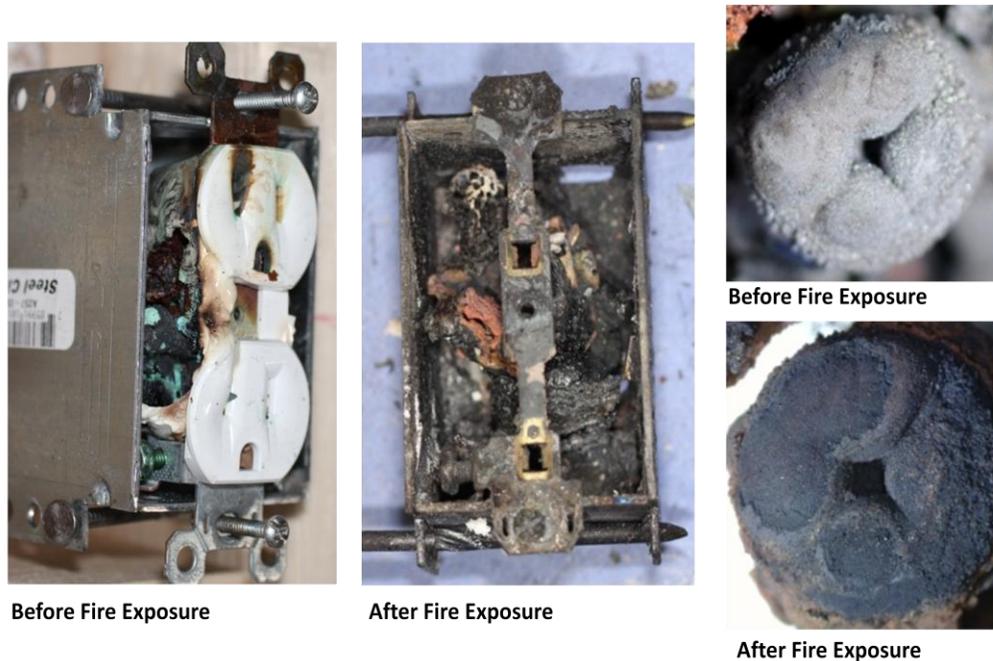
Figure 3-82 PVC receptacle with enlarged screw head before (left) and after (center) furnace fire exposure; enlarged screw head before (top right) and after (bottom right) fire exposure (PSE133).

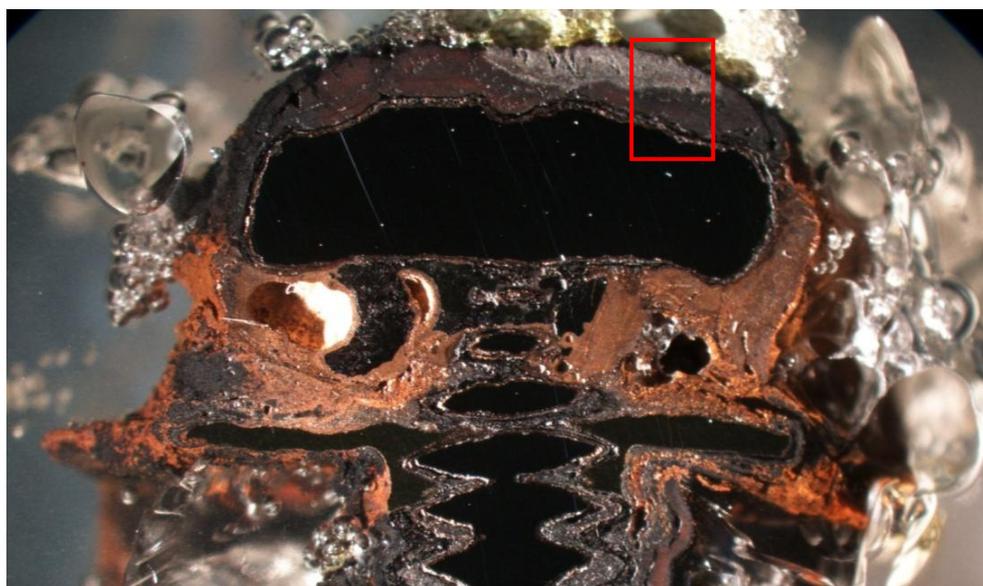
Figure 3-83. Sectioned and polished enlarged screw head from PSE133 after fire exposure.
Note: square indicates area of EDS mapping.

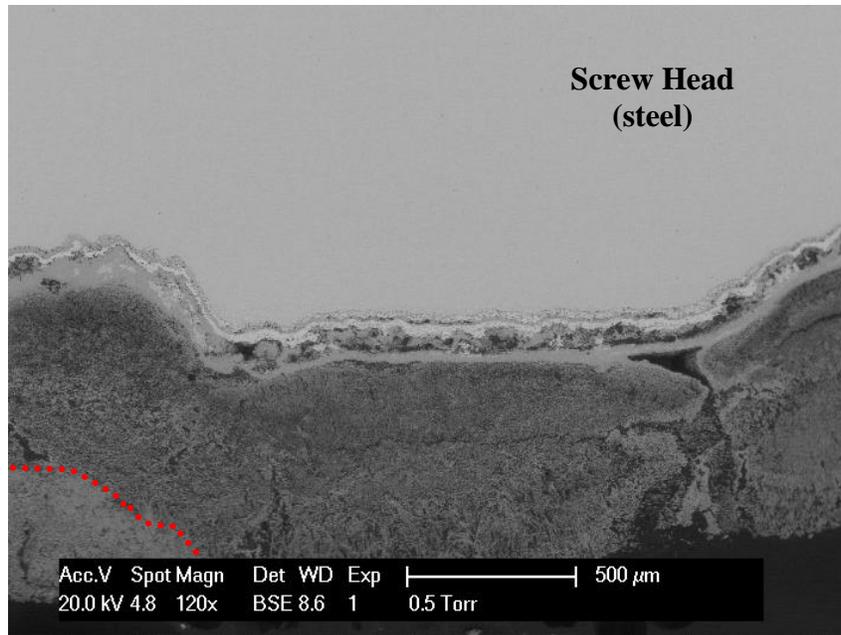
Figure 3-84. SEM image (120x) showing layer of corrosion for sectioned PSE133 enlarged screw.

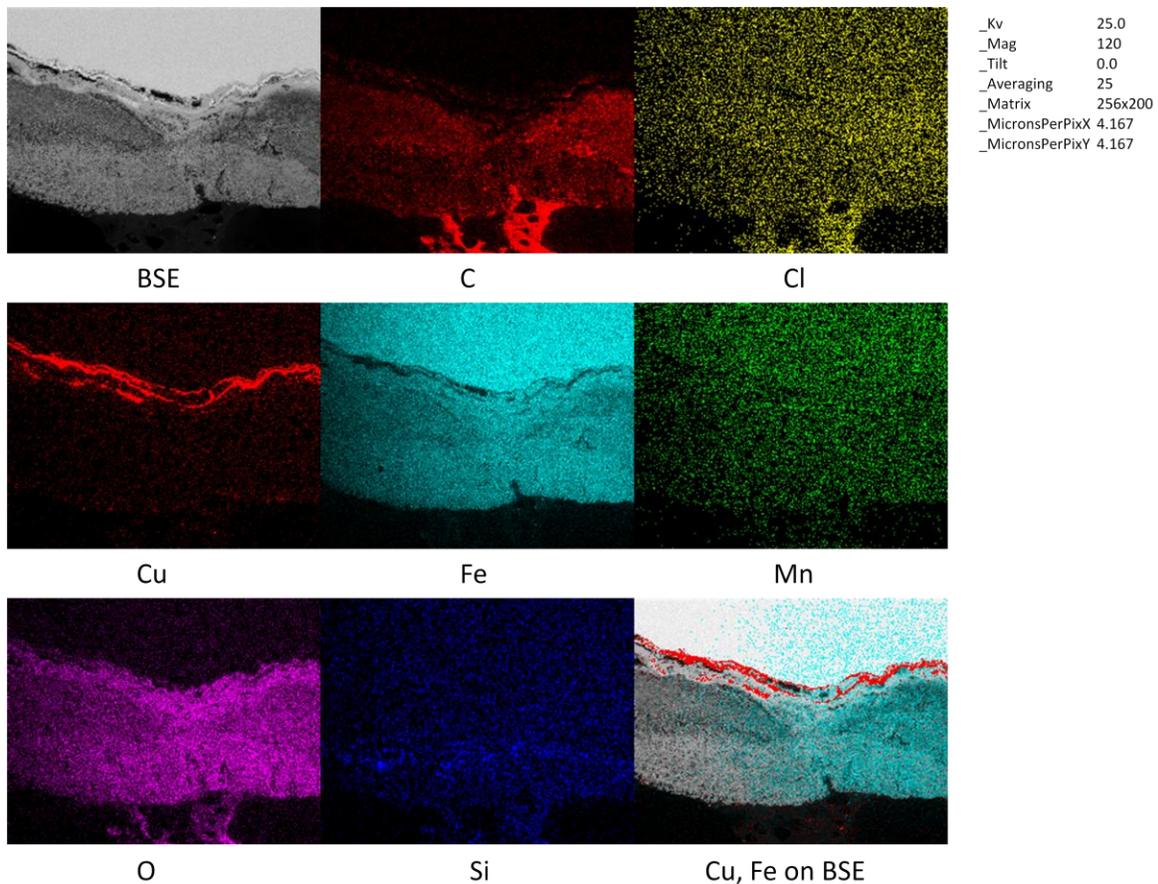
Figure 3-85. EDS Mapping of Oxide Layer for sectioned screw from PSE133.

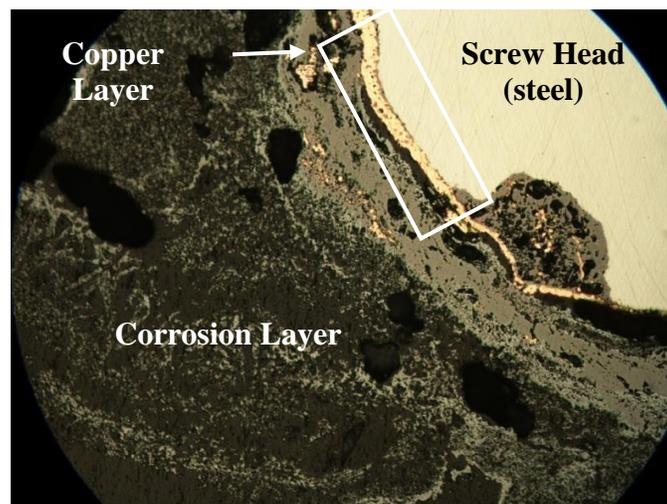
Figure 3-86. Microscope image (200x) of PSE133 showing copper at surface of screw beneath corrosion layer of enlarged screw head after fire exposure.
