The author(s) shown below used Federal funds provided by the U.S. Department of Justice and prepared the following final report:

Document Title: Development and Analysis of Electrical Receptacle Fires

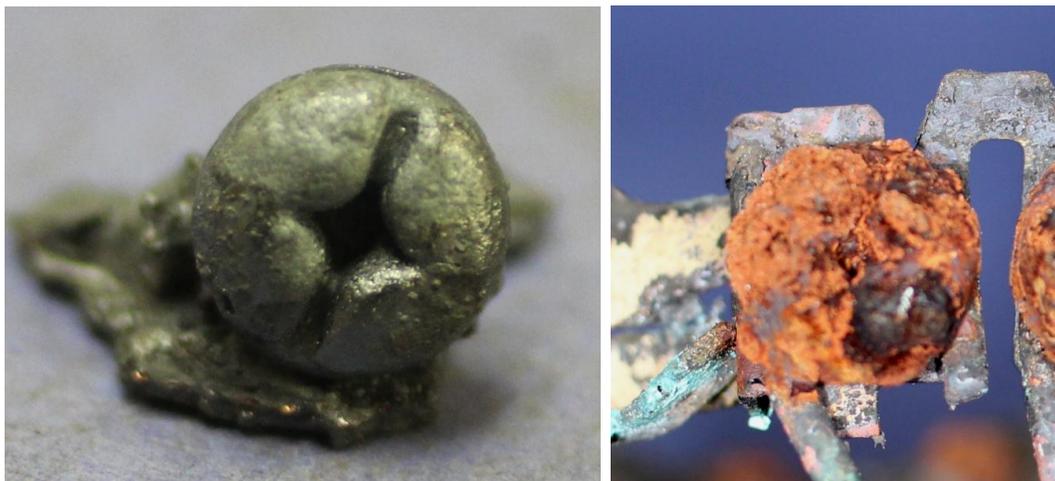
Figure 3-87. Photographs of screws from furnace testing; one located at bottom of furnace (left) and other from PSE362 (right).

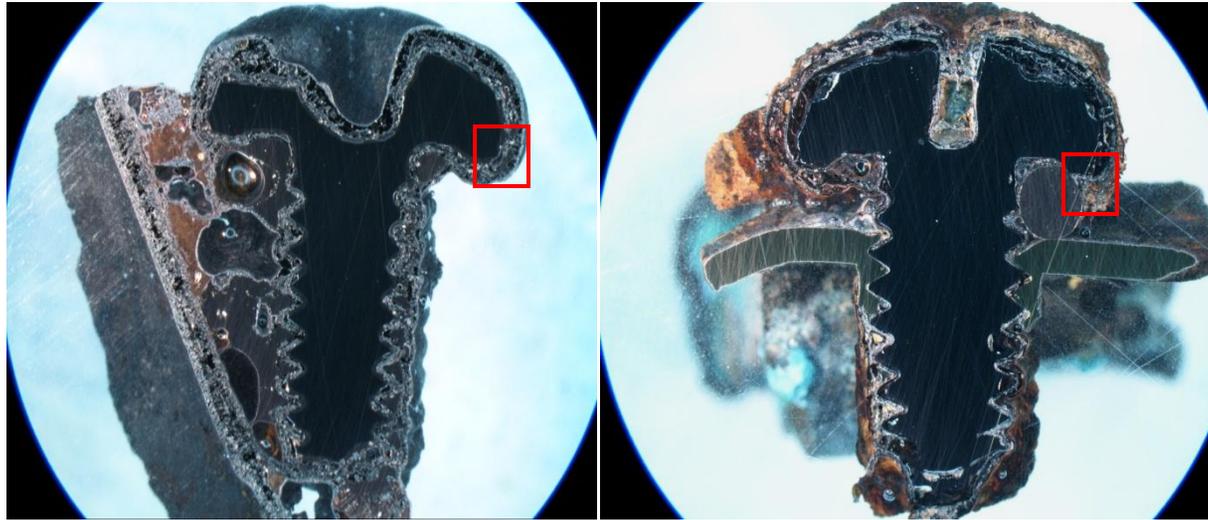
Figure 3-88. Sectioned and polished screws from furnace testing; Furnace Screw X (left) and screw from PSE362 (right).
 Note: Squares indicate areas of EDS mapping.

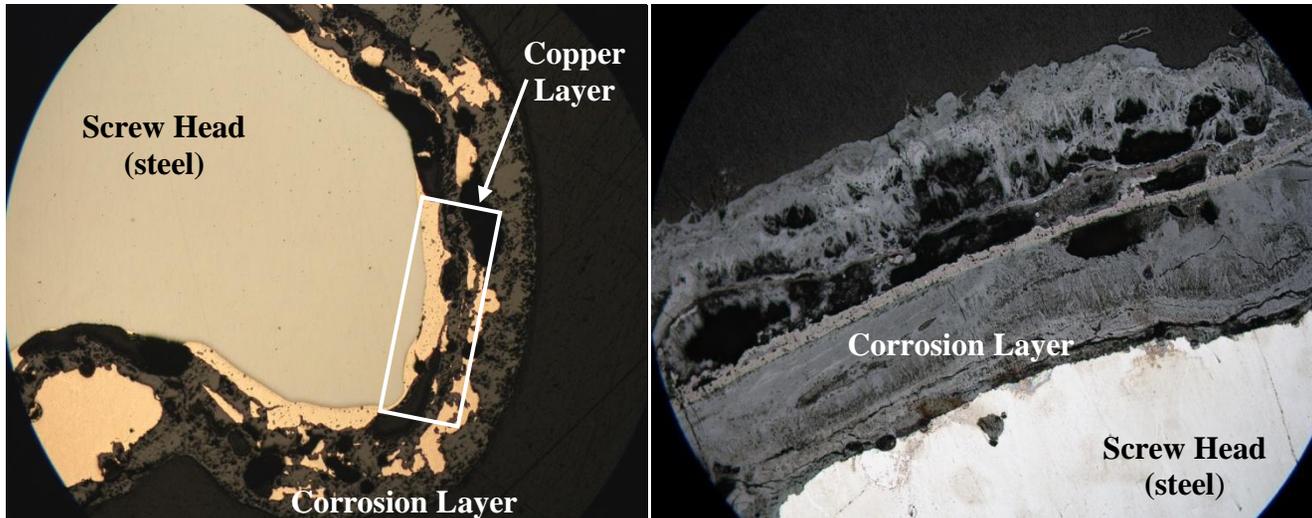
Figure 3-89. Microscope images of; Furnace Screw X (left; with copper layer and corrosion) and screw from PSE362 (right; without copper layer beneath corrosion).

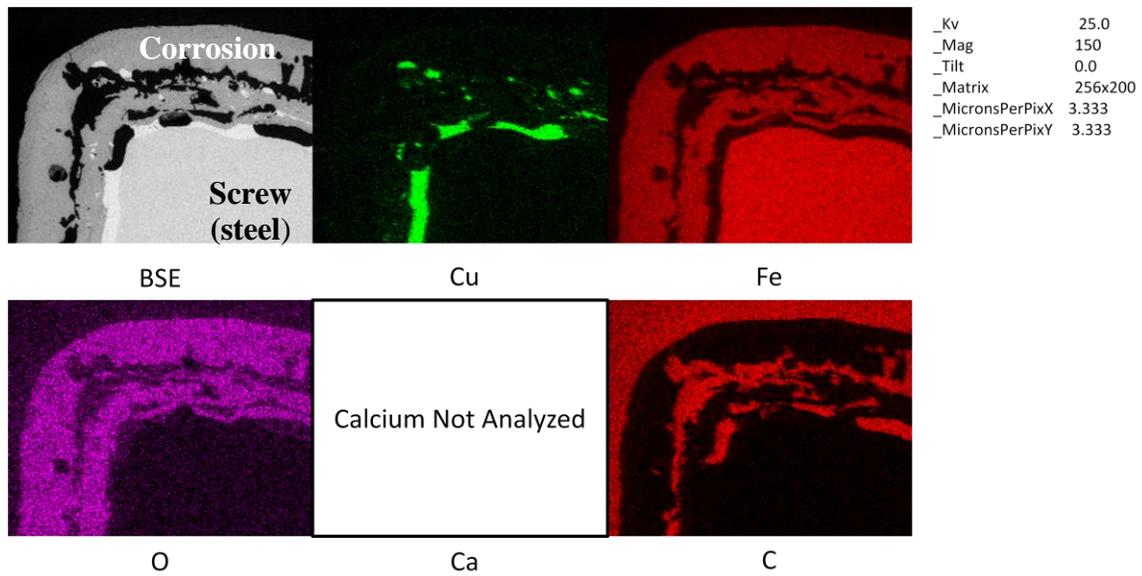
Figure 3-90. EDS Mapping of oxide layer for sectioned Furnace Screw X.

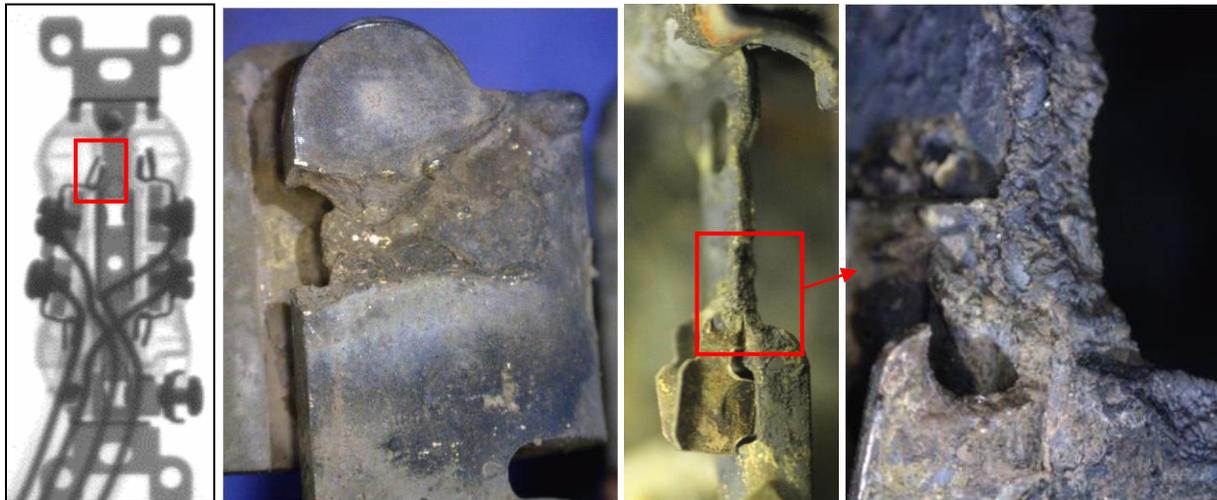
Figure 3-92. X-ray image before (left) and photographs after (right three) of arcing damage from a polypropylene receptacle failure event (LEV011).

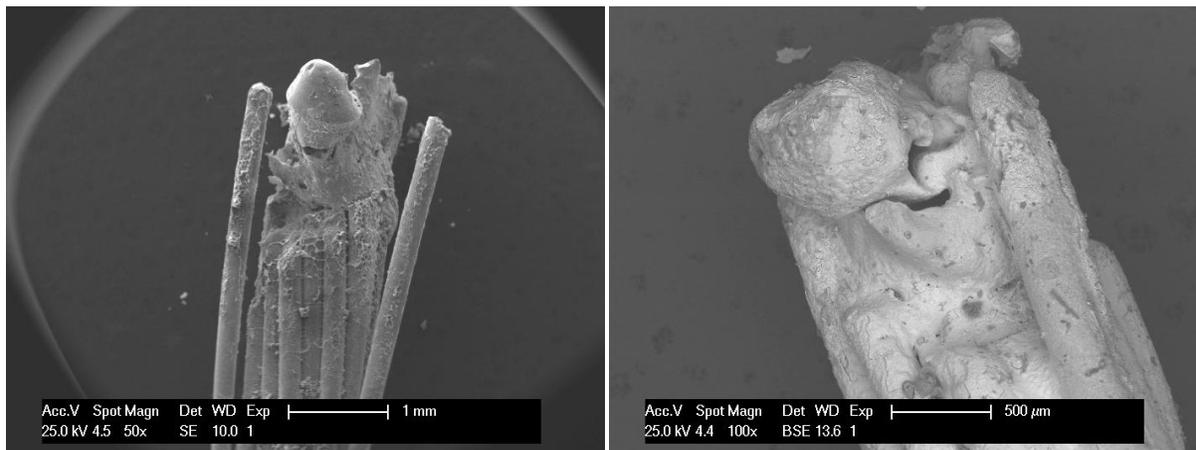
Figure 3-93. SEM images of stranded hot wire with arc bead from extension cord (LEV318) before (left) and after (right) furnace exposure.

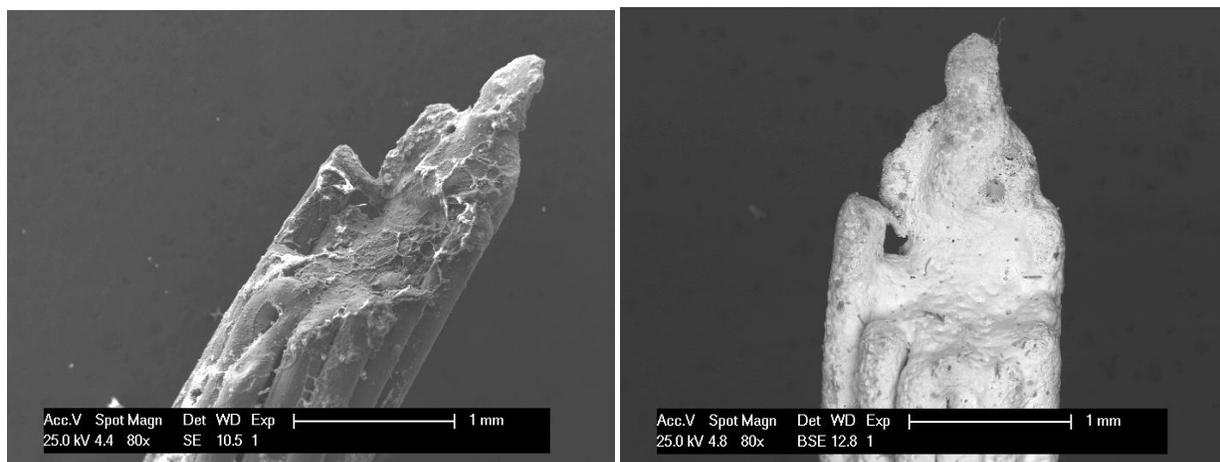
Figure 3-94. SEM images of stranded neutral wire with arc notch from extension cord (LEV318) before (left) and after (right) furnace exposure.

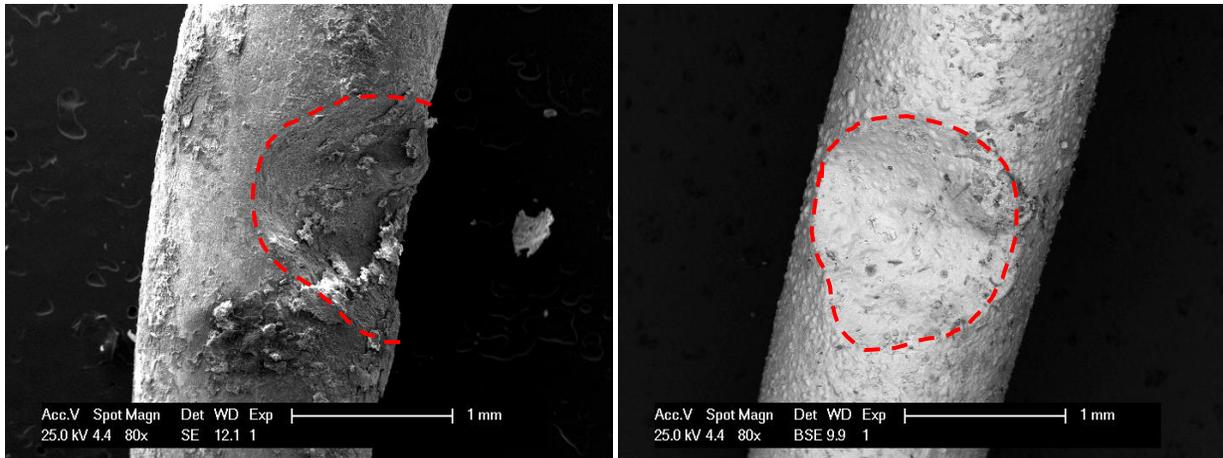
Figure 3-95. SEM images of neutral wire with arc notch from thermoset receptacle (B007) before (left) and after (right) furnace exposure.

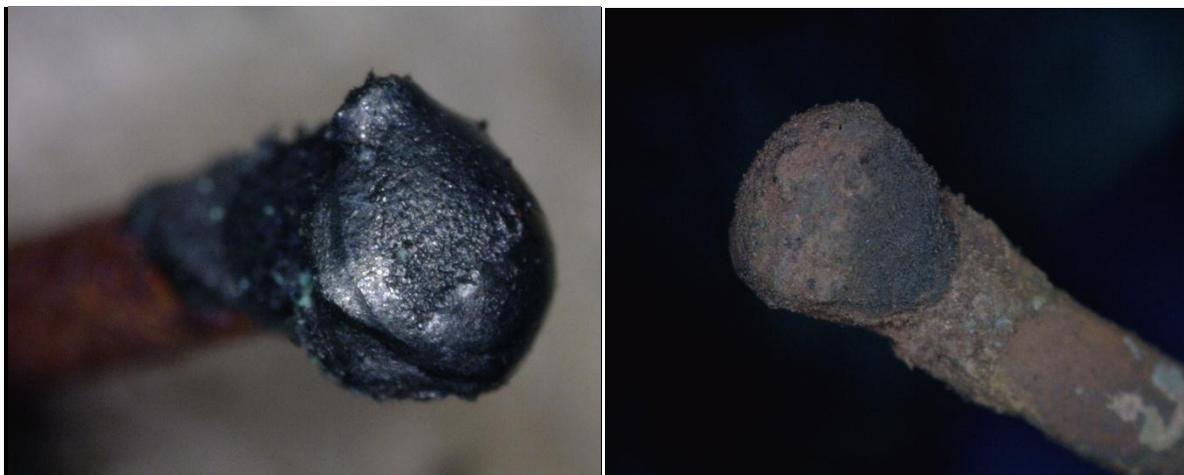
Figure 3-97. Photographs of severed conductor end on wire from PVC (PSE023) receptacle before (left) and after (right) furnace exposure.

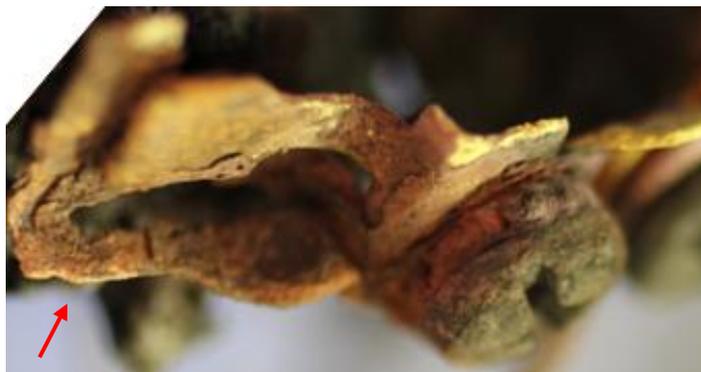
Figure 3-99. Photograph of internal plug contacts thinned by oxidation and overheating from PVC receptacle (PSE023).

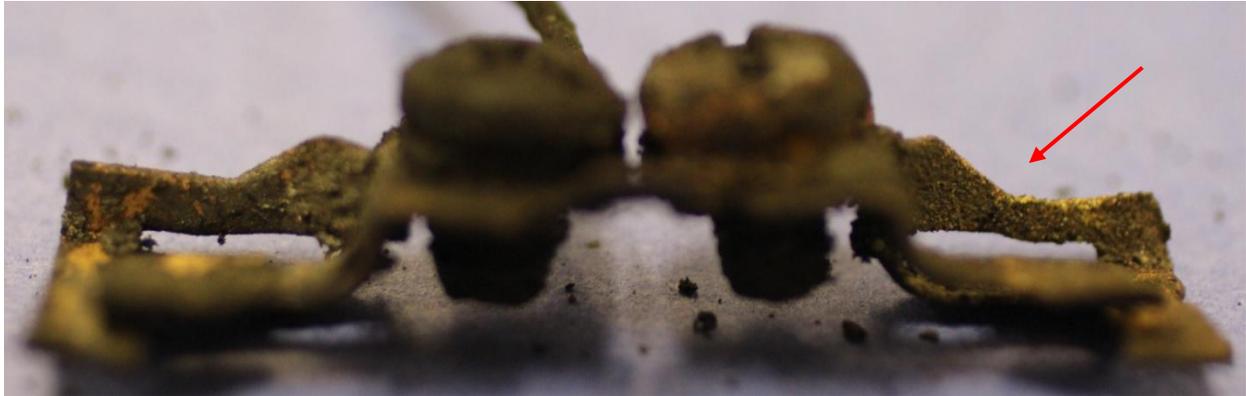
Figure 3-101. Photograph of internal plug contacts thinned by oxidation and overheating from PVC receptacle (PSE024).

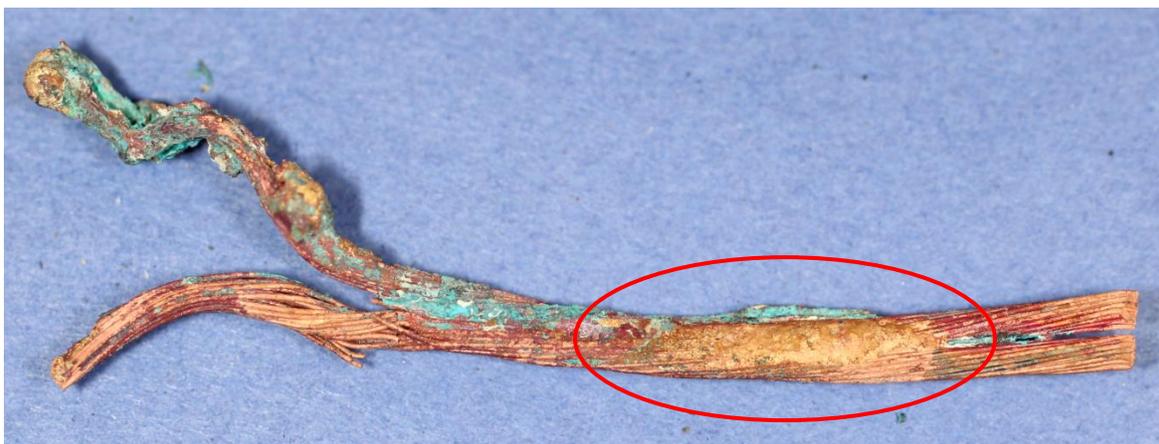
Figure 4-1. Corresponding damage on opposing conductor(s) for receptacle with melting (LEV397).

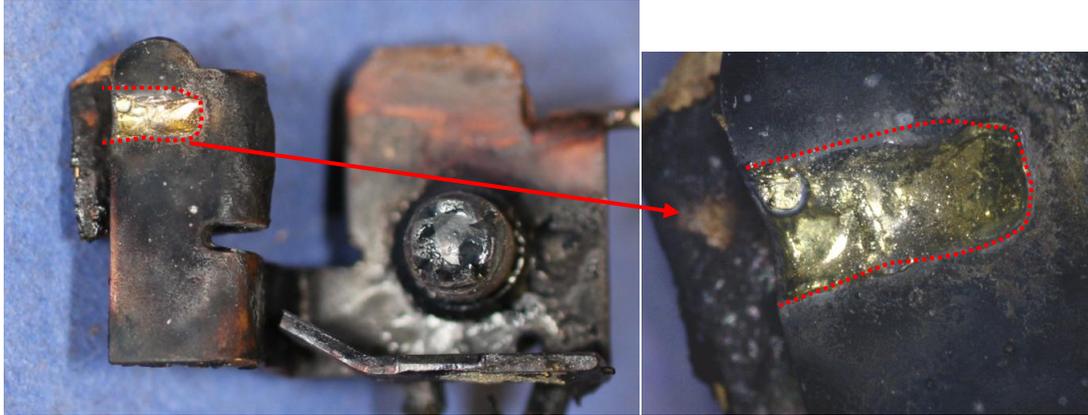
Figure 4-2. Localized point of contact with sharp line of demarcation noted as a dashed line around the notch (LEV015).

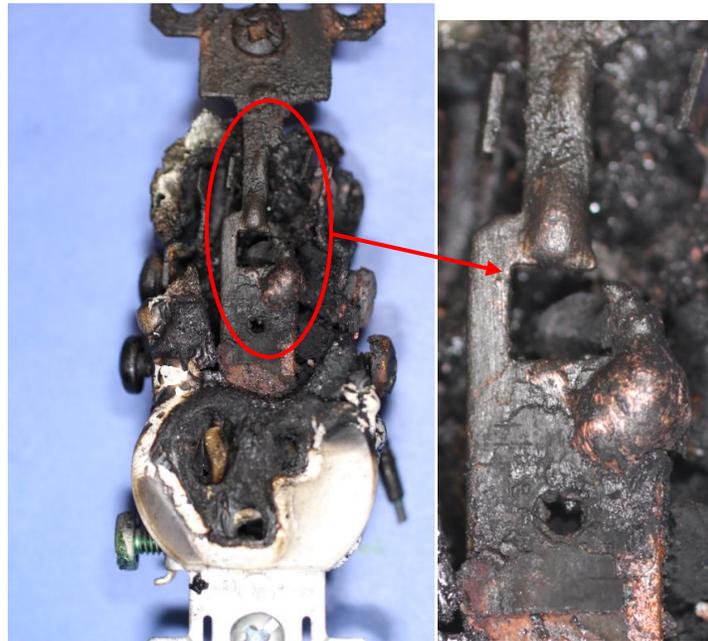
Figure 4-3. Localized point of contact without a sharp line of demarcation (PSE 285).

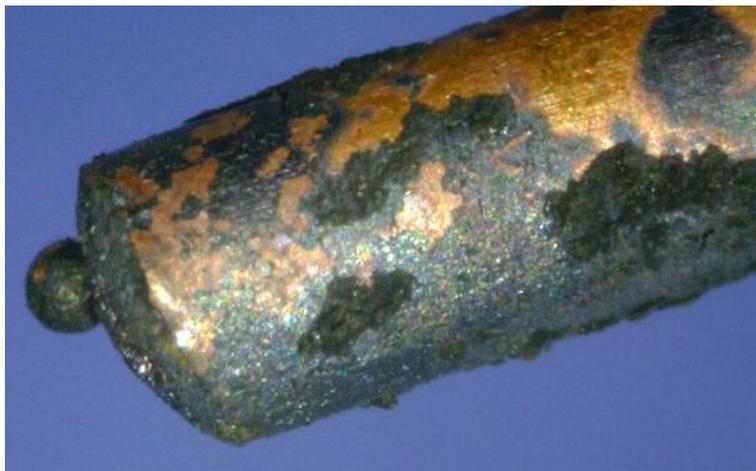
Figure 4-4. Localized point of contact with a sharp line of demarcation (LEV391).

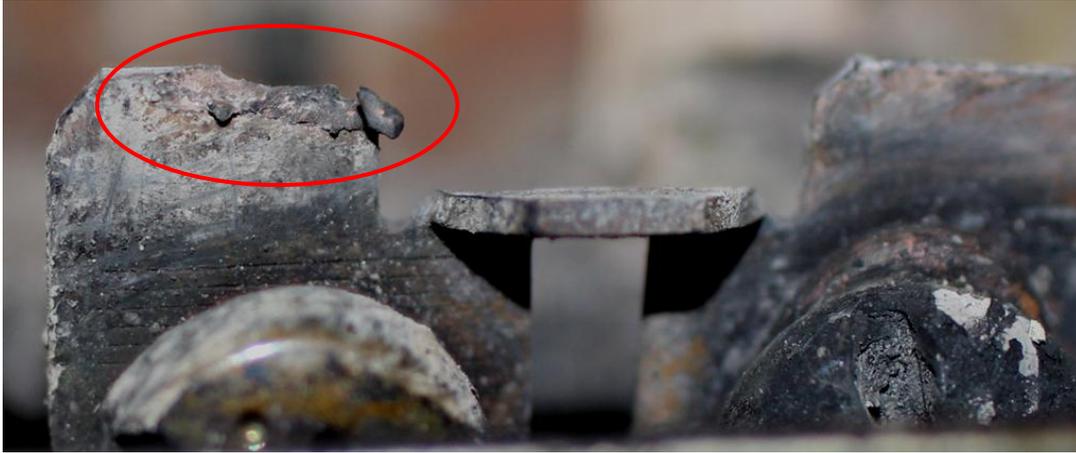
Figure 4-5. Notch in brass plug contact which is not round and smooth (LEV144).

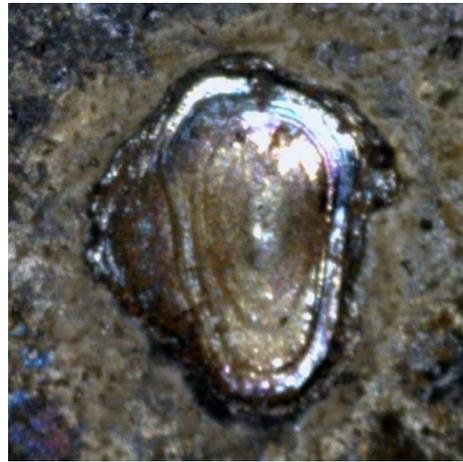
Figure 4-6. Notch in steel faceplate which is round and smooth (PSE331).

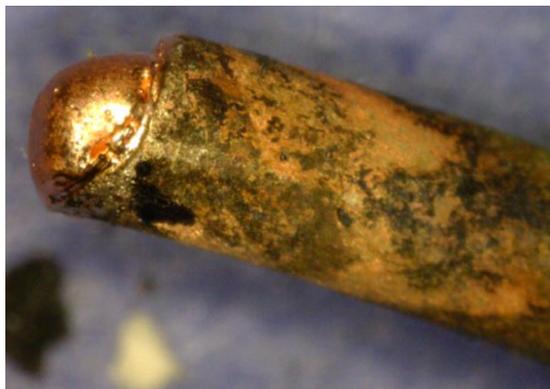
Figure 4-7. Round and smooth bead on end of wire severed by arcing (E001).

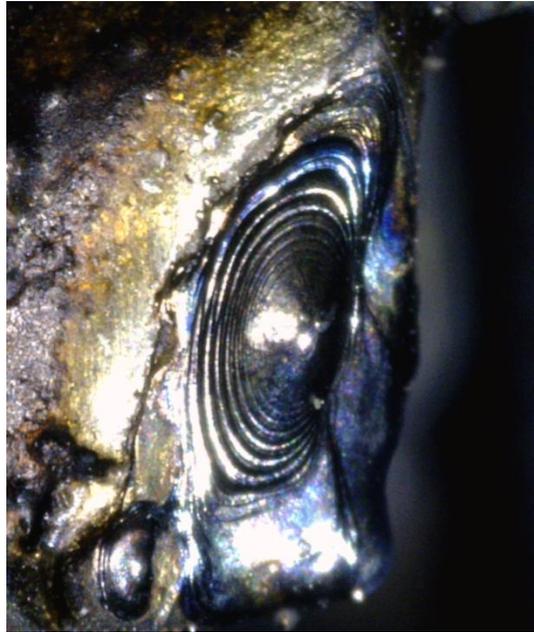
Figure 4-8. Arcing damage on grounding strap showing resolidification waves (LEV276).

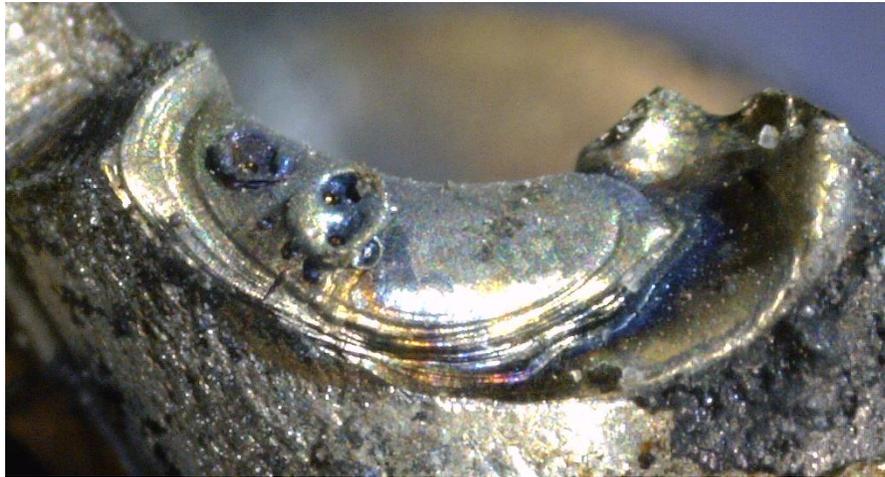
Figure 4-9. Arcing damage on grounding strap showing resolidification waves that are more pronounced on the major axis (LEV174).

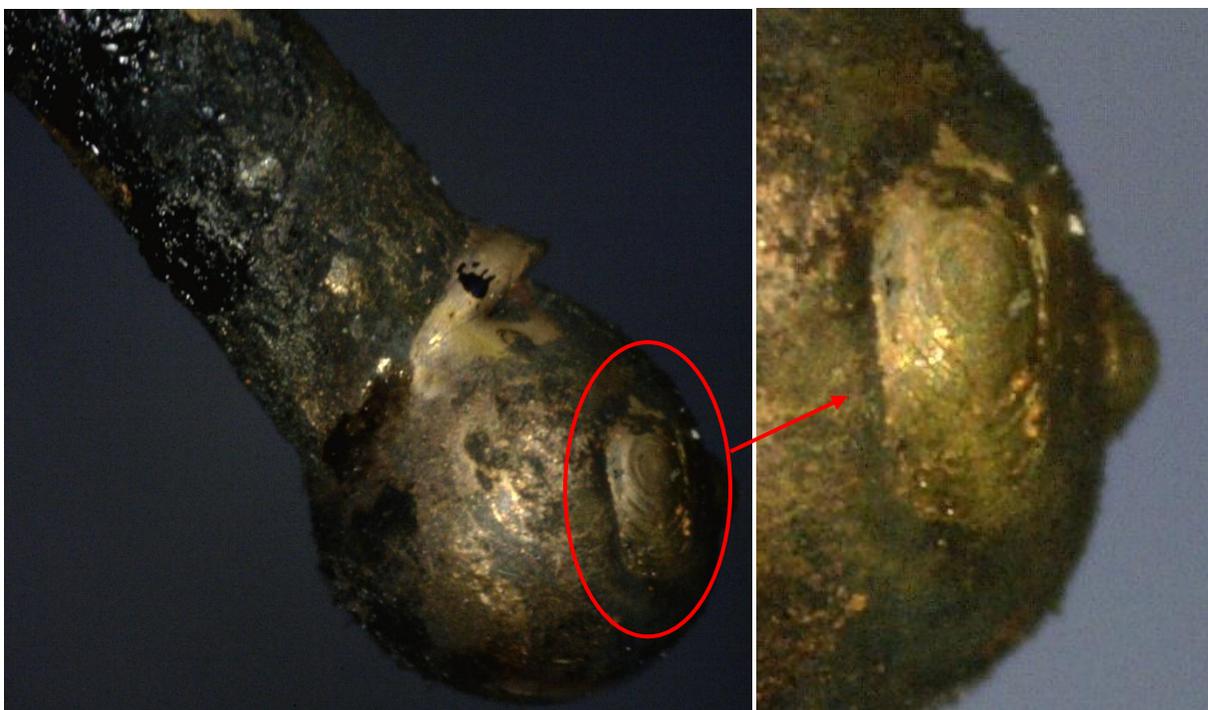
Figure 4-10. Arcing damage on copper wire showing resolidification waves (LEV172).

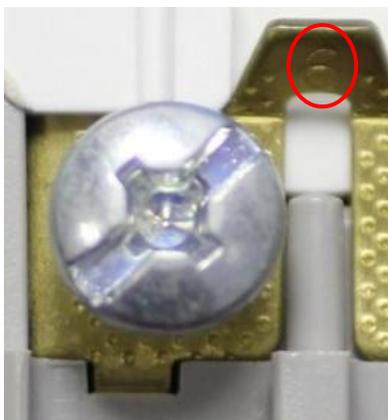
Figure 4-11. Typical stamped number (circled), bent brass plug contact with crisp edges from an exemplar PVC receptacle.

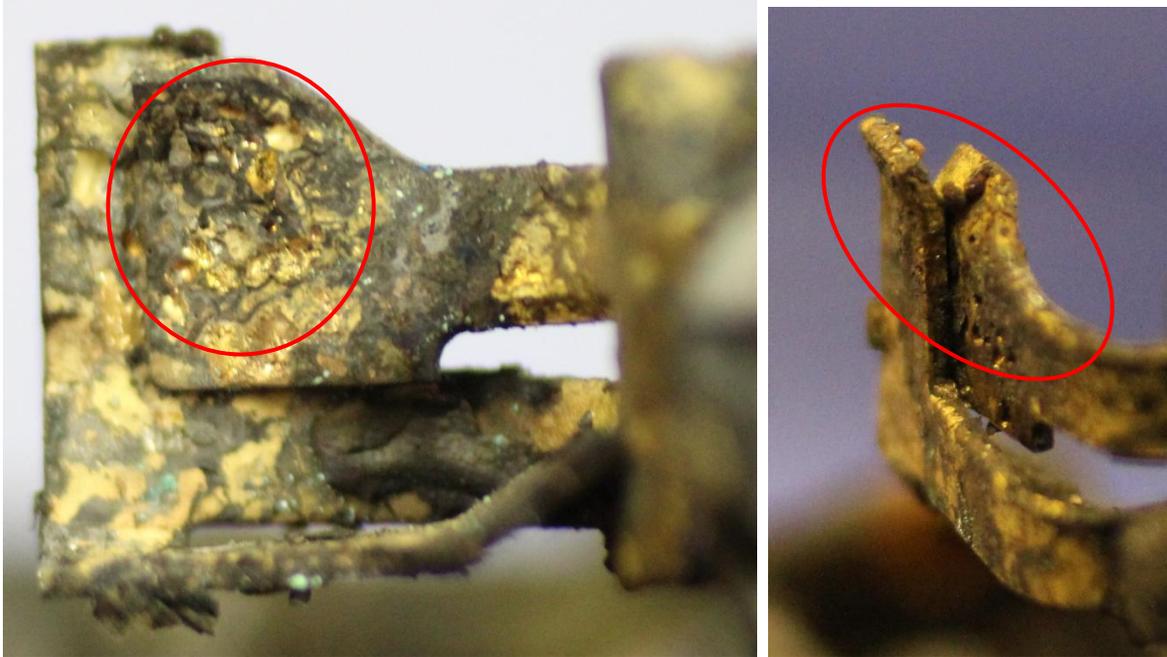
Figure 4-12. Photos of melting damage on non-energized plug contact which has tooling marks (sharp edges) visible outside the damaged areas (PSE359).

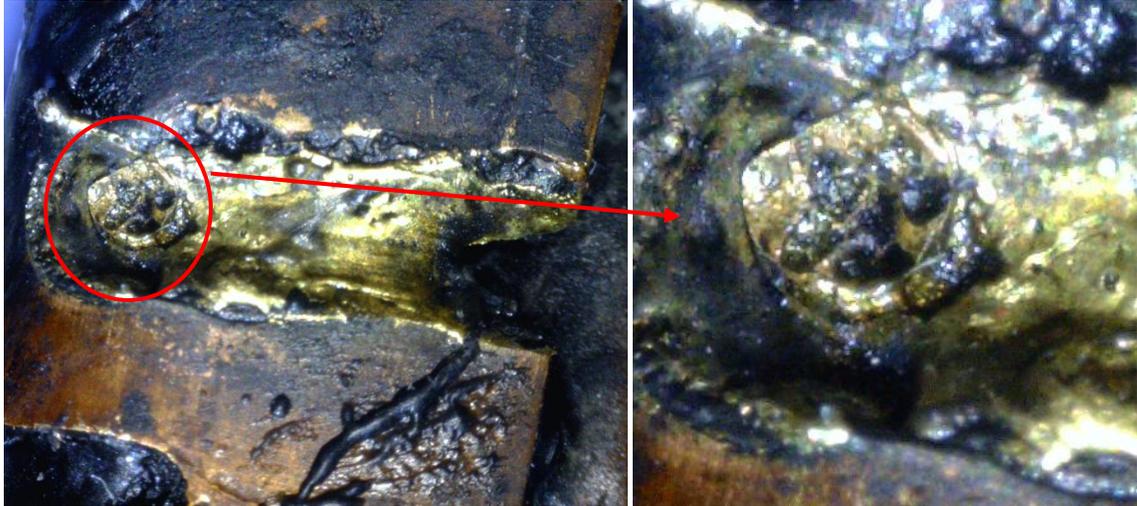
Figure 4-13. Arcing damage on brass plug contact showing large voids (LEV266).

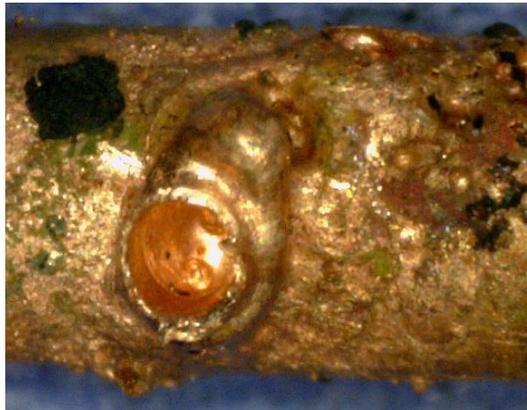
Figure 4-14. Arcing damage on solid copper wire with possible high internal porosity (LEV173).

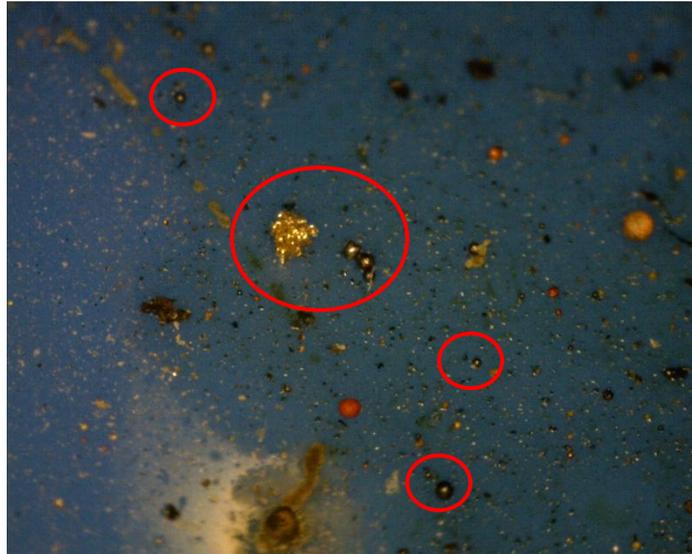
Figure 4-15. Spatter from arcing, deposited on PVC outlet box (LEV172).

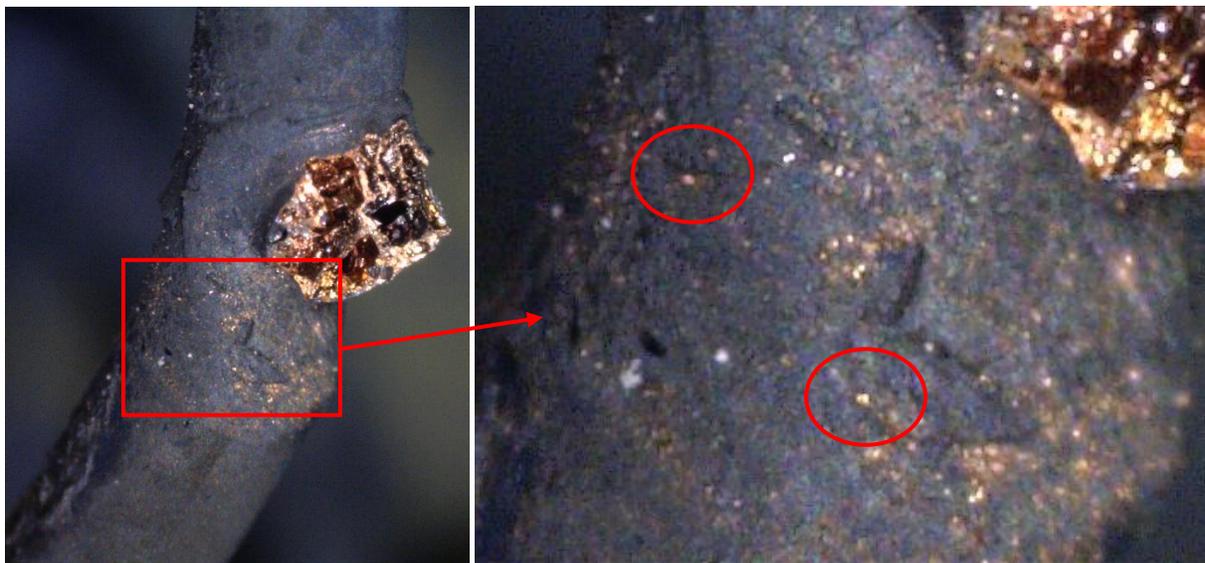
Figure 4-16. Possible spatter near arcing damage, circled (B020).

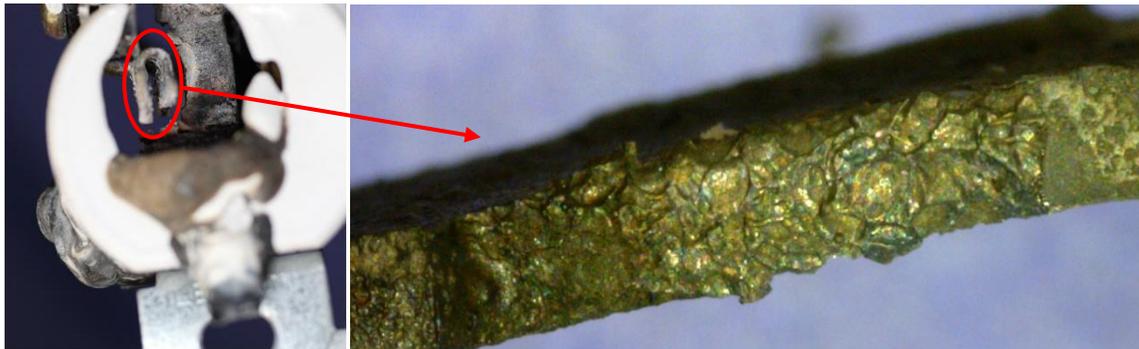
Figure 4-17. Small divots (and localized round depressions) on a grounding strap from a neutral to ground arc during receptacle failure (LEV008).

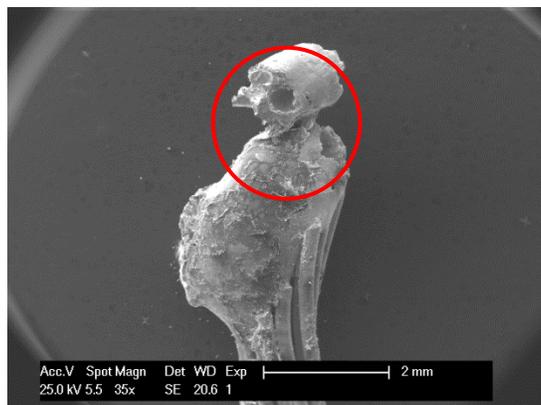
Figure 4-18. Localized round depressions on stranded copper wire for fire induced arcing (LEV318).

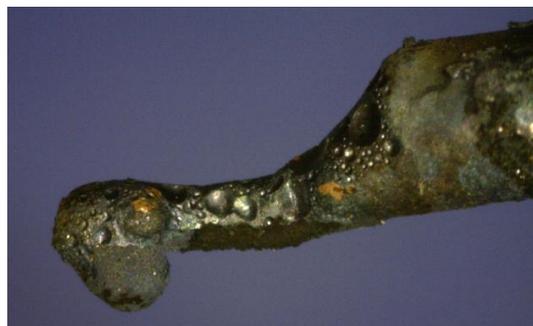
Figure 4-22. Pitting of copper wire due to fire-melting (LEV391).

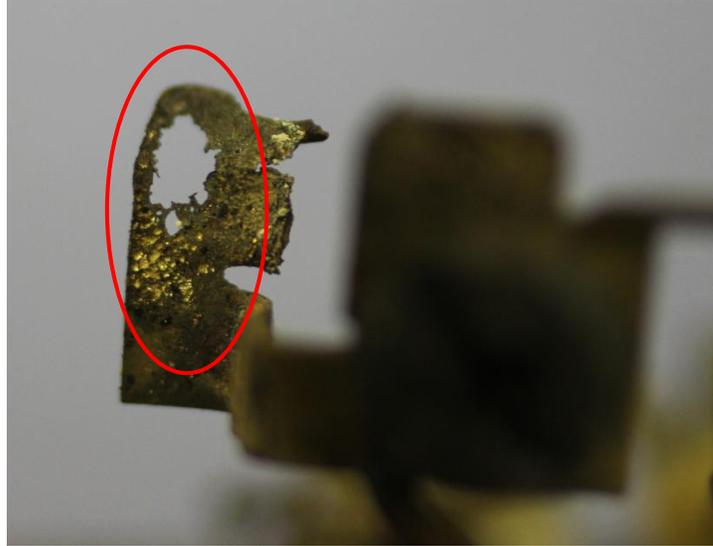
Figure 4-23. Pitting, thinning, and presence of holes on brass plug contacts due to fire-melting (LEV358).

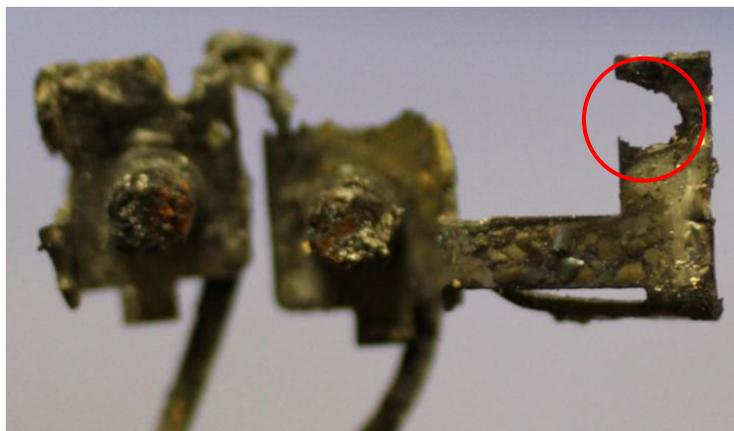
Figure 4-24. Holes formed on brass plug contacts due to fire-melting (PSE381).

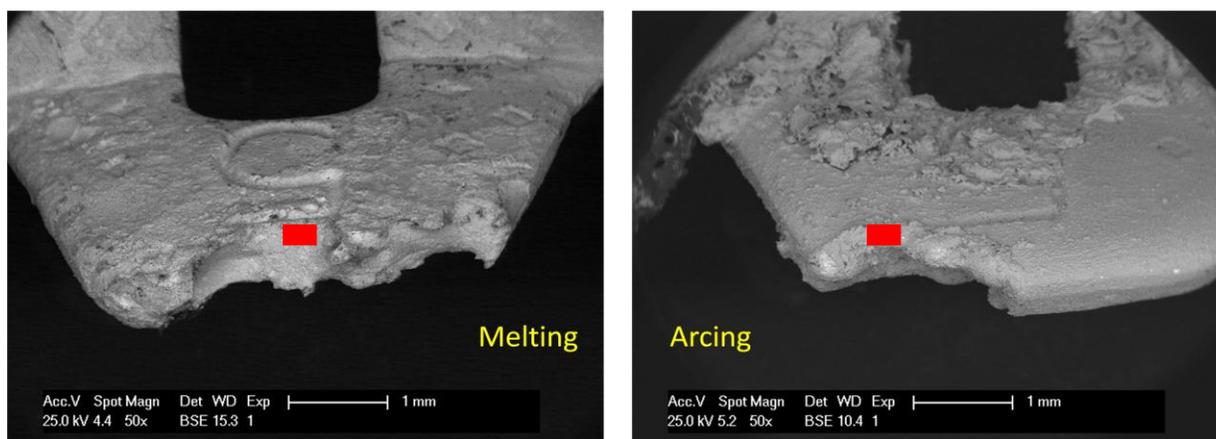
Figure 4-25. SEM images of break-off tabs from two PVC receptacles: PSE358 (left) and PSE323 (right) – EDS location noted by red box.

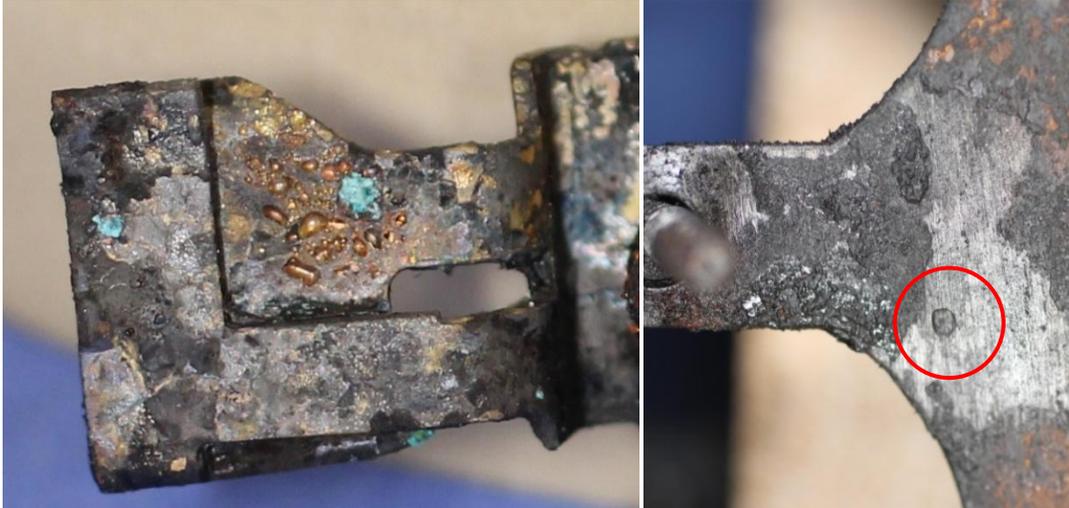
Figure 4-26. Surface pitting on brass contacts from PSE358 (left) and corresponding arcing damage on faceplate from PSE323 (right).

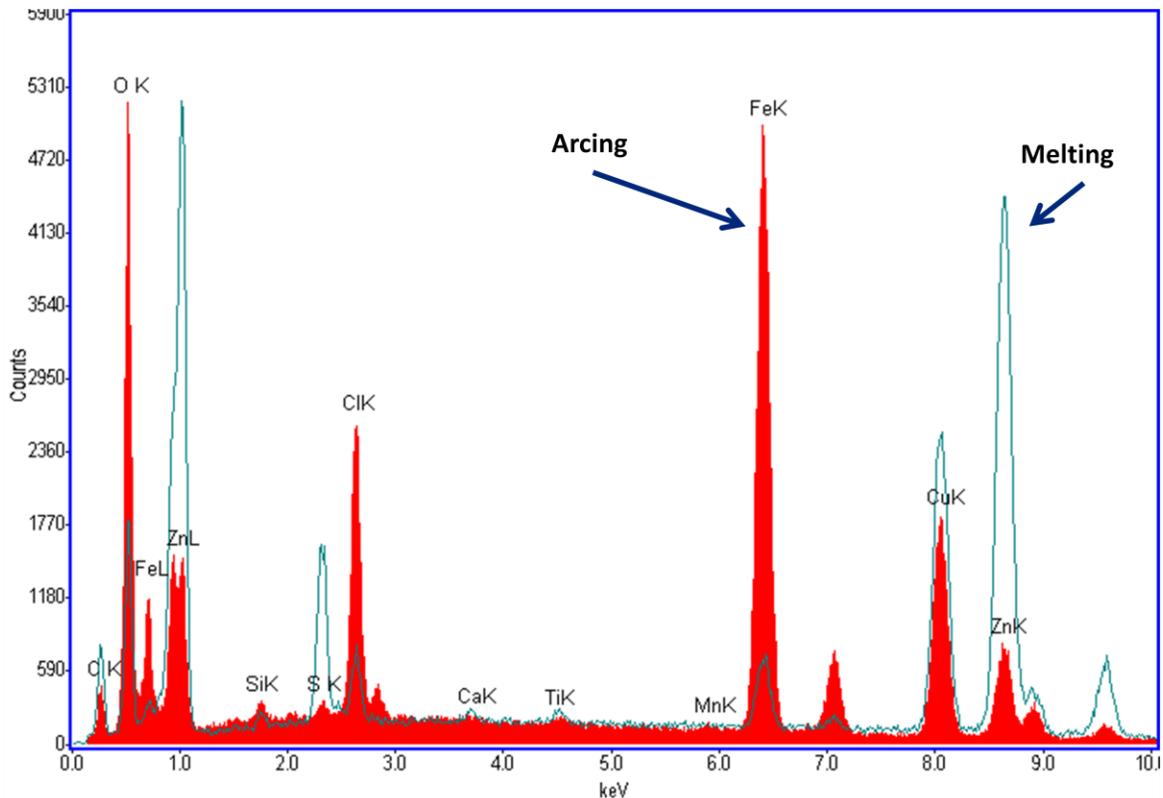
Figure 4-27. Overlaid EDS spectra for PSE358 (melting, outlined plot) and PSE323 (arcing, solid plot).

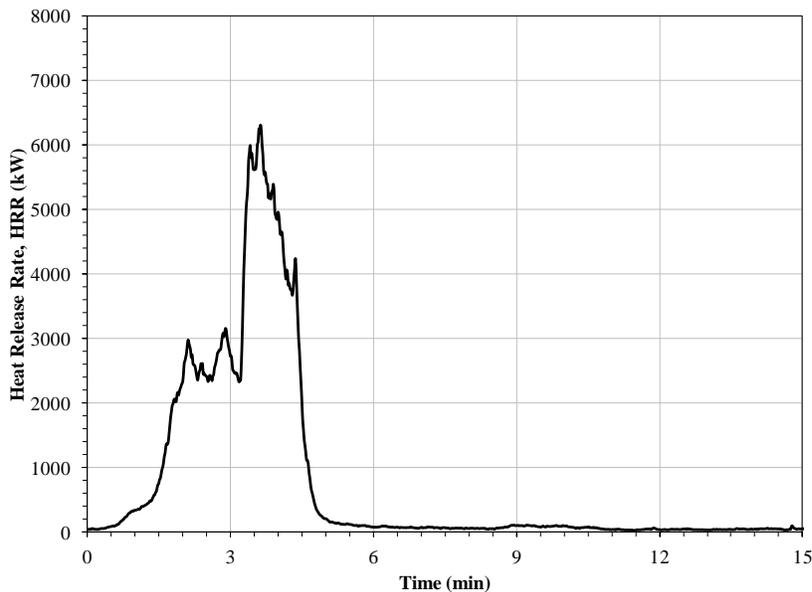
Figure B-1. Plot of Heat Release Rate (HRR) for compartment fire Test 1.

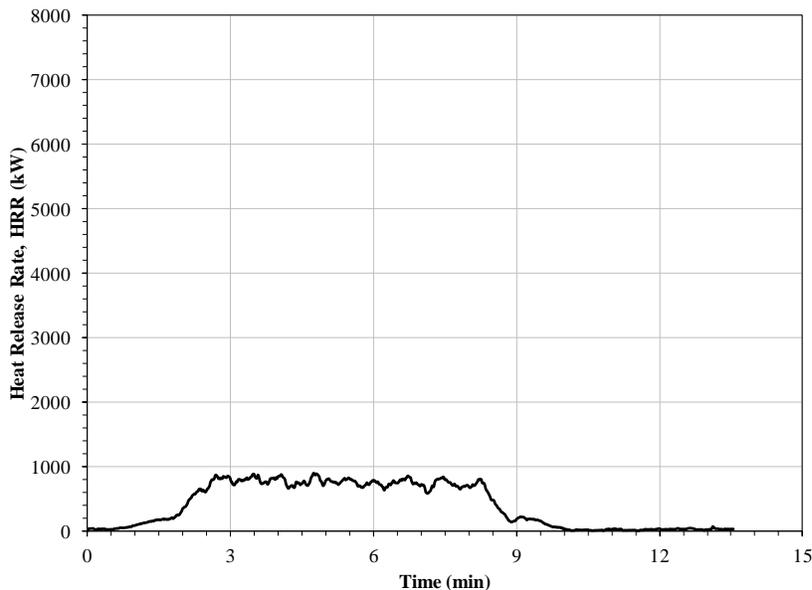
Figure B-4. Plot of Heat Release Rate (HRR) for compartment fire Test 2.

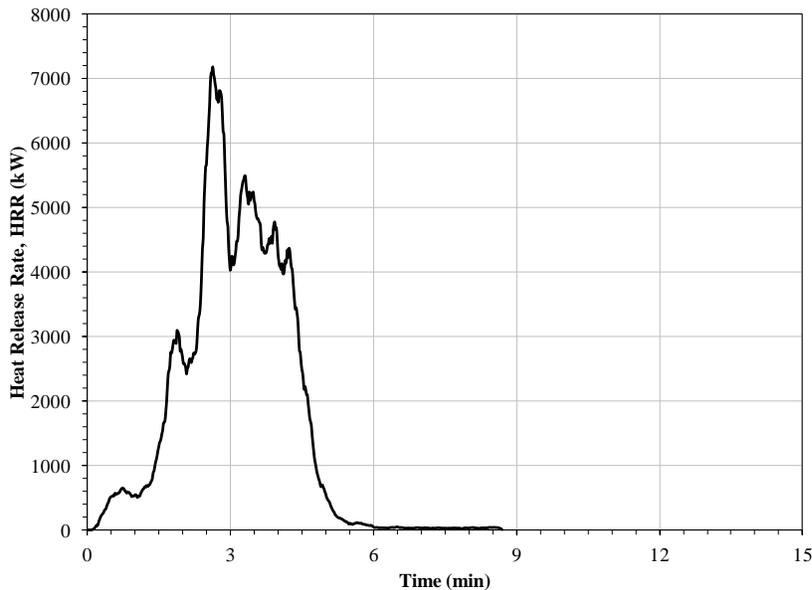
Figure B-7. Plot of Heat Release Rate (HRR) for compartment fire Test 3.

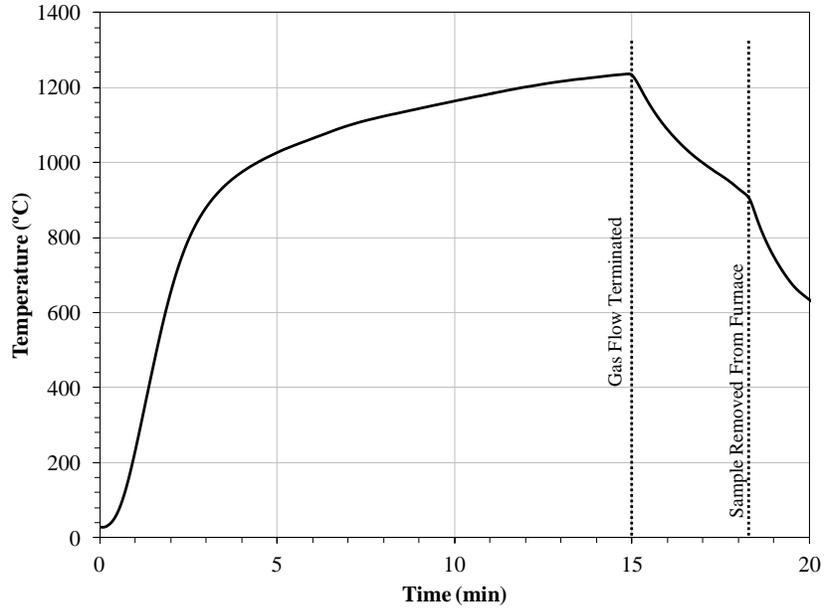
Figure C-6. Plot of average furnace temperature for furnace fire Test 4.

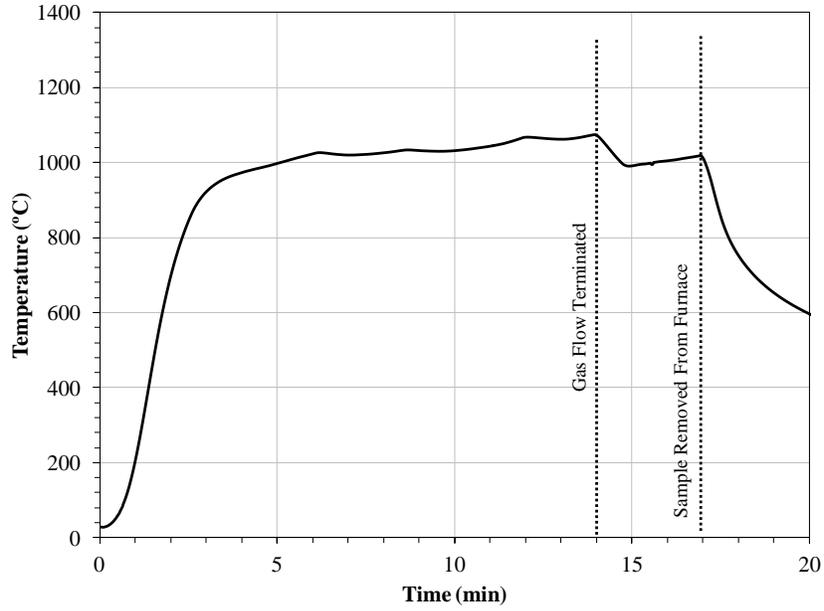
Figure C-8. Plot of average furnace temperature for furnace fire Test 5.

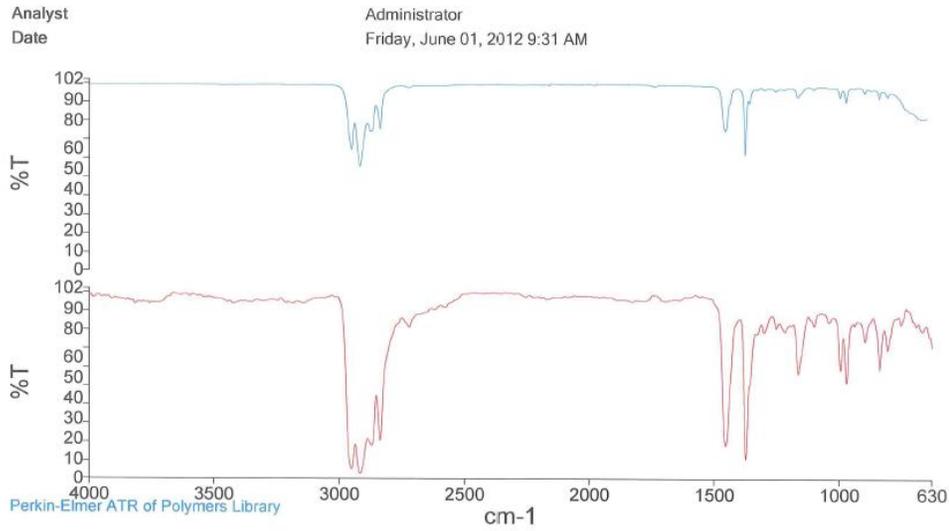
— LEV277-white LEV277 white body
— AP0065 POLYPROPYLENE, ISOTACTIC
