# NBS TECHNICAL NOTE 837

## Barrier Penetration Tests

Sixteen structural barrier panels were tested to determine their resistance to forcible penetration through the use of readily available tooling. Thirteen of these represented experimental techniques to reinforce an existing structural barrier of low penetration resistance; the other three were designs which would be most appropriate to consider as replacement barriers. Minimum man-passable sized openings were made in the barriers in working times which averaged 7.85 minutes and ranged from 1.52 to 25.56 minutes. One of the replacement and two of the reinforcing designs showed superior cost-effectiveness.

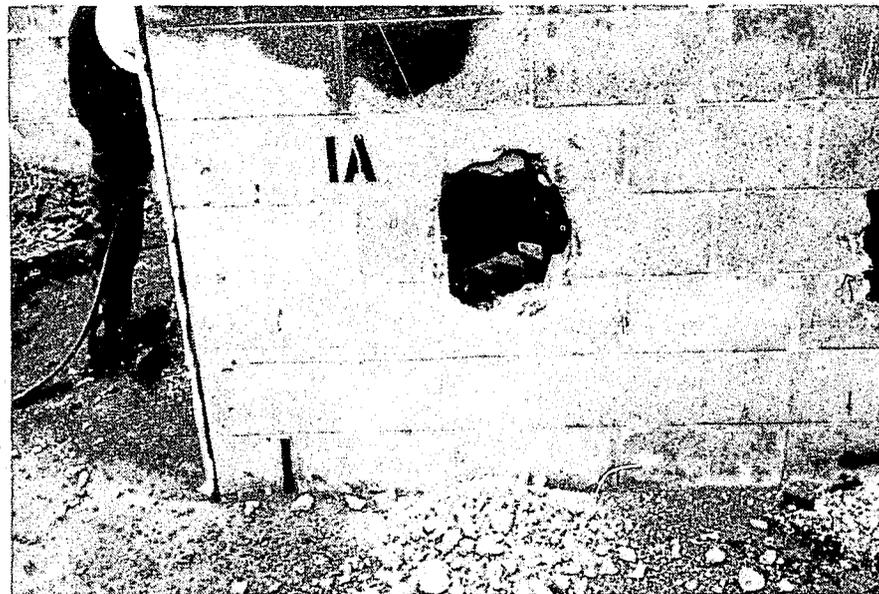
Figure 3. Opening Produced by Test 1A

and a number 5 cutting tip was employed. (Unless otherwise noted, these same gas pressures and tip size were used for all torch cuts in the test series.) The two cuts were made by a relatively inexperienced operator and required 1.41 minutes yielding a total working time of 3.84 minutes and elapsed time of 5.03 minutes for the penetration shown in figure 3. A more experienced torch operator then demonstrated that the section of reinforcing bar removed from the opening could be cut in only 19 seconds. It appears reasonable to expect that this operator could have completed the penetration in a total working time of only 3.06 minutes.

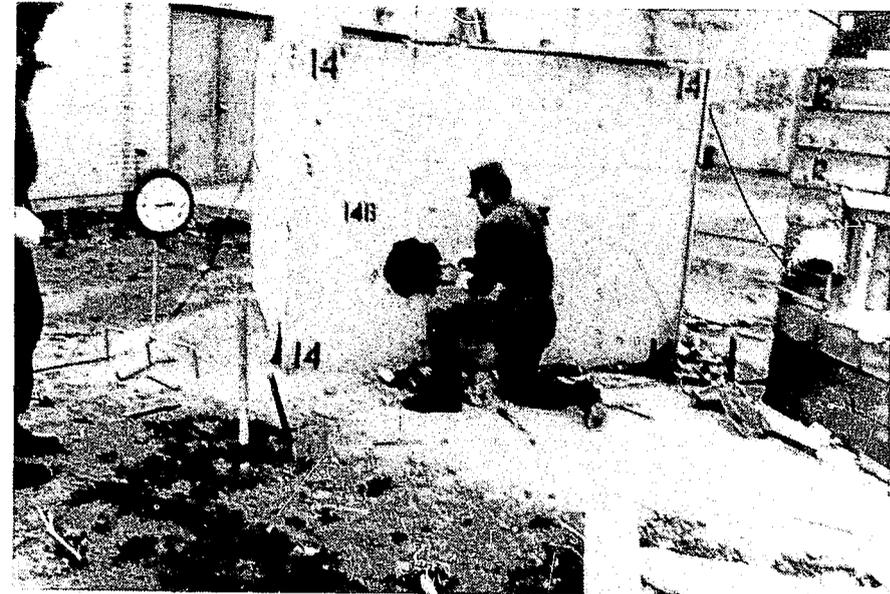
Figure 130. Cutting Reinforcing Rod with Bolt Cutters; Test 14B

Finally, as shown in figure 130, the reinforcing rod was cut with 3/8" bolt cutters in 0.74 minute. The 16 cuts required an average time of 2.74 seconds each. The total working time on this test was 9.75 minutes and the elapsed time was 12.24 minutes.
