SHORT TAKE OFF - LANDING
FIXED WING, ROTARY WING
COST EFFECTIVENESS
STUDY

Final Report

LEAA # 71 - DF - 1119

Los Angeles County
SHERIFF'S DEPARTMENT
PETER J. PITCHES, Sheriff

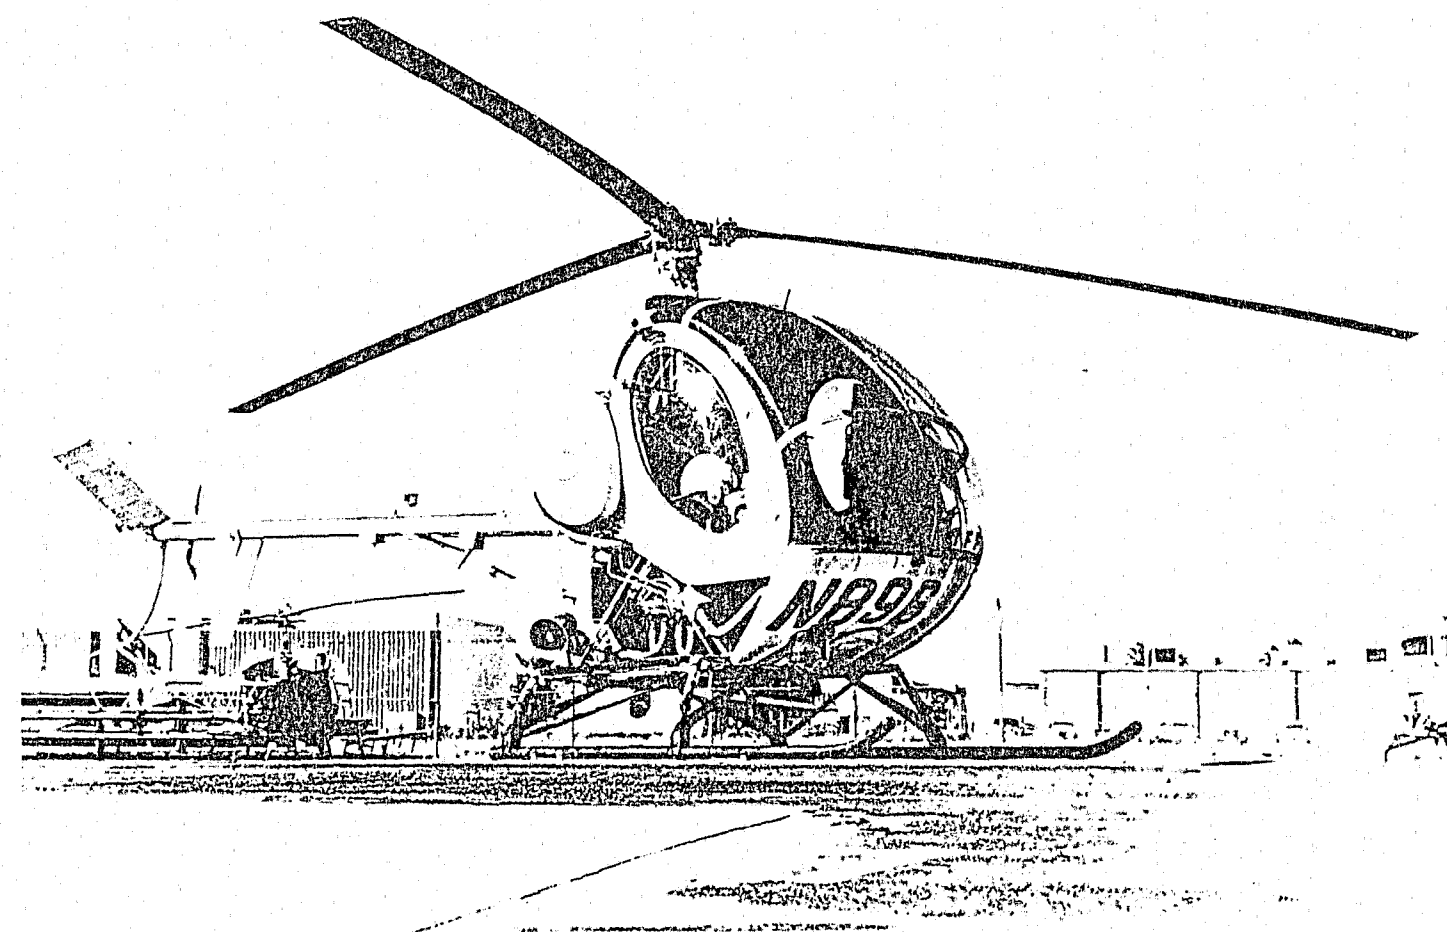
THE HUGHES 300-C HELICOPTER

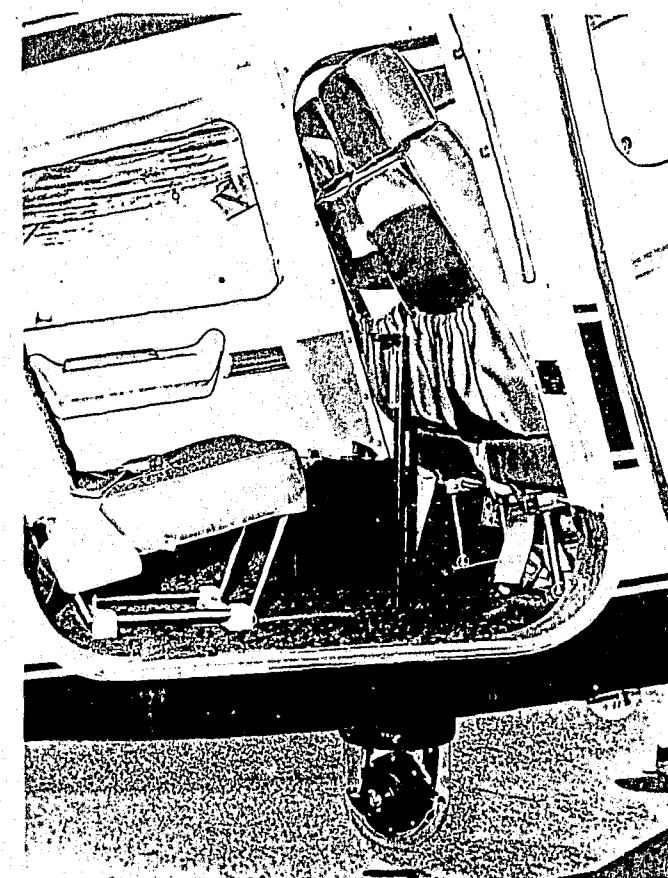
THE NIGHT ILLUMINATION DEVICE AND
CONTROL STICK INSTALLATION IN THE HELIO COURIER

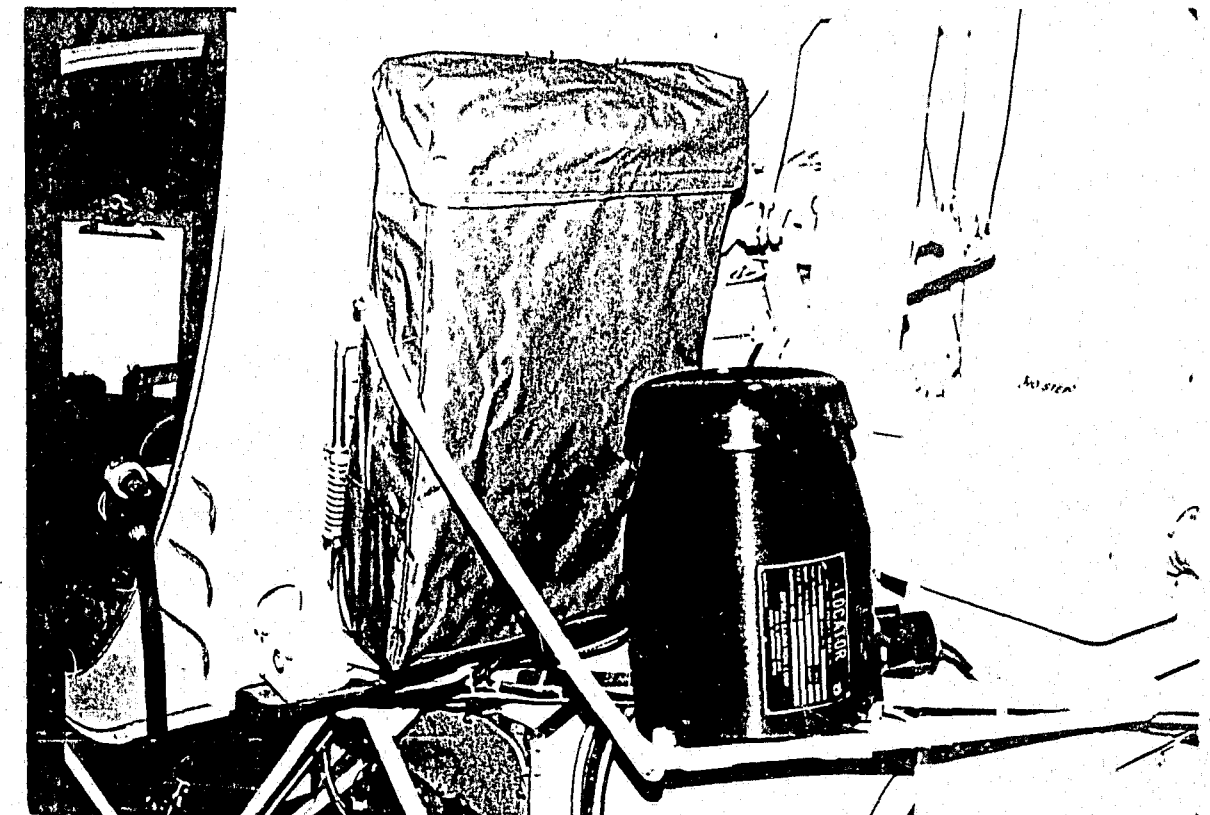
INSTALLATION OF THE DOME-SHAPED POWER PACK FOR THE
NIGHT ILLUMINATION DEVICE ON THE HUGHES 300 C HELICOPTER.
