Document Title: Fire Dynamics and Forensic Analysis of Limited Ventilation Compartment Fires Volume 1: Experimental

Author: Andrew J. Wolfe, Christopher L. Mealy, Daniel T. Gottuk

**Fire Dynamics and Forensic Analysis of Limited
Ventilation Compartment Fires
Volume 1: Experimental**

Hughes Associates, Inc.
3610 Commerce Drive, Suite 817
Baltimore, Maryland 21227
Ph. 410-737-8677
Fax 410-737-8688

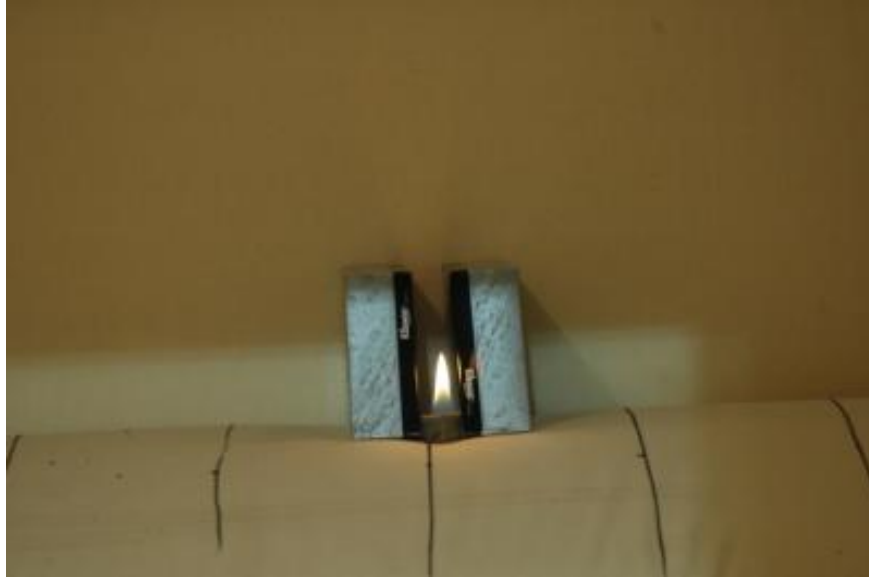
Figure 3-5. Accidental flaming ignition scenario setup

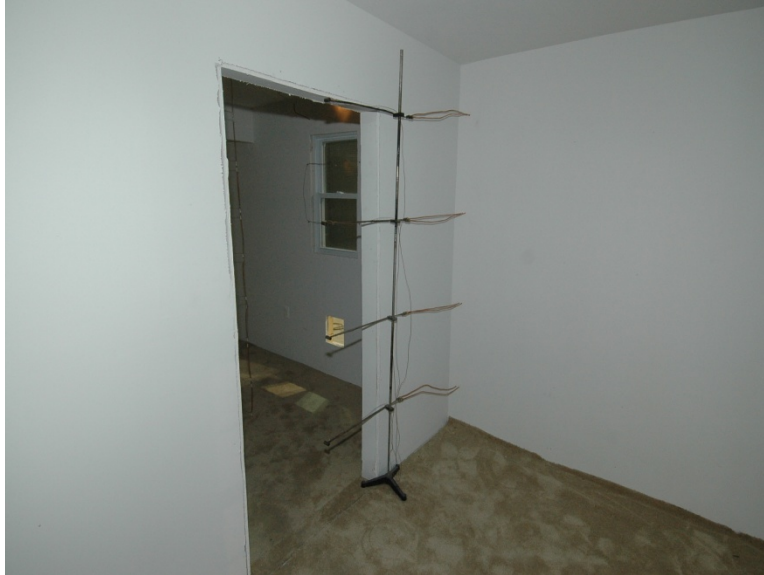
Four velocity probes were located in the opening between the DR and BR, 1.37 m (4 ft 6 in) from Wall 2. These four probes were at elevations of 0.51 m (1 ft 8 in), 1.02 m (3 ft 4 in), 1.52 m (5 ft), and 2.01 m (6 ft 7 in) as seen in Figure 4-7. An additional velocity probe was located in the bedroom window during ventilated conditions, 1.26 m (4 ft 1.5 in) from Wall 2. The elevation of this probe was 1.35 m (4 ft 5 in) during full open window ventilation, and 1.24 m (4 ft 1 in) during half open window and no window ventilation (see Figure 4-8).

Figure 4-7. BR door velocity probes

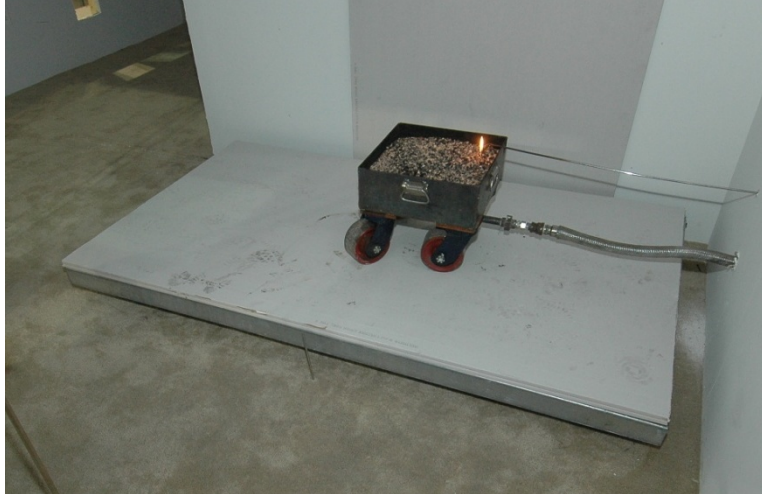
Figure 4-12. Mass loss frame in place during burner test

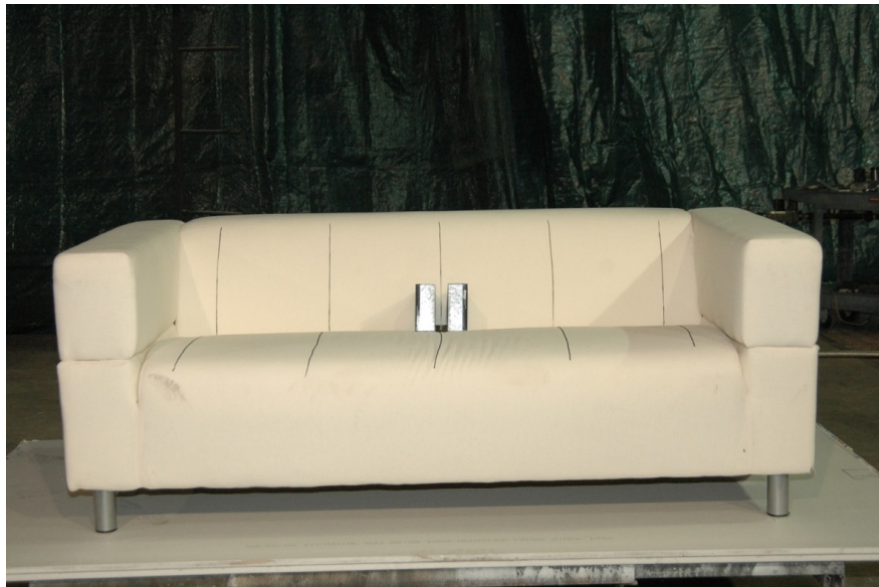
For test CAL1, the sofa was placed on two sheets of 0.012 m (0.5 in) GWB, which was placed on top of the load cell (no frame). The ignition scenario used was the accidental flaming ignition scenario. Figure 5-1 shows the calorimetry setup. The sofa was ignited and allowed to burn to complete consumption. This test was performed twice to assess repeatability of results.

Figure 5-1. Test CAL1 setup

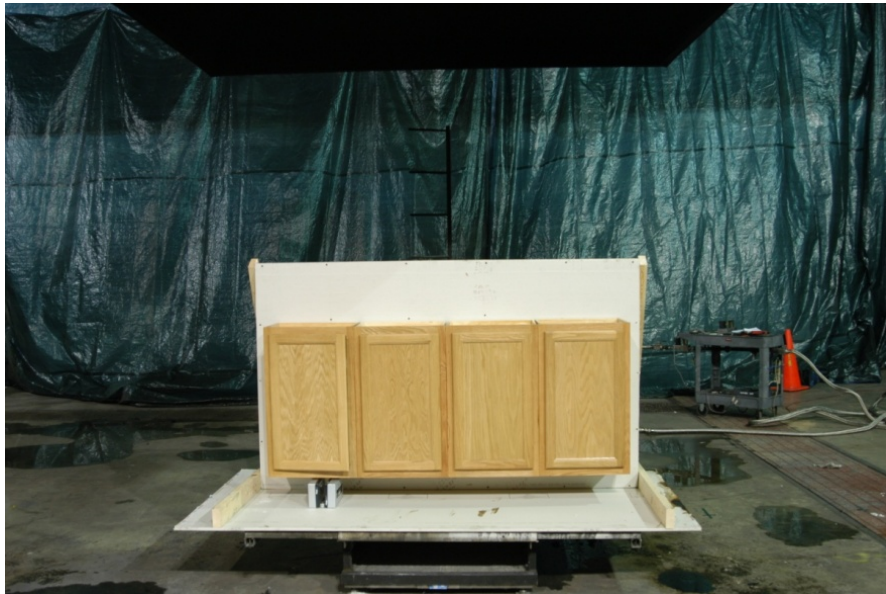
For tests CAL2, the array of four cabinets were hung on a 2.44 m (8 ft) by 1.22 m (4 ft) wall that had the same construction as the interior walls of the enclosure (see Figure 5-2). The assembly was placed on top of the load cell. The two leftmost cabinets were loaded as described in Section 3.4.2. The ignition was performed using the accidental flaming ignition scenario. The cabinets were allowed to burn to complete consumption. This test was performed twice.

Figure 5-2. Test CAL2 setup

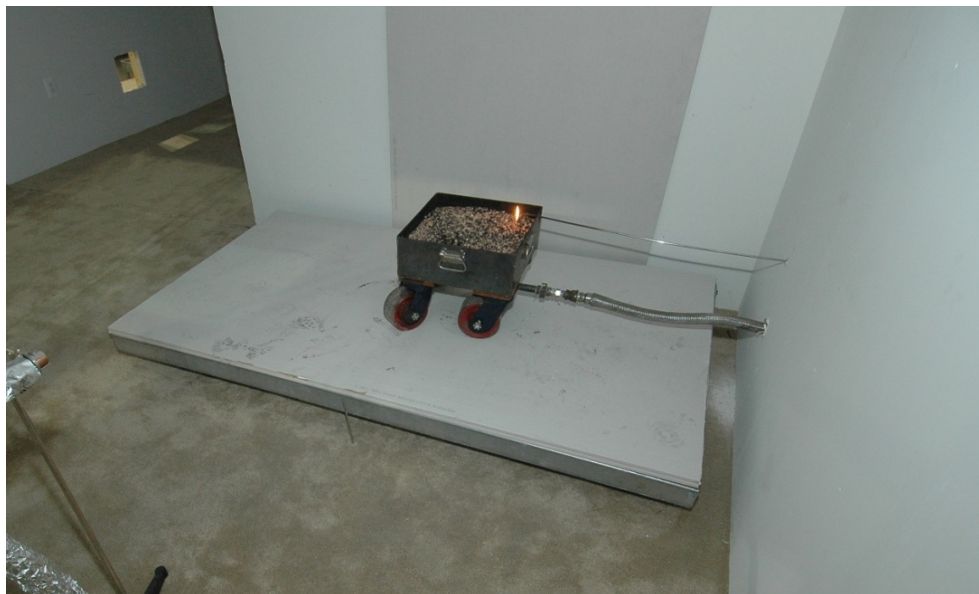
Burner tests were performed inside the enclosure to check the operation of instrumentation and to determine baseline fire behavior inside the enclosure for a well-characterized source. The fire in these tests was provided by a 0.41 m (16 in) by 0.41 m (16 in) sand burner with natural gas fuel. The fire size was 125 kW and was controlled by an Alicat Scientific Model MCR-1000S2PM-D mass flow controller that was in-line with the natural gas supply line. The uncertainty of the flow controller was $\pm 0.8\%$ of the reading. Ignition of the burner was achieved by a propane pilot flame. The pilot was ignited with the natural gas mass flow controller secured. After the pilot was ignited and the compartment sealed, the mass flow controller was turned on and the 125 kW flame was verified. The burner was placed in the LR where the sofa would be placed during fire tests (see Figure 5-6). The burner was turned off after 10 minutes, and the test was ended 2 minutes later, for a total duration of 12 minutes. Two burner tests were performed. One test (B1) was performed with no ventilation, the other with full open window ventilation (test B2).

Figure 5-6. Burner placement for tests B1 and B2

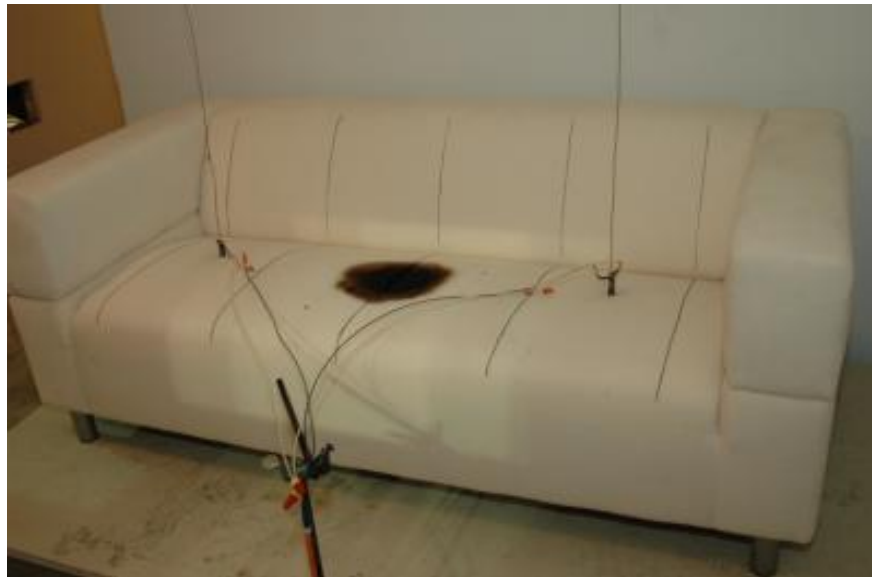
Similar to test SM2, test SM3 was designed to simulate a smoldering sofa fire. This test used the smoldering ignition scenario and no ventilation. The sofa was placed on the load cell setup in the living room (see Figure 5-15). In this test, two cartridge heaters were used, positioned in 0.01 m (0.4 in) diameter holes located 0.25 m (10 in) from the back of the seat and 0.25 m (10 in) from either armrest. The cartridge heaters were tied to the ceiling in this test to prevent the heaters from dropping through the sofa as the foam pyrolyzed. Two cartridge heaters were used to attempt to get a larger portion of the sofa involved in the smoldering process than had occurred in SM2. The door and windows were all closed prior to beginning the test. The cartridge heater power source was located outside of the enclosure. To initiate the test, both cartridge heaters were powered on. The cartridge heaters were left on for the duration of the test to ensure continued smoldering. Visible smoke was observed coming from the sofa after approximately 3 minutes. The test was allowed to continue until visible smoke production ceased, a duration of 126 minutes.

Figure 5-15. Test SM3 setup with damage from SM2 in the center.

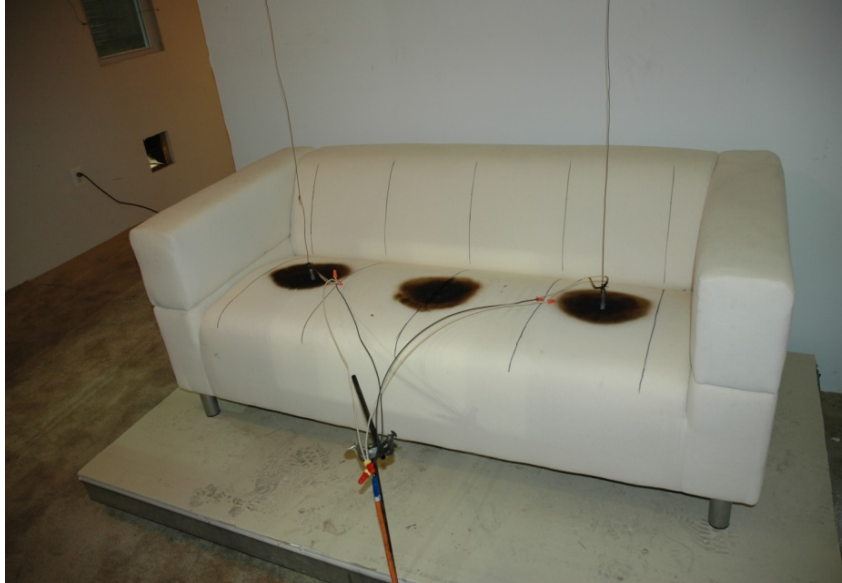
The temperatures in this test did not rise above 29 °C. During the test, there was no measurable change in any gas concentration. In addition, there was no measurable mass loss. An approximately 0.24 m (9.5 in) diameter area surrounding each of the cartridge heaters sustained charring to the cover and foam (see Figure 5-16, Figure 5-17). None of the material was completely consumed.

Figure 5-16. Test SM3 damage (the center char area is from test SM2)

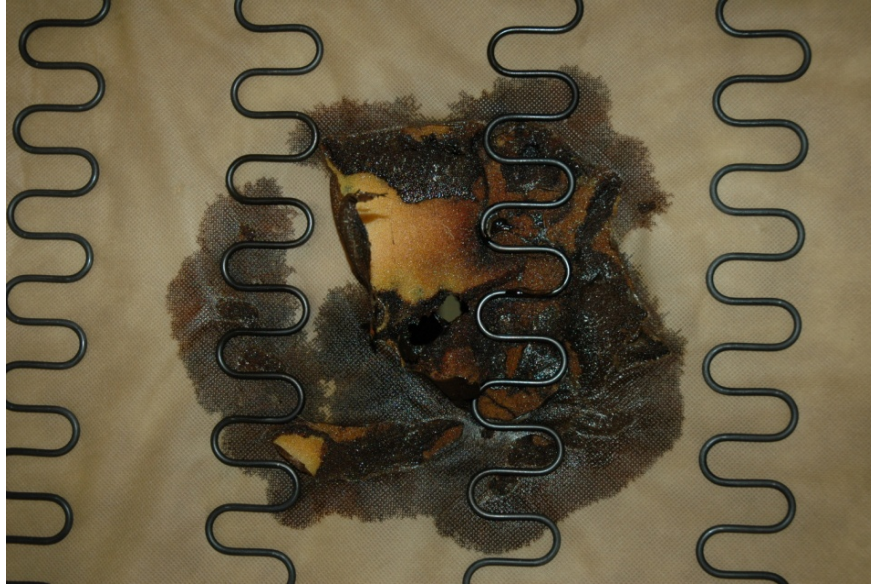
Figure 5-18. Close-up view of damage to underside of sofa seat caused in SM2, SM3

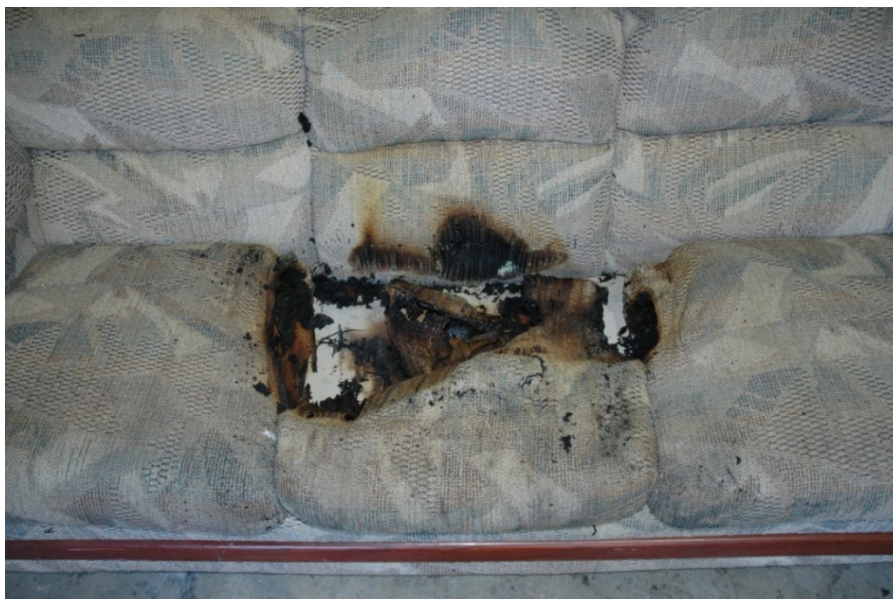
The temperatures in this test did not rise above 29°C. During the test, there was no measurable change in oxygen or CO₂ concentrations. CO concentrations reached a maximum of 0.075%. This test was run chronologically between two cabinet tests, and due to this, the load cell was installed in the kitchen. Therefore, the cushions were removed and weighted before and after the test using the scale from test SM1 to determine the total mass loss over the duration of the test. The original mass of the bottom seat cushions was 5.63 kg. The total mass loss was 1.09 kg, approximately 19% of the total mass. Mass lost from the attached seat cushions was not measurable; however, the mass lost appeared to be negligible compared to the mass lost from the bottom seat cushions (see Figure 5-21). Approximately half of the center cushion was completely consumed. Charring and some consumption of material were present on the sides of the outer cushions and back of the sofa.

Figure 5-21. Test SM4 damage

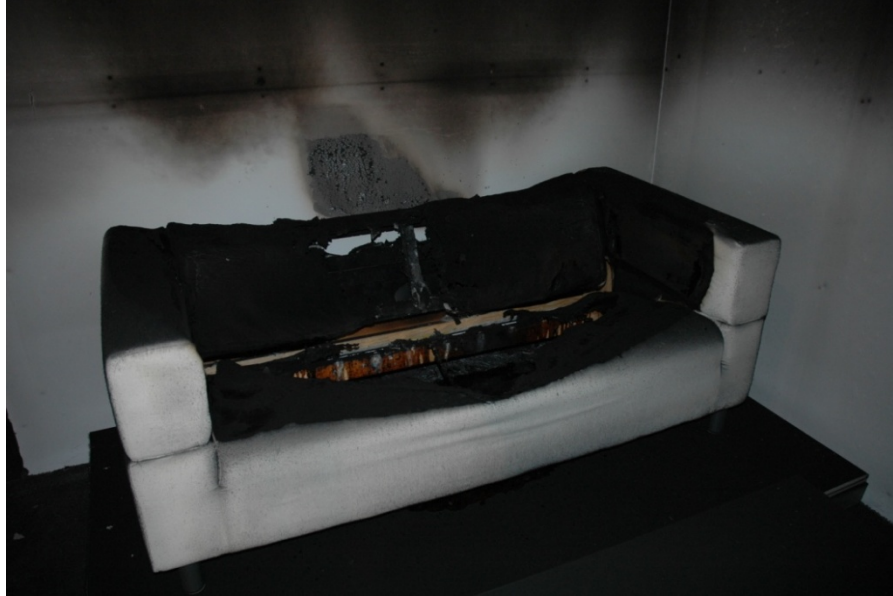
Data from this test is presented in Figure 5-24. The peak temperature reached during this test was 286°C in the living room. The oxygen concentration at 2.41 m (7 ft 11 in) dropped to a minimum value of 13.6%. The peak CO concentration was 0.4%. The peak CO₂ concentration was 4.5%. The initial mass of the sofa was 49.77 kg. During the test, the total mass loss was 5.80 kg, approximately 12% of the initial mass. The maximum heat release rate calculated during this test was 353 kW. The fire burned away a section of the seat and back approximately 3 ft wide. The remainder of the seat and back were heavily charred but still intact (see Figure 5-23).

Figure 5-23. Test S1 damage

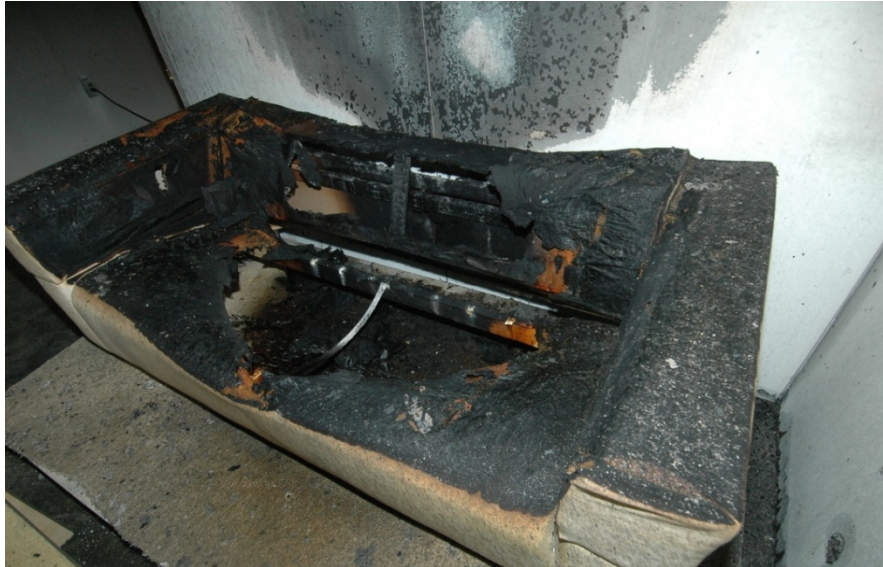
Data from this test is presented in Figure 5-26. Before suppression, the peak temperature reached during this test was 638°C. Oxygen concentration at 2.41 m (7 ft 11 in) dropped to a minimum value of 4.8%. The peak CO concentration was 3.7%. The peak CO₂ concentration was 12.9%. The initial mass of the sofa was 49.64 kg. During the test, the total mass loss was 5.1 kg, approximately 11% of the initial mass. The maximum heat release rate calculated during this test was 1.03 MW, which occurred just before suppression. The choice to suppress the fire was made due to rapidly increasing temperatures and flaming across the ceiling which was visible through the wall 1 window. A majority of the material was burned away on the sofa seat, back and interior of the armrests (see Figure 5-25).

Figure 5-25. Test S2 damage

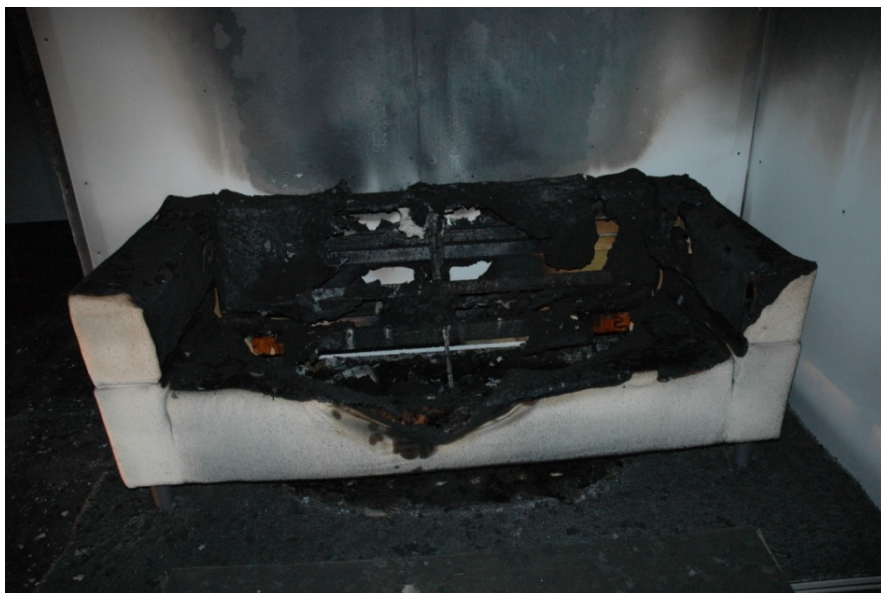
The data from this test is presented in Figure 5-28. The peak temperature reached during this test was 630°C. Oxygen concentration at 2.41 m (7 ft 11 in) dropped to a minimum value of 3.4%. The peak CO concentration was 5.5%. The peak CO₂ concentration was 14.3%. The initial mass of the sofa was 49.80 kg. During the test, the total mass loss was 6.75 kg, approximately 14% of the initial mass. The maximum heat release rate calculated during this test was 862 kW. A majority of the material was burned away on the sofa seat, back and interior of the armrests. Also, the center of the front portion had begun to burn away and the wooden frame had begun to char along the back of the sofa (see Figure 5-27).

Figure 5-27. Test S3 damage

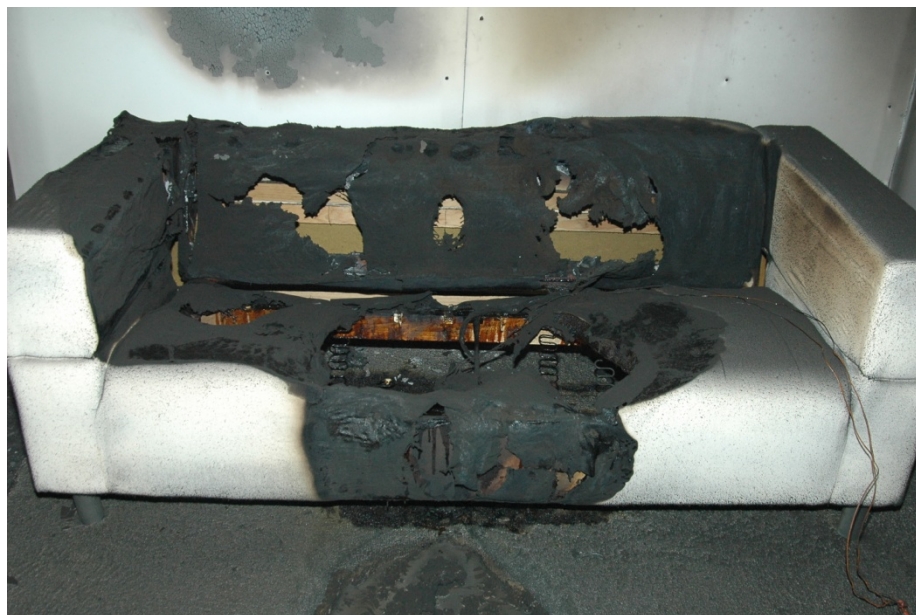
The data from this test is displayed in Figure 5-30. The peak temperature reached during this test was 345°C. Oxygen concentration at 2.41 m (7 ft 11 in) dropped to a minimum value of 16.3%. The peak CO concentration was 0.3%. The peak CO₂ concentration was 3.7%. The initial mass of the sofa was 49.45 kg. During the test, the total mass loss was 3.99 kg, approximately 8% of the initial mass. The maximum heat release rate calculated during this test was 300 kW. The front face and center of the couch where the gasoline had been poured were burned away. The remainder of the seat and back were charred, but not burned away. The most severe charring occurred on the side of the sofa closest to the dining room, and only the inner armrest on that side of the sofa was charred, with the other armrest relatively unchanged aside from soot deposition (see Figure 5-29).

Figure 5-29. Test S4 damage

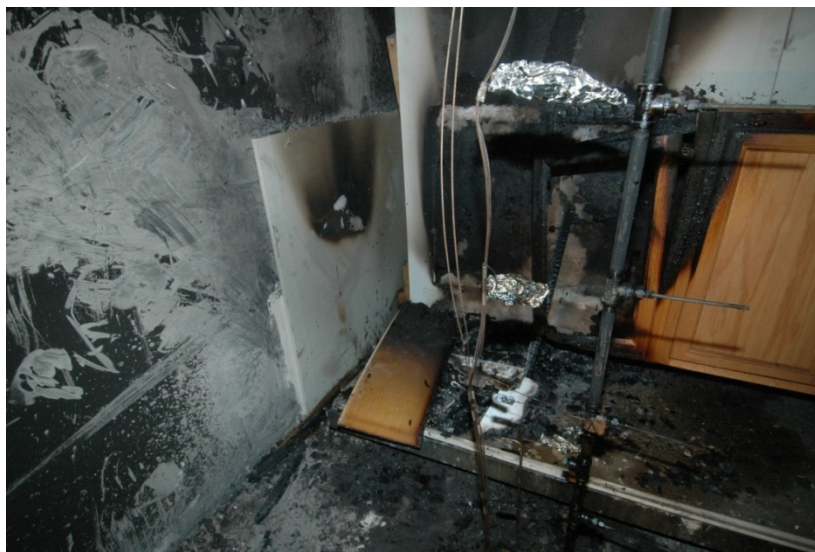
The data for this test is presented in Figure 5-34. The peak temperature reached during this test was 806°C. Oxygen concentration at 2.41 m (7 ft 11 in) dropped to a minimum value of 1.4%. The peak CO concentration was 1.8%. The peak CO₂ concentration was 17.2%. The initial mass of the cabinets was 53.84 kg. During the test, the total mass loss was 30.42 kg, approximately 57% of the initial mass. The maximum heat release rate calculated during this test was 599 kW. The entire first cabinet was consumed, as well as all of the second cabinet except the right side and some of the front frame. There was some charring to the front face of the third cabinet and little damage fourth cabinet

Figure 5-33. Test CL1 damage – low cabinets with no ventilation.

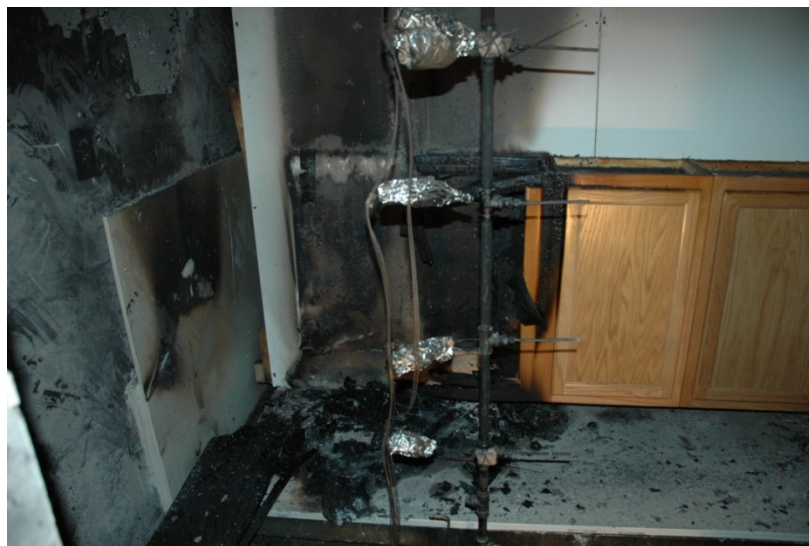
The data for this test is presented in Figure 5-36. The peak temperature reached during this test was 785°C. Oxygen concentration at 2.41 m (7 ft 11 in) dropped to a minimum value of 2.5%. The peak CO concentration was 2.2%. The peak CO₂ concentration was 17.1%. The initial mass of the cabinets was 53.66 kg. During the test, the total mass loss was 30.95 kg, approximately 58% of the initial mass. The maximum heat release rate observed during this test was 595 kW. The majority of the first and second cabinets were completely consumed. Additionally, there was charring present on the top and left side of the front face of cabinet three. There was little damage to the fourth cabinet (see Figure 5-35).

Figure 5-35. Test CL2 damage – low cabinets with half open window

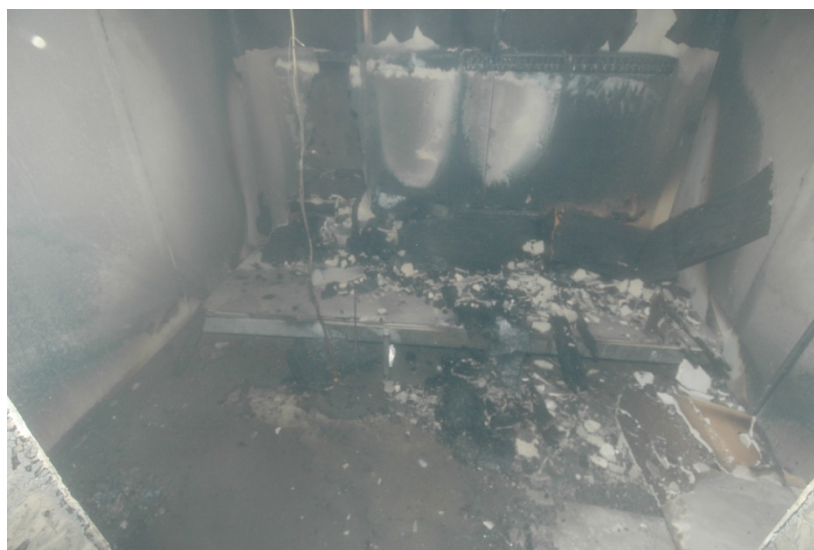
The data for this test is presented in Figure 5-38. The peak temperature reached during this test was 727°C. Oxygen concentration at 2.41 m (7 ft 11 in) dropped to a minimum value of 5.8%. The peak CO concentration was 0.5%. The peak CO₂ concentration was 13.0%. The initial mass of the cabinets was 53.41 kg. During the test, the total mass loss was 49.87 kg, approximately 93% of the initial mass. The maximum heat release rate calculated during this test was 984 kW. Due to falling debris, the heat release rate data had a few false readings, most notably at 19.05 and 27.50 minutes. The majority of all of the cabinets were consumed during this test (see Figure 5-37).

Figure 5-37. Test CL3 damage – Low Cabinets with Open Door

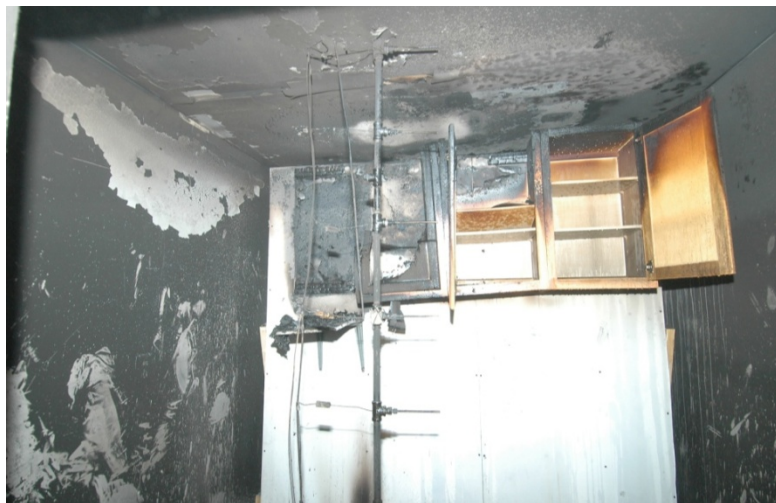
The data for this test is presented in Figure 5-42. The peak temperature reached during this test was 425°C. Oxygen concentration at 2.41 m (7 ft 11 in) dropped to a minimum value of 0.3%. The peak CO concentration was 9.0%. The peak CO₂ concentration was 19.0%. The initial mass of the cabinets was 55.73 kg. During the test, the total mass loss was 28.77 kg, approximately 52% of the initial mass. The maximum heat release rate calculated during this test was 662 kW. The first was completely consumed during this test. The majority of the frame of the second cabinet was also consumed. In addition, the top half of the third cabinet was consumed and there was substantial charring both inside and out. There was also some charring on the top of the fourth cabinet (see Figure 5-41).

Figure 5-41. Test CH1 damage – high cabinets with no ventilation

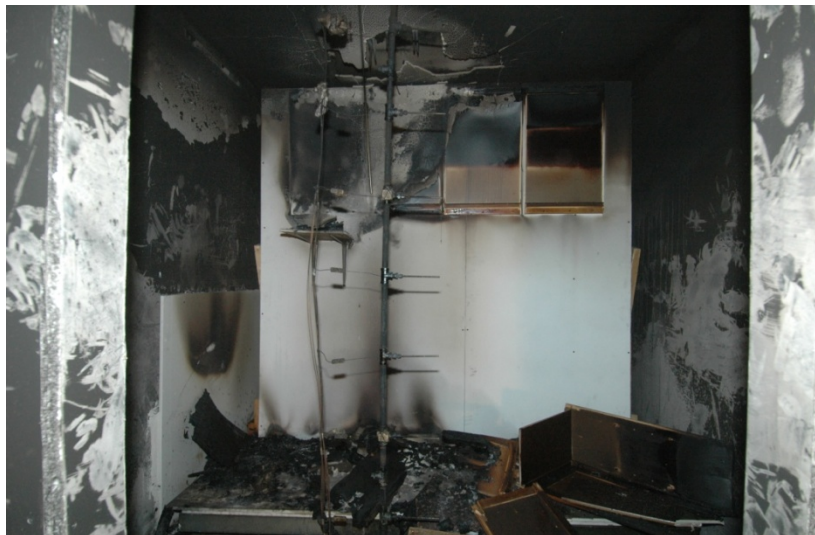
The data for this test is presented in Figure 5-44. The peak temperature reached during this test was 563°C. Oxygen concentration at 2.41 m (7 ft 11 in) dropped to a minimum value of 1.3%. The peak CO concentration was 7.9%. The peak CO₂ concentration was 17.6%. The initial mass of the cabinets was 55.45 kg. During the test, the total mass loss was 40.94 kg, approximately 74% of the initial mass. The maximum heat release rate calculated during this test was 657 kW. The first three cabinets were consumed during the test. The fourth cabinet fell off of the wall sometime during the test. The top frame of the fourth cabinet was consumed, and there was severe charring throughout the rest of the cabinet (see Figure 5-43).

Figure 5-43. Test CH2 damage – high cabinets with half open window

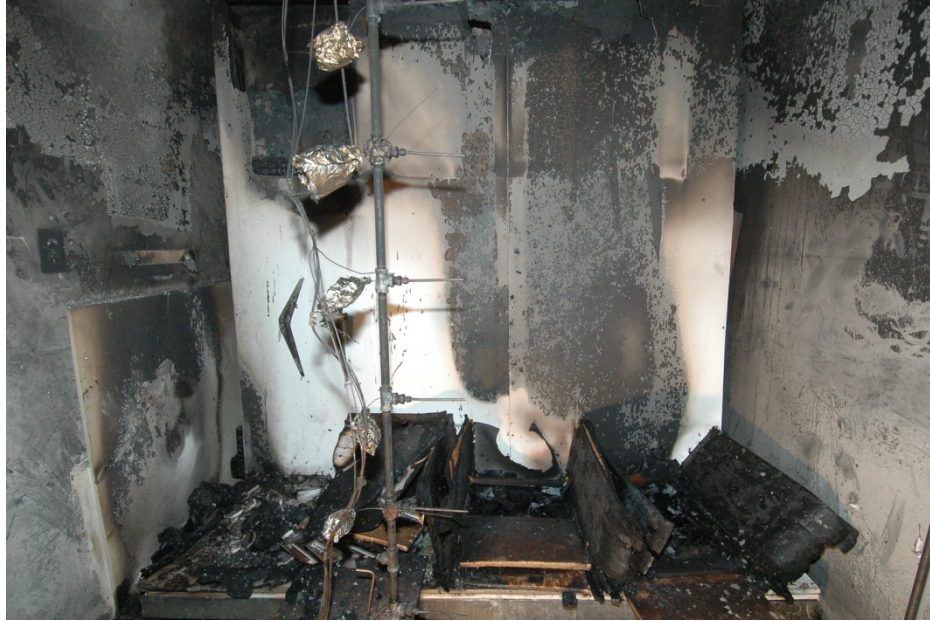
The data for this test is presented in Figure 5-46. The peak temperature reached during this test was 718° C. Oxygen concentration at 2.41 m (7 ft 11 in) dropped to a minimum value of 5.1%. The peak CO concentration reached was 1.6%. The peak CO₂ concentration was 13.1%. The initial mass of the cabinets was 54.07 kg. During the test, the total mass loss was 29.75 kg, approximately 55% of the initial mass. The maximum heat release rate calculated during this test was 469 kW. The first cabinet and the majority of the second cabinet were consumed during the test. The frame of the third and fourth cabinets remained mostly intact, but had substantial charring throughout (see Figure 5-45). After the cabinets fell at about 30 minutes, the fire started to grow on the floor as the cabinets had fallen from a vitiated upper layer to the lower layer with higher oxygen concentrations. All analyses in this study only consider events up until the time when the cabinets fell so as to consider the effects of the cabinets being high in the space. The fact that the third and fourth cabinets fell early in their involvement was an artifact of the test installation. Due to prior test damage to the wood studs of the false wall that the cabinets were installed to, the screws prematurely pulled out of the studs during the CH3 fire.

Figure 5-45. Test CH3 damage – high cabinets with no bedroom window

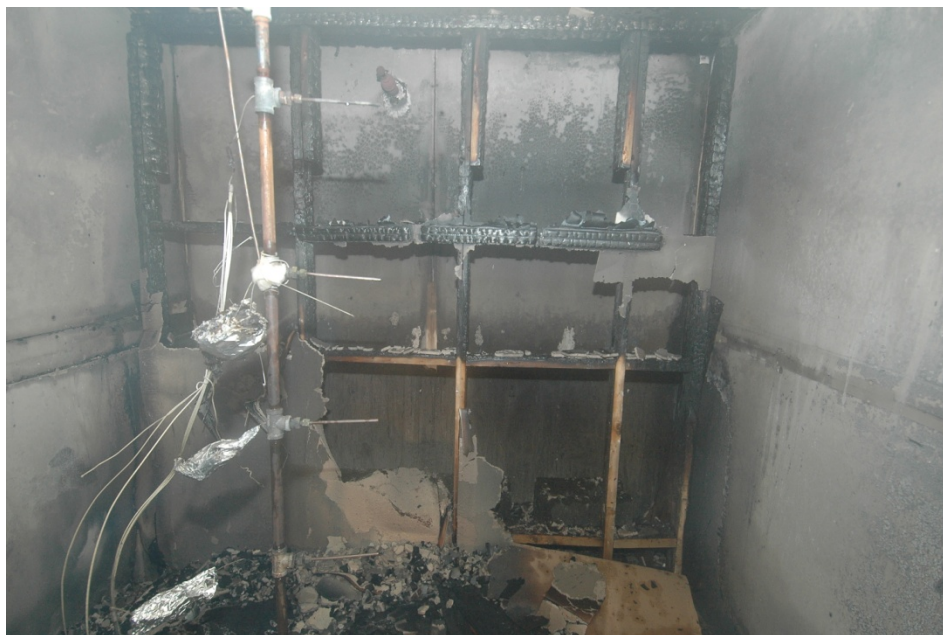
The data for this test is presented in Figure 5-48. The peak temperature reached during this test was 829°C. Oxygen concentration at 2.41 m (7 ft 11 in) dropped to a minimum value of 0.2%. The peak CO concentration was 8.9%. The peak CO₂ concentration was 17.9%. The initial mass of the cabinets was 57.93 kg. During the test, the total mass loss was 48.45 kg, approximately 84% of the initial mass. This mass loss only represents the part of the test before the cabinets fell off of the wall, since the test was allowed to continue after the cabinets fell. The parts of the cabinet that fell off of the wall continued to burn on the platform. The maximum heat release rate calculated during this test was 1.1 MW. Due to falling debris, the heat release rate data has several false readings, most notably at 19.8, 26.17, 27.02, and 31 minutes. The majority of the cabinets were consumed; the rest, with most of the GWB from the false wall, were left on the base of the load cell stand (see Figure 5-47).

Figure 5-47. Test CH₄ damage – high cabinets open door

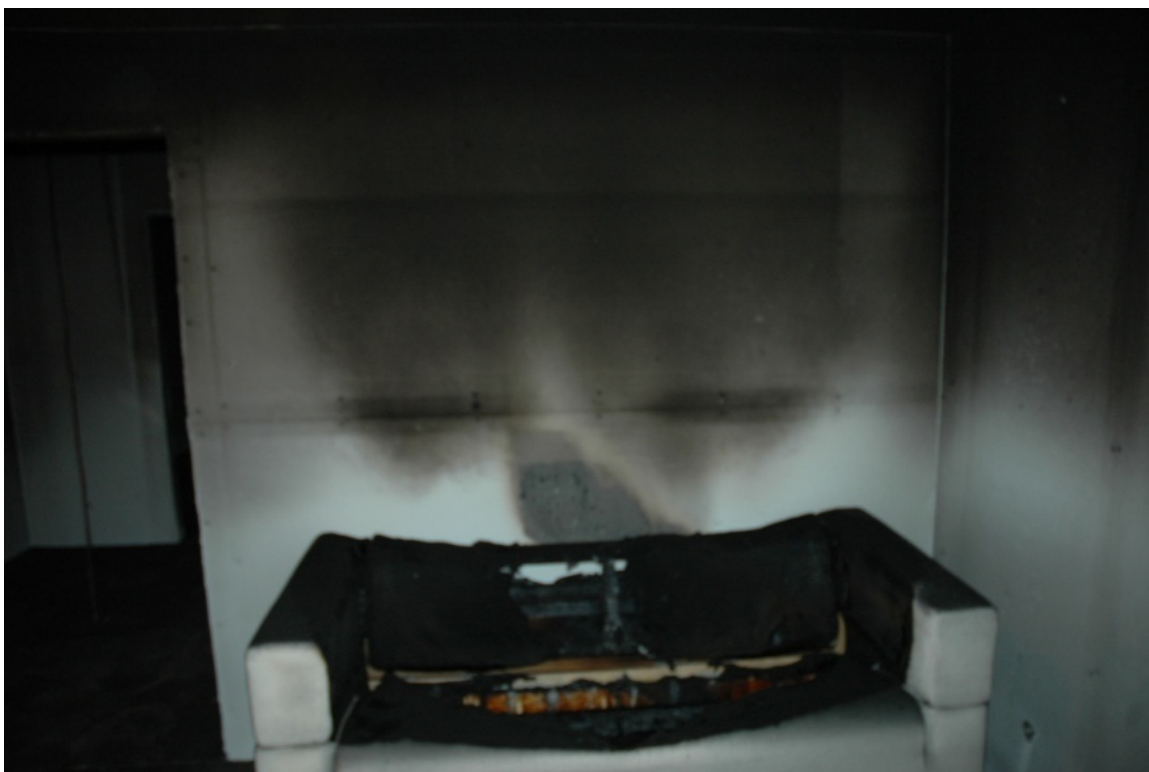
Figure 8-1. Fire pattern from test S1 (no ventilation)

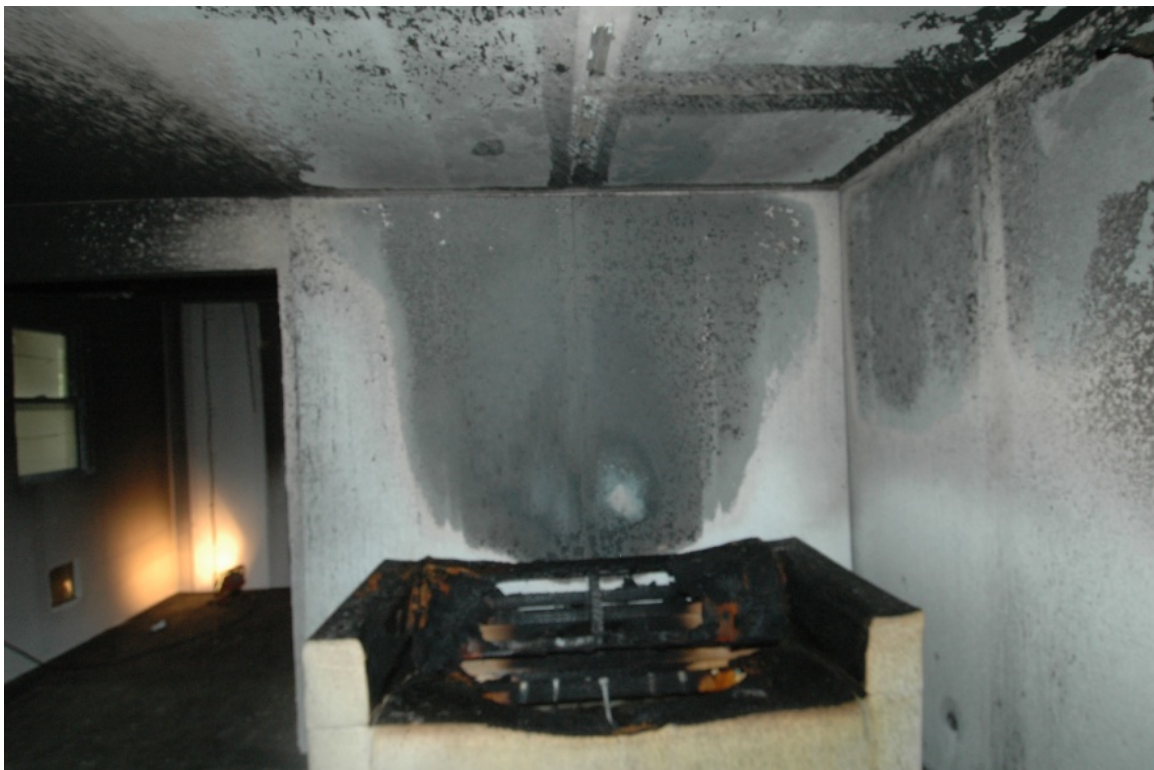
Figure 8-5. Fire pattern from test S2 (full open window)

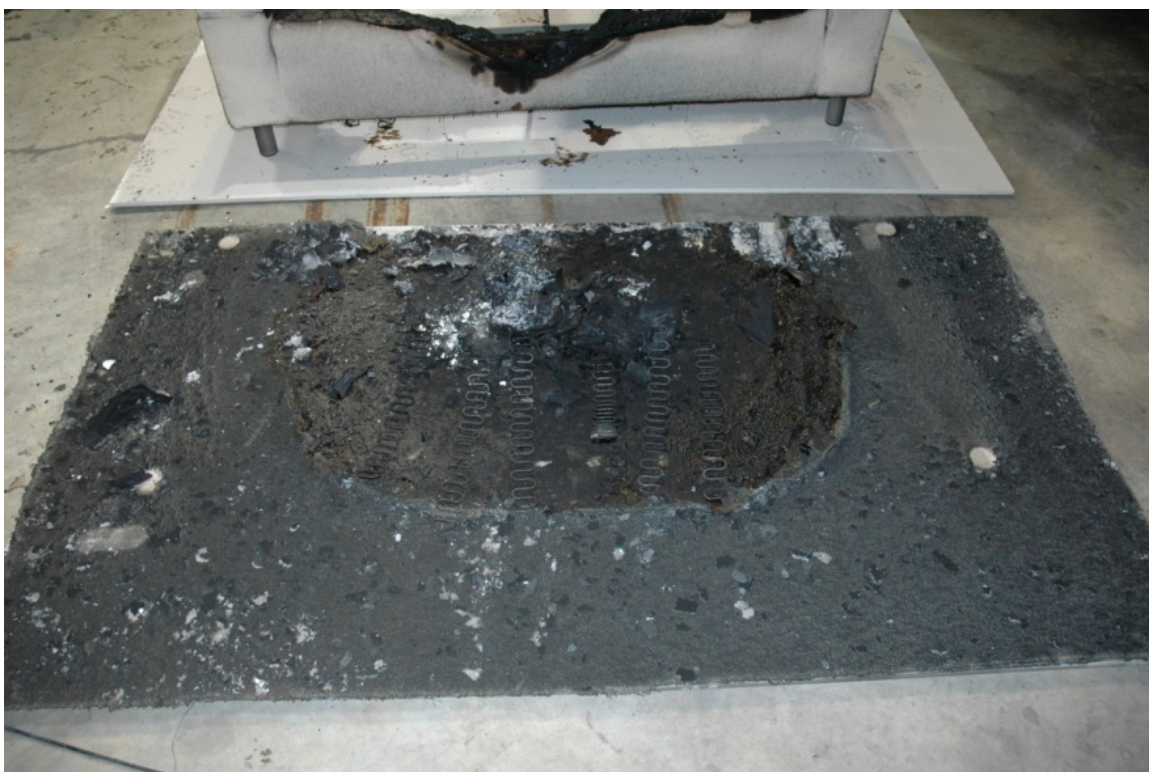
Figure 8-6. Burn pattern under sofa common to all accidental tests.

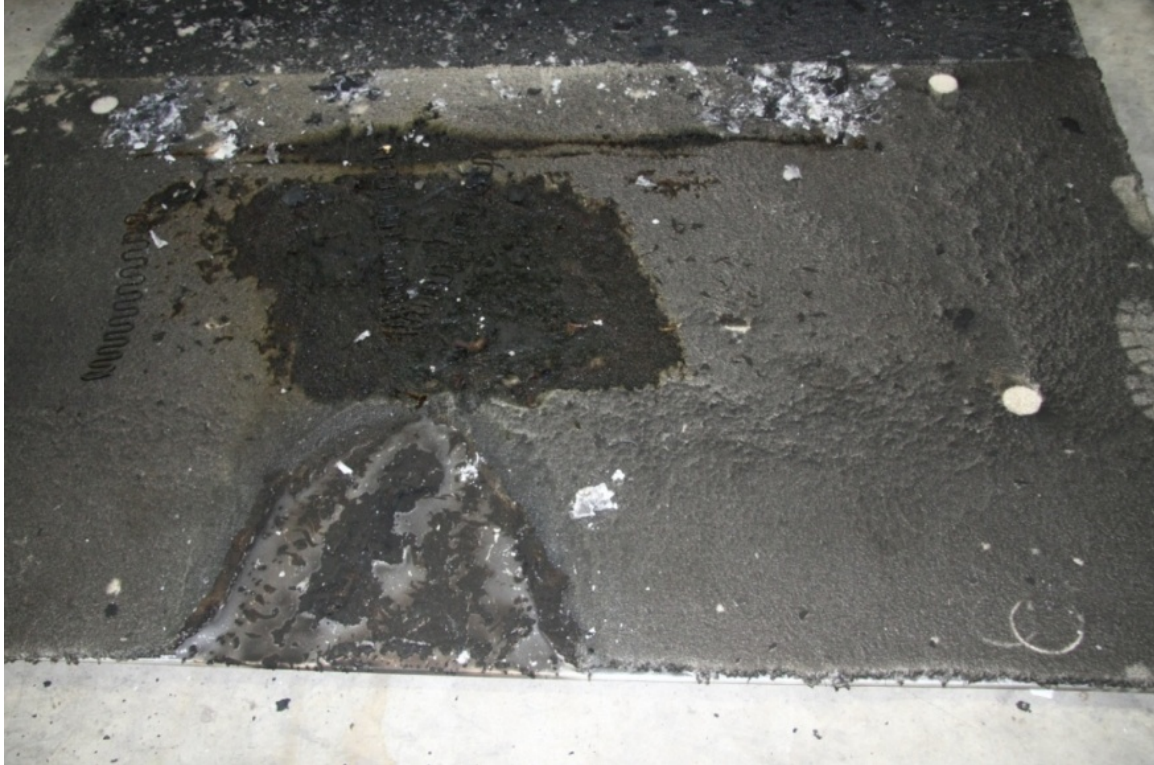
Figure 8-7. Burn pattern under and in front of sofa during accelerated test

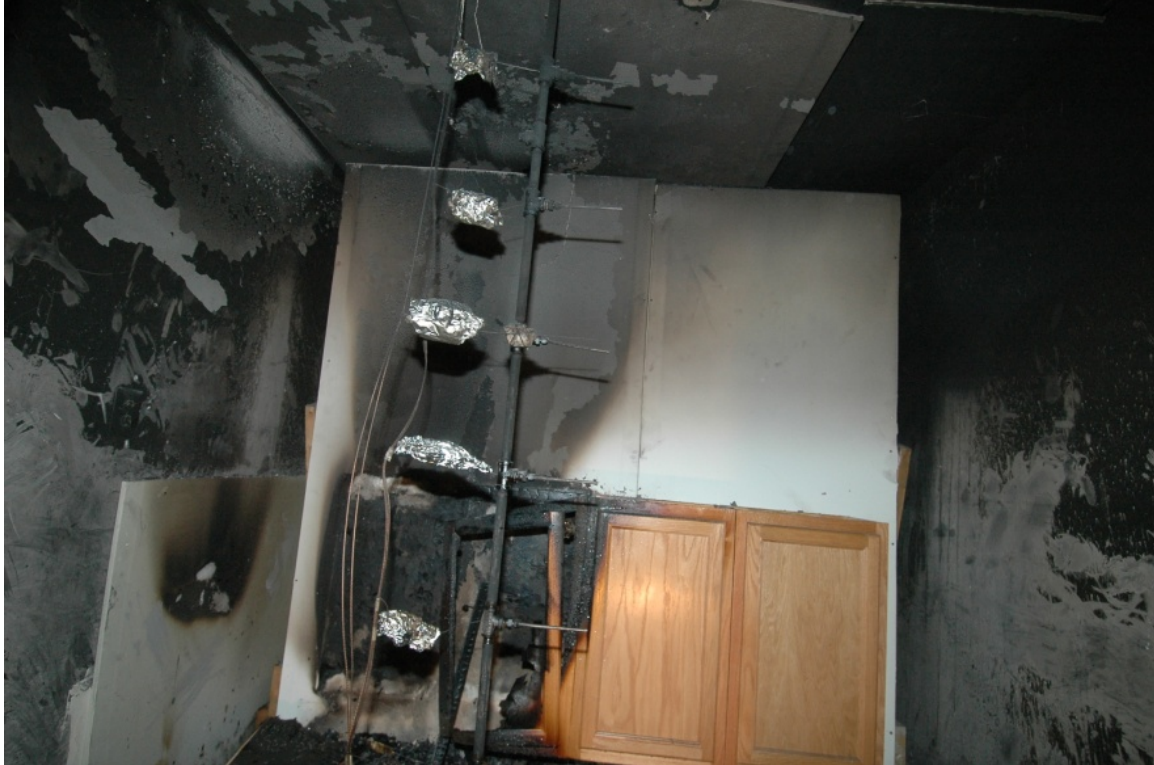
Figure 8-8. Fire pattern from test CL1 (no ventilation)

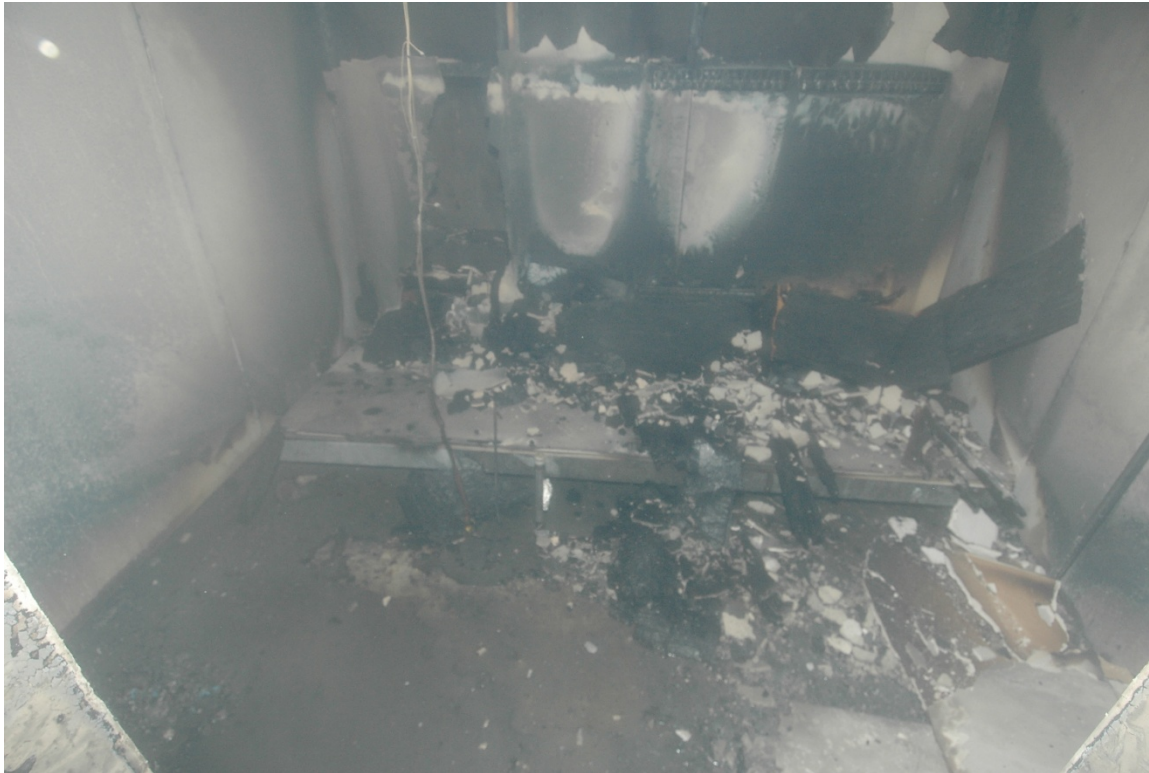
Figure 8-10. Fire pattern from test CL3 (open door)

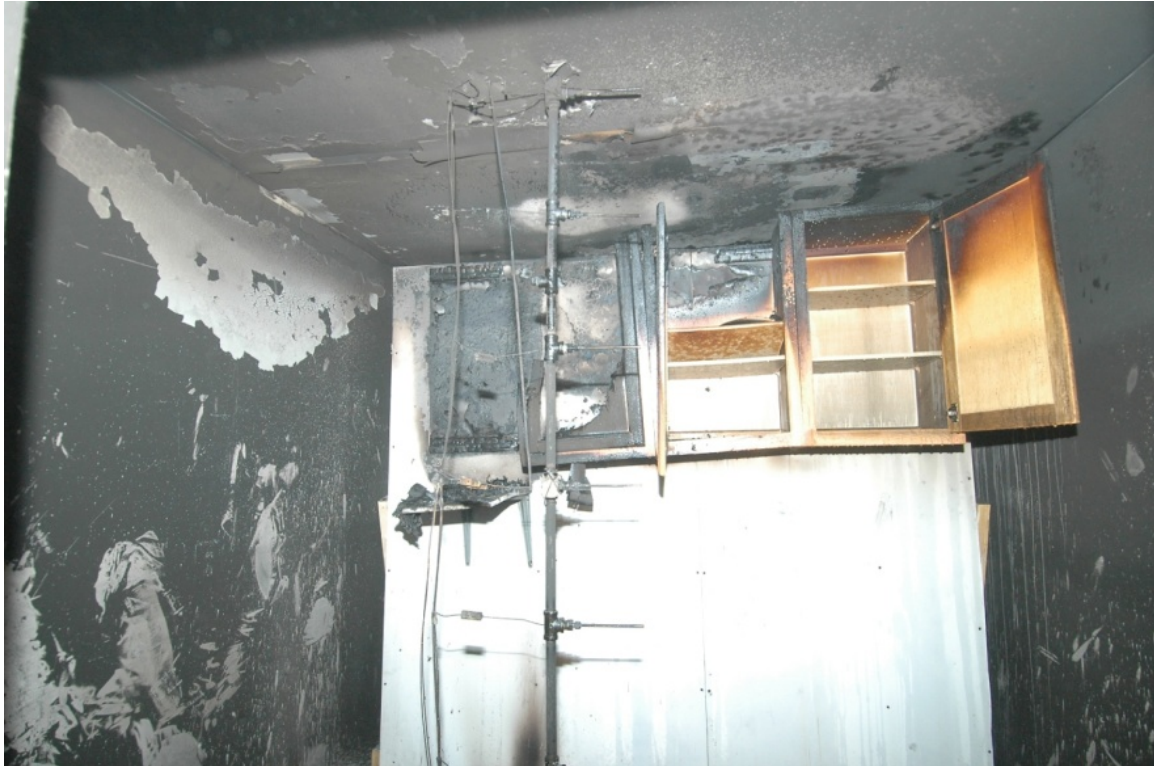
Figure 8-11. Fire pattern from test CH1 (no ventilation)

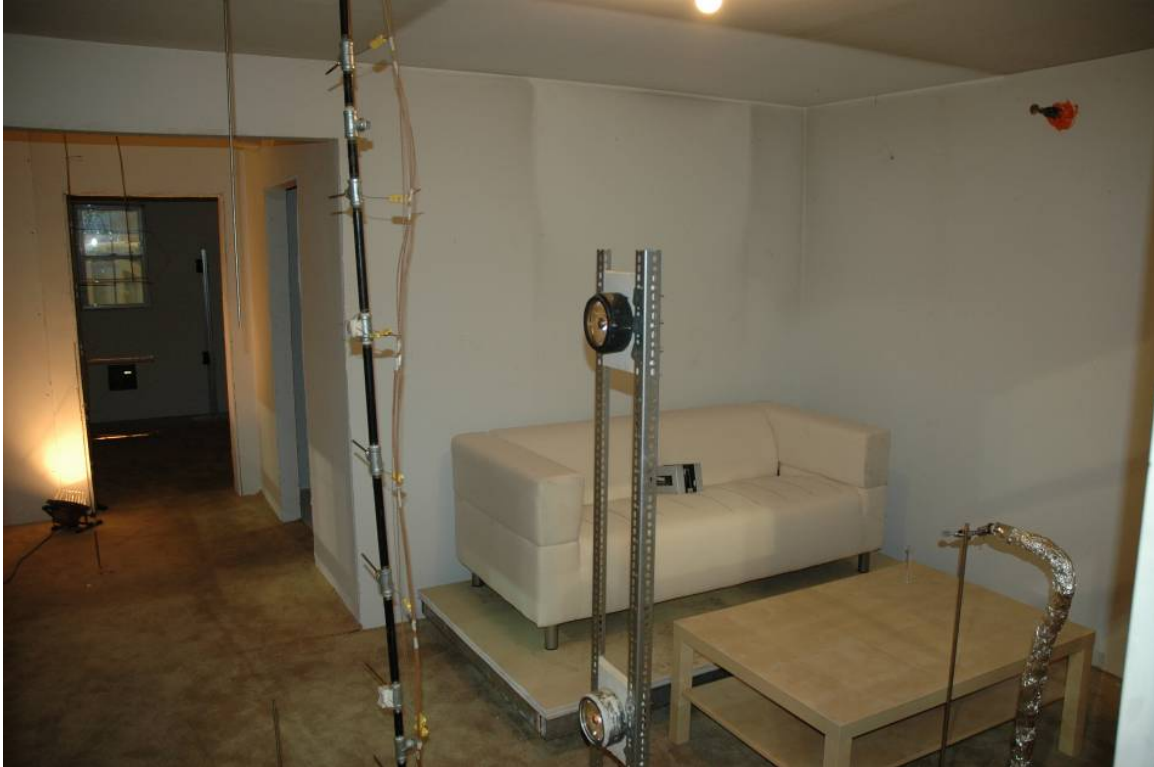
Figure 8-35. Before flaming sofa test (S1 – no ventilation)

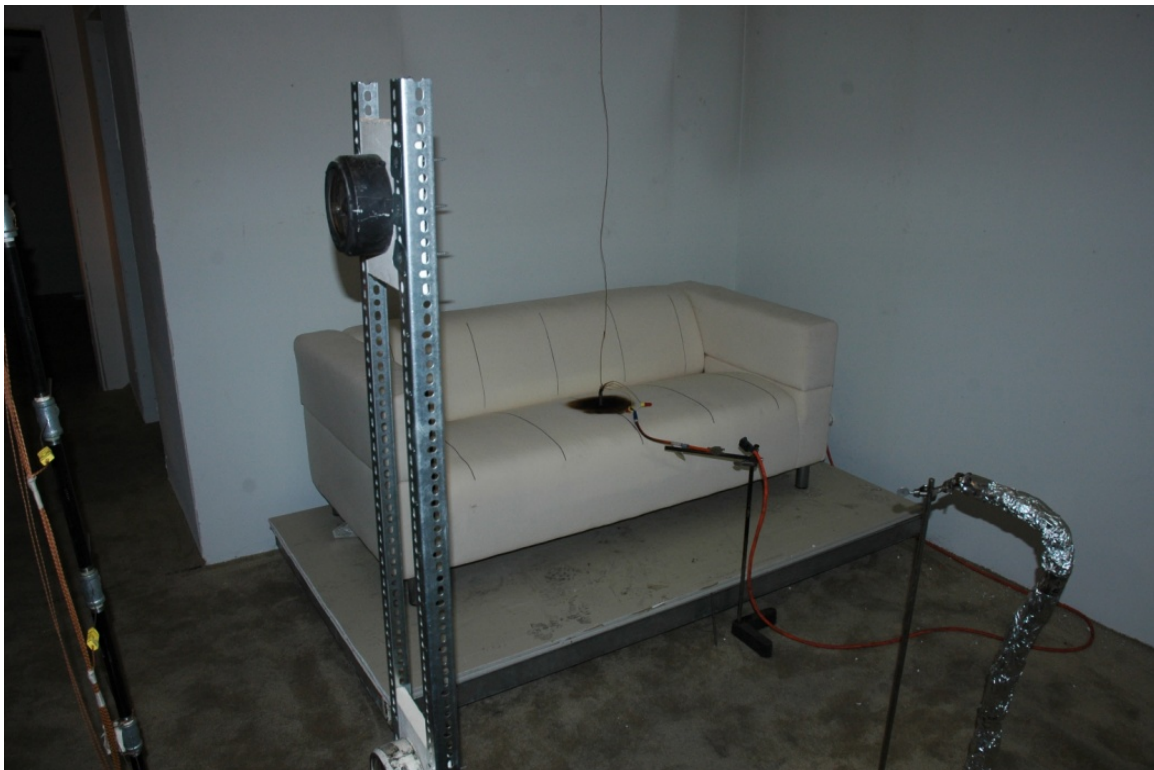
Figure 8-38. After smoldering sofa test (SM2 – no ventilation) (Note: this photo actually portrays the scene darker than observed on site due to the lighting in the space when the photo was taken.)
