Document Title: Fire Dynamics and Forensic Analysis of Limited Ventilation Compartment Fires Volume 1: Experimental

Author: Andrew J. Wolfe, Christopher L. Mealy, Daniel T. Gottuk

**Fire Dynamics and Forensic Analysis of Limited
Ventilation Compartment Fires
Volume 1: Experimental**

Hughes Associates, Inc.
3610 Commerce Drive, Suite 817
Baltimore, Maryland 21227
Ph. 410-737-8677
Fax 410-737-8688

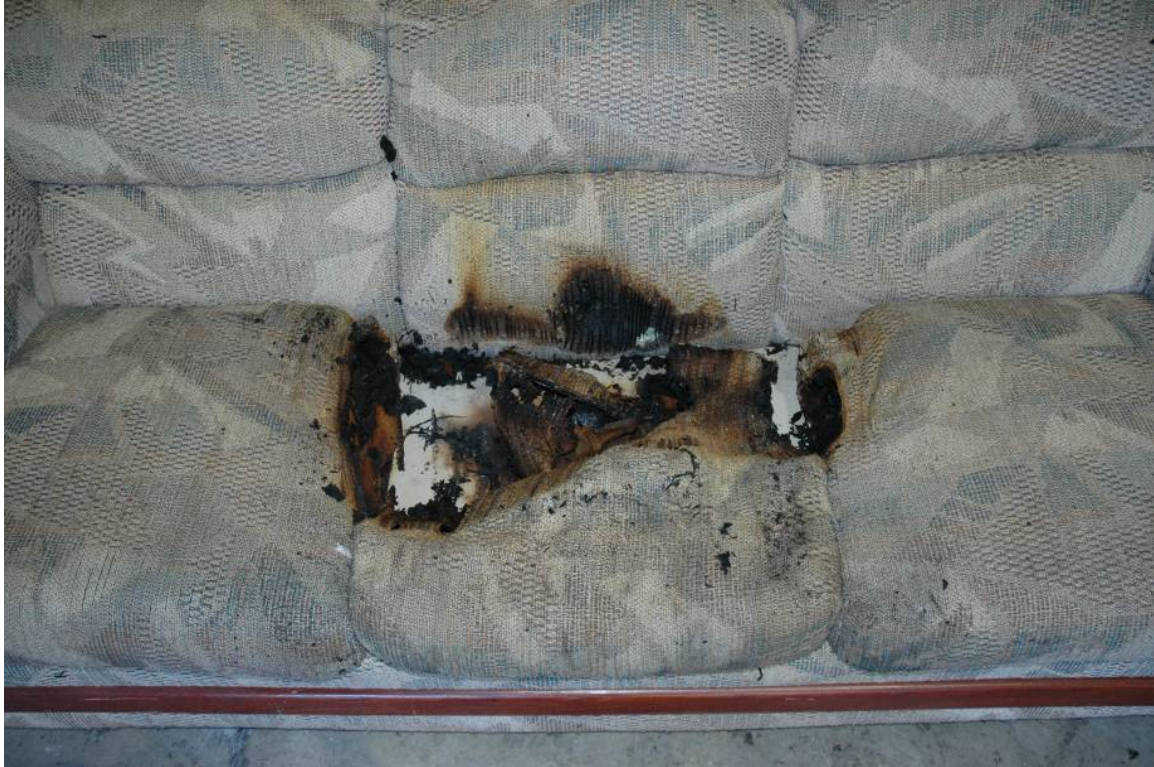
Figure 8-39. Damage to sofa after smoldering test (SM4 – no ventilation)

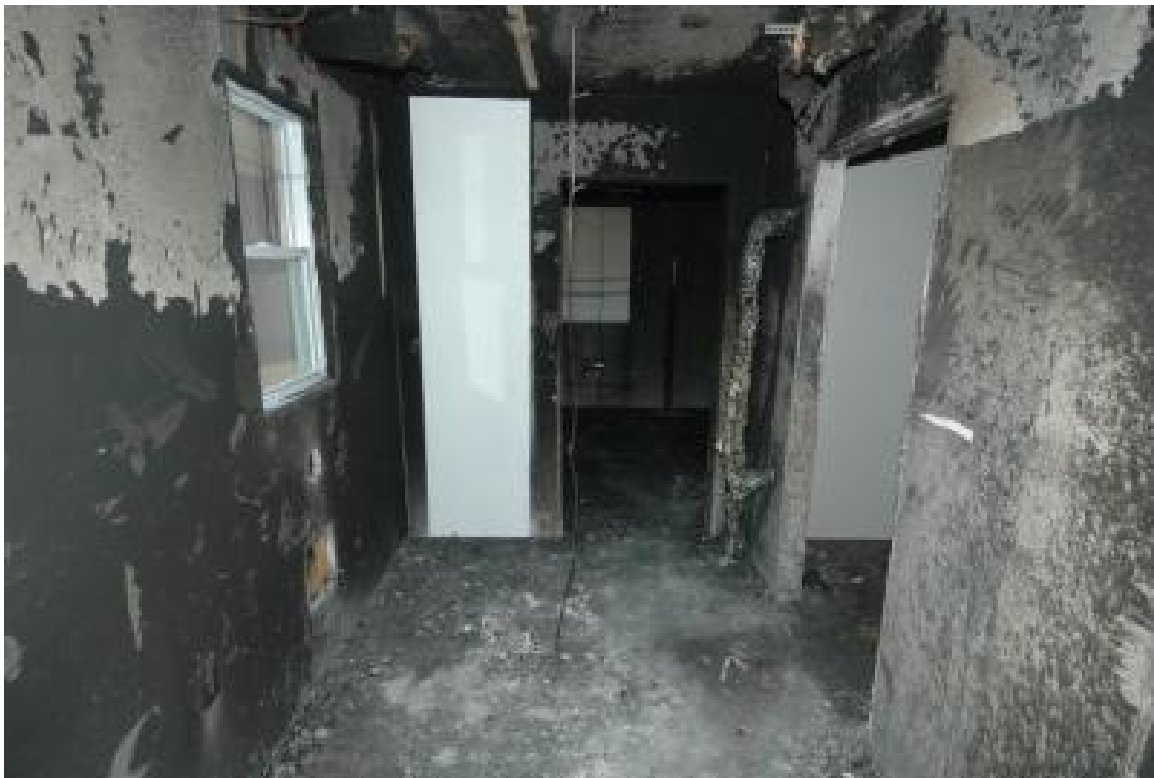
Figure 8-40. Soot deposition on GWB target after smoldering sofa test (SM4 – no ventilation)
